Safety Recall: VSA System Unexpectedly Activates

(Supersedes 13-026, dated June 28, 2013, to revise the information marked by the black bars)

**Safety Recall: VSA System Unexpectedly Activates
NHTSA- Recall 13V-092**

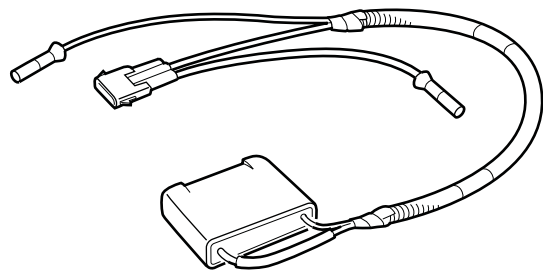
SUBHARNESS WITH CAPACITOR

VSA Subharness: P/N 06326-SFE-000

- Includes:
- Subharness with Capacitor
 - Wire Ties (4)
 - 3P Short Connector

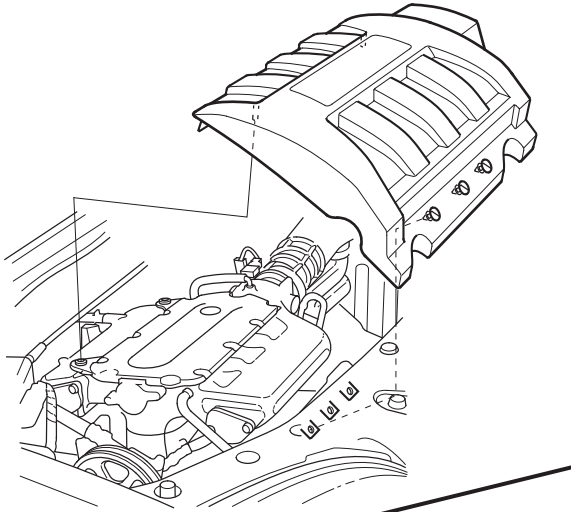
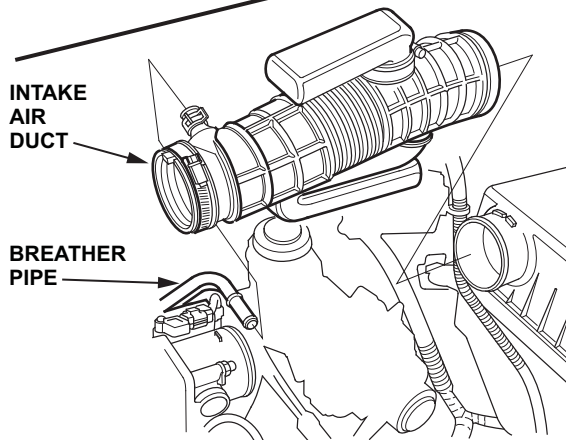
1. Turn the ignition switch to LOCK (0).
2. Remove the engine cover and the intake air duct.

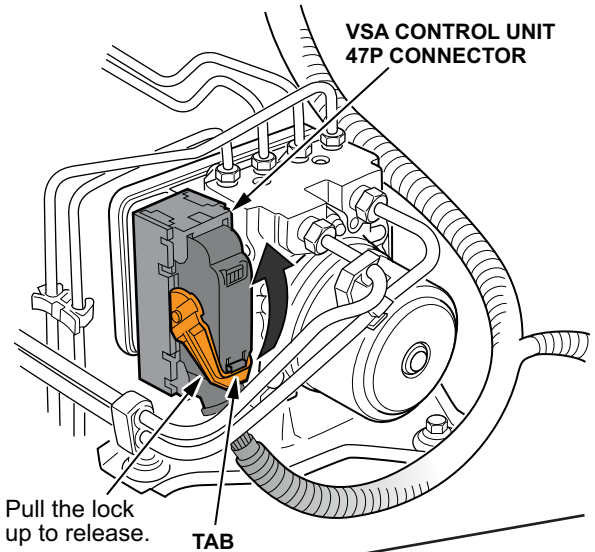
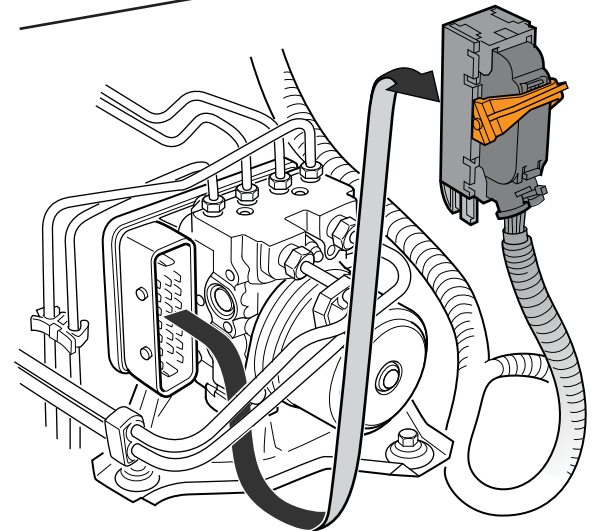
3. Disconnect the VSA modulator-control unit 47P connector.

- Do not force the lock because if you break it, the entire harness must be replaced. Make sure that you press the release tab before trying to move the lock. If needed, wiggle the connector while moving the lever to release the sliding mechanism in the connector.
- Disconnect the harness clips as needed to access the harness.

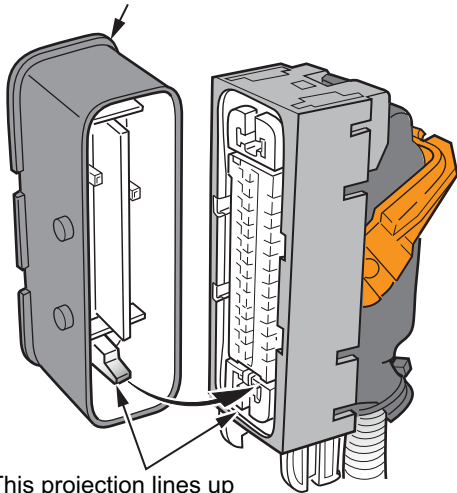
LANCE RELEASE HOUSING

4. Insert the lance release housing into the 47P connector.

This projection lines up with the primary lock at the bottom of the connector.

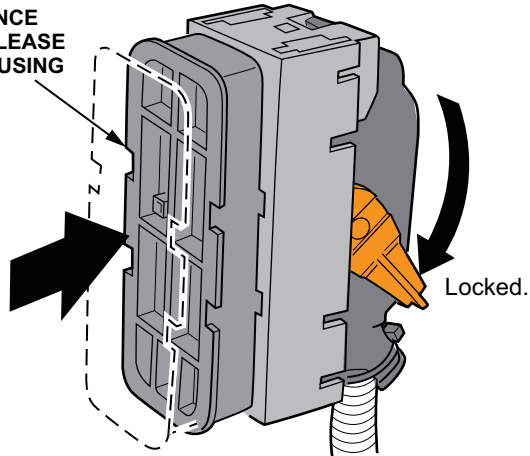
LANCE RELEASE HOUSING

5. Move the lock to the locked position. The lance release housing is fully drawn into the connector and clicks into place.

- Do not apply excessive force.
- If the lock sticks or will not move smoothly, return the lock to its original position, recheck the position of the lance release housing, and try again.

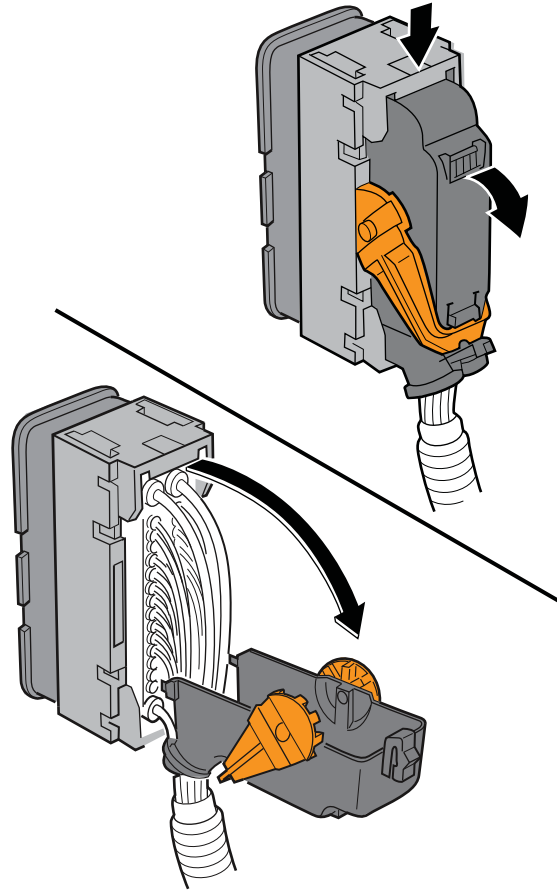
6. Use a small screwdriver to unlock and remove the lock assembly from the 47P connector.

Press to release lock assembly.

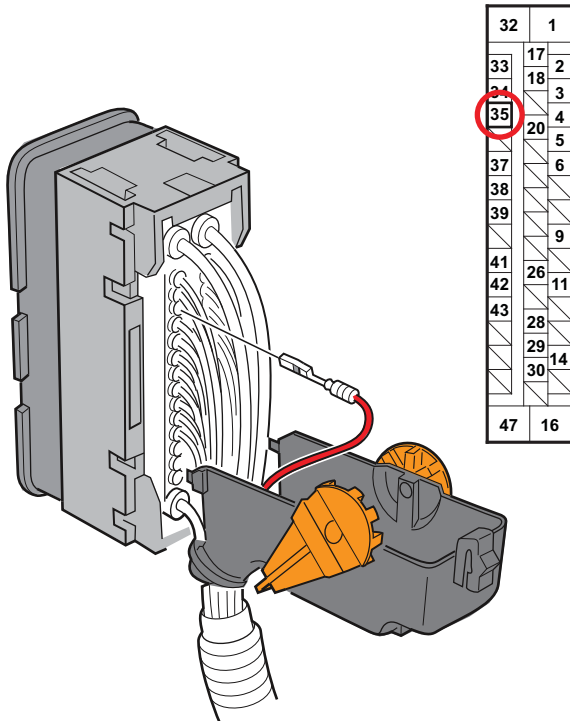
- Remove the No. 35 red wire terminal from the connector while pushing up on the lance release housing.

NOTE: Take note of the orientation of the notch in the terminal when it comes out because you'll insert the new terminal the same way.

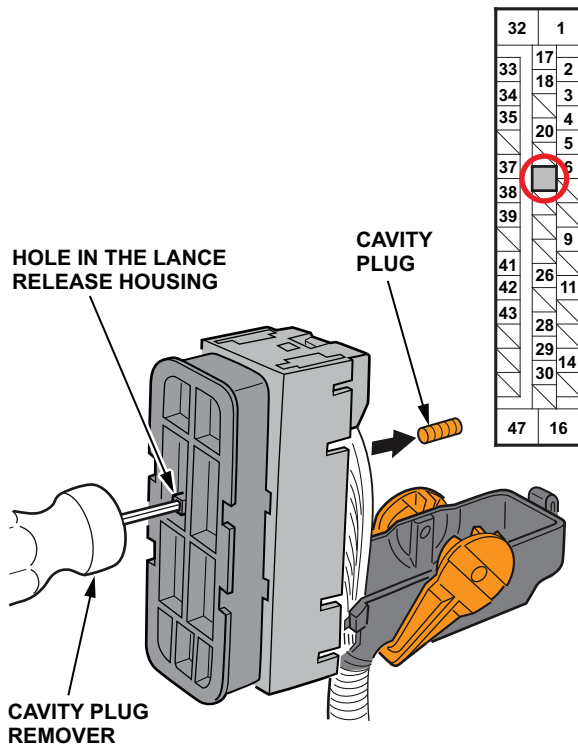
- Insert the cavity plug remover into the hole in the lance release housing as shown, and push out the plug from the No. 22 cavity.

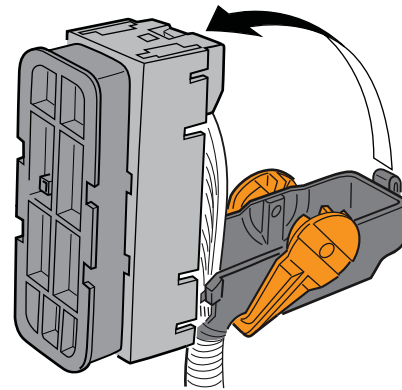
- Tuck the loose terminal and wire into the housing, then install the lock assembly onto the 47P connector as shown.

- Make sure the harness is not pinched.
- Make the lever is properly aligned.

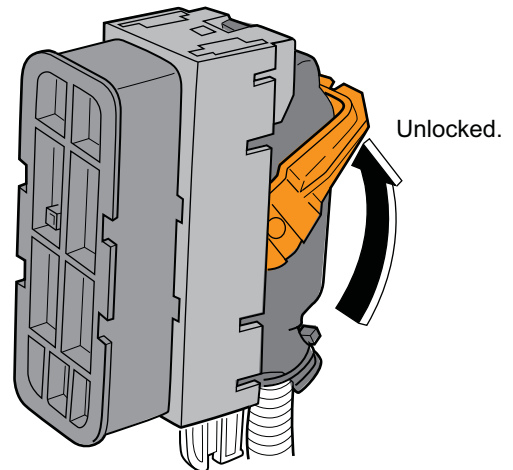
- Press the lock release tab, then move the lock to the unlocked position. The lance release housing also moves into the unlocked position.

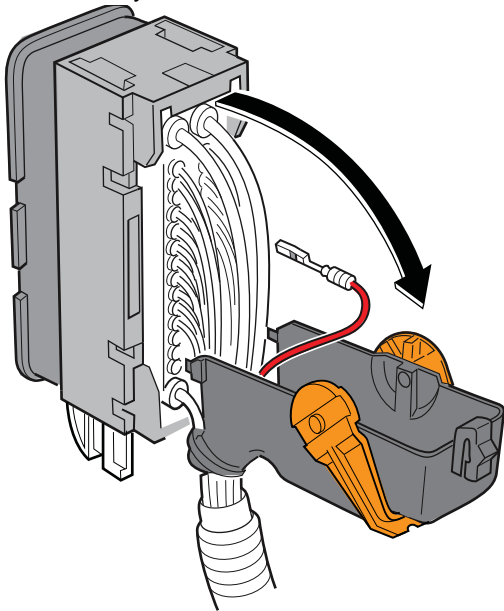
11. Using a small screwdriver, unlock and remove the lock assembly from the 47P connector.

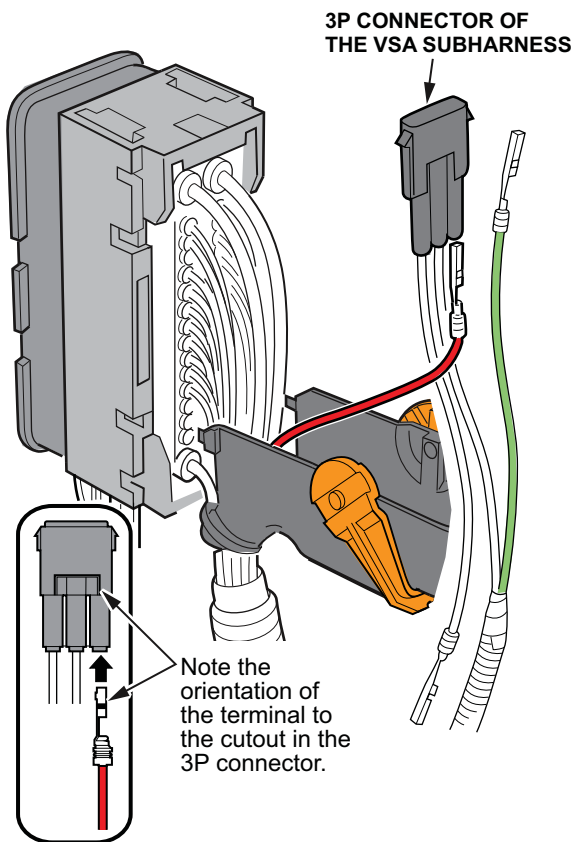
12. Install the VSA subharness.

- Make sure the terminal and connector are properly oriented; the notched part of the terminal should be aligned as shown.

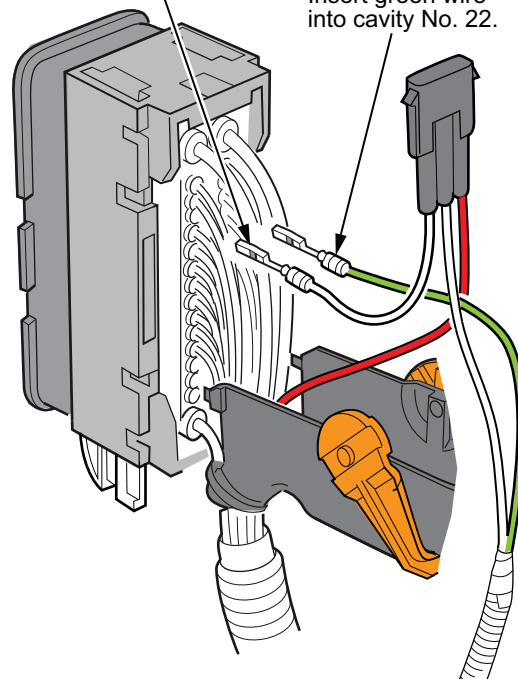
- Do not force the terminal into the connector to avoid damaging the terminals.
- You may hear a click when the terminal (red wire) is seated in the 3P connector.
- After inserting the terminal (red wire) into the 3P connector, gently pull on the wire to make sure it is locked into place.
- Insert the red wire terminal that was removed from cavity No. 35 into the 3P connector of the VSA subharness.
- Insert the VSA subharness white wire into the VSA control unit 47P connector cavity No. 35.
- Insert the VSA subharness green wire into the VSA control unit 47P cavity No. 22.

Insert white wire into cavity No. 35.

Insert green wire into cavity No. 22.

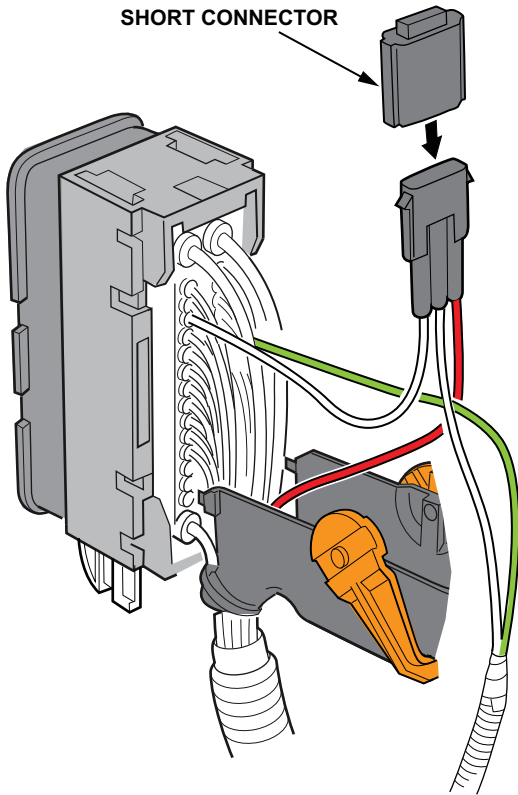
SHORT CONNECTOR

13. Install the short connector to the 3P connector.

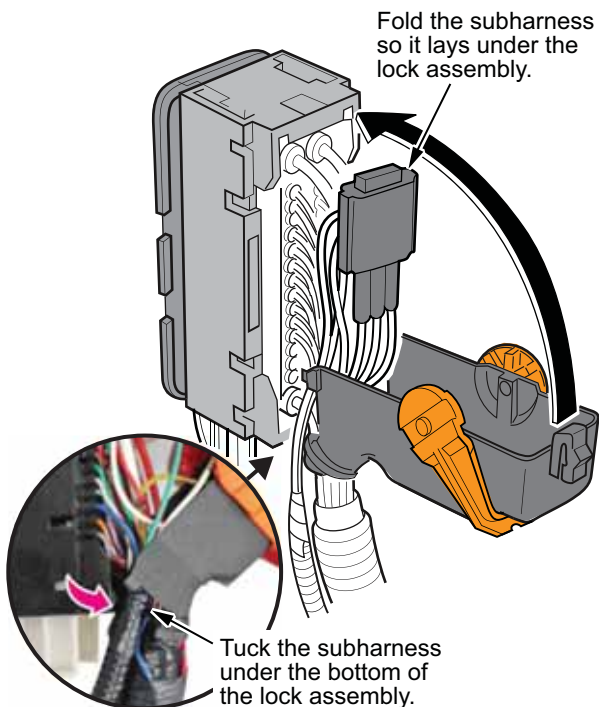
14. Lay out the subharness as shown, then install the lock assembly.

- Make sure the subharness is not pinched.
- Make sure the lock is properly aligned.

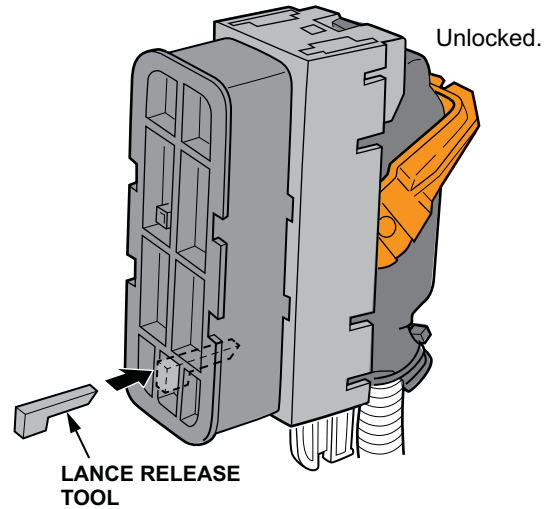
15. Make sure the lance release housing is in the unlocked position, then fully insert the lance release tool into the hole as shown.

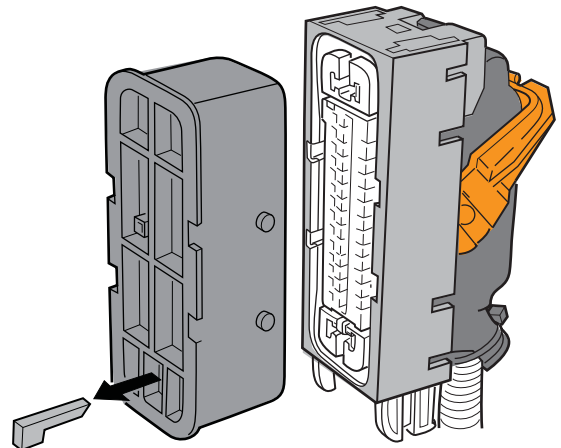
16. Remove the lance release tool, then remove the lance release housing.

NOTE: You may have to slightly squeeze the ends of the connector to remove the lance release housing.

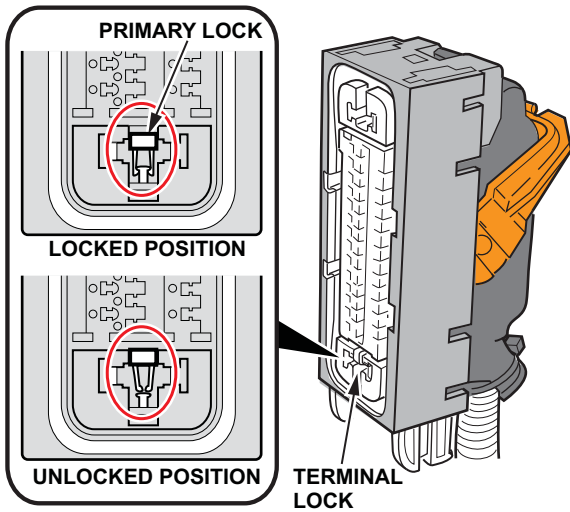
17. Inspect the primary lock to make sure it is in the locked position.

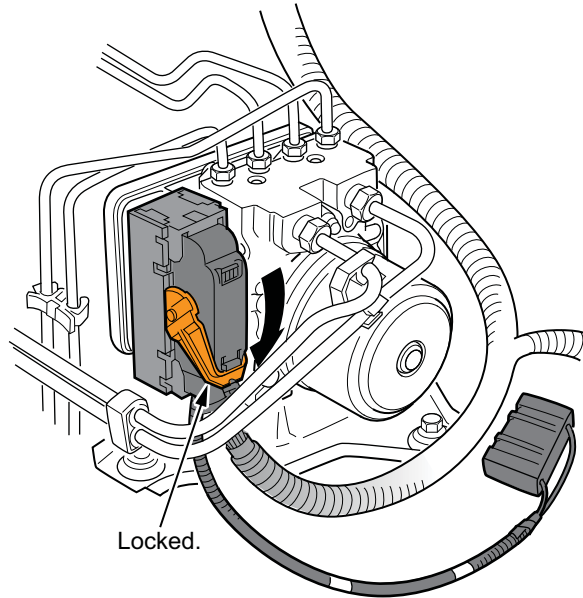
19. Route the subharness as shown. Use the two wire ties provided in the kit to secure the capacitor to the wire harness.

- Wrap wire tie A around the capacitor and the vehicle harness only. Do not wrap it around the VSA subharness.
- Wrap wire tie B around the capacitor, the vehicle harness, and the VSA subharness.

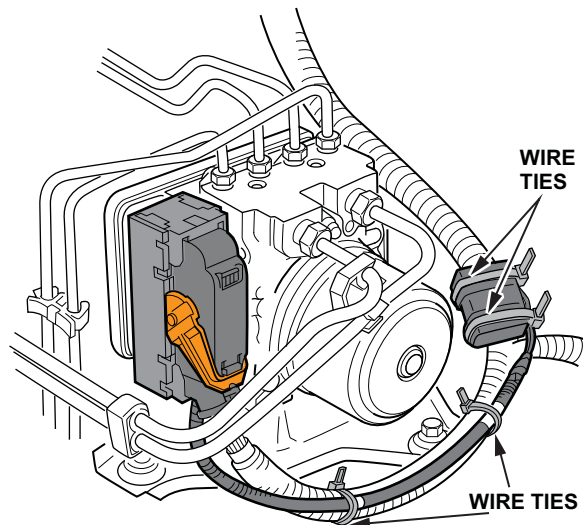
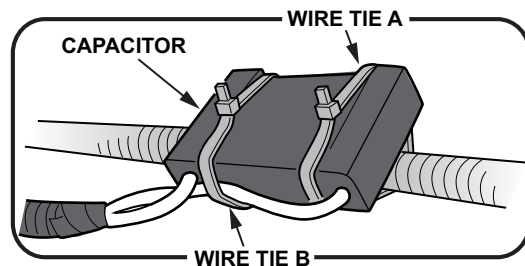
20. Secure the VSA subharness to the vehicle harness in the area of the white tape as shown, then reconnect any disconnected wire harness clips.
 - > Wire Ties (2)
21. Reinstall the intake air duct and the engine cover.
22. Start the engine and make sure the VSA system indicator goes off.

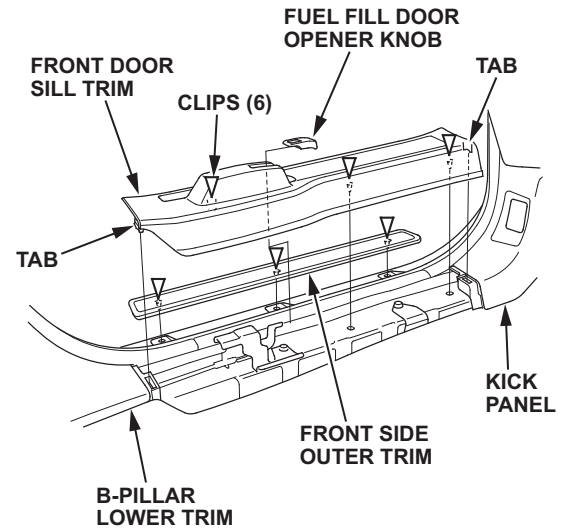
1. Remove the fuel fill door opener knob.

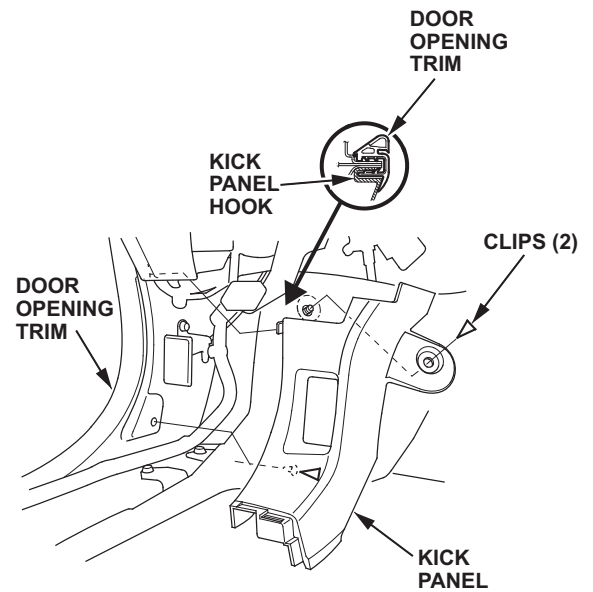
2. Remove the driver's front door sill trim.
3. Remove the driver's kick panel.

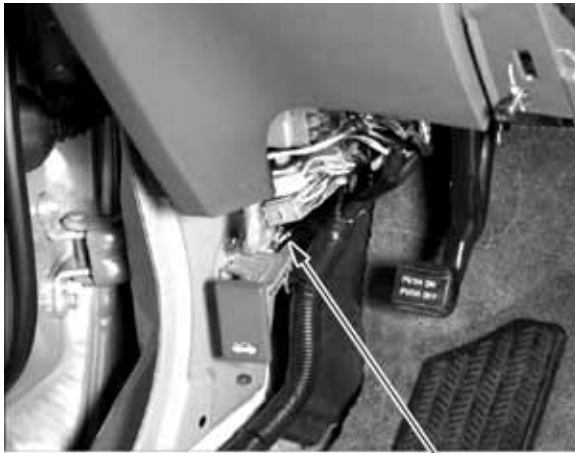
4. Remove the G302 bolt.

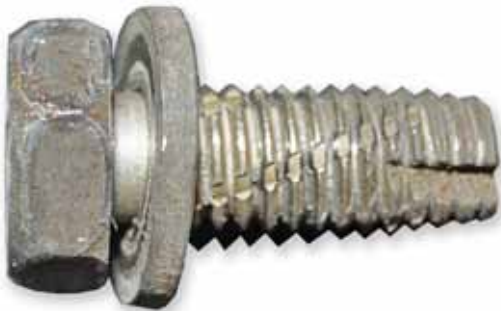
GROUND BOLT

5. Inspect the bolt for the following issues:
 - Corrosion
 - Damage
 - Cross-threading
 - The bolt is a regular bolt, not a ground bolt
 - If the bolt has any of the above issues, replace it before going to step 6.
 - If the ground bolt does not have any of the listed issues, it is OK. Go to step 6.
