02246 Version 2

Fluttering Noise From Behind Dashboard

Supersedes 15-042, Dated September 23, 2015; to revise the information highlighted in **yellow**.

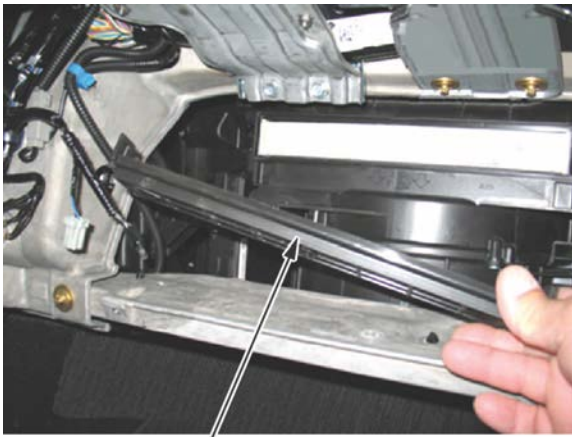
Remove HVAC filter cover.

1. Remove the glove box according to the service information.
2. Remove the HVAC filter cover.

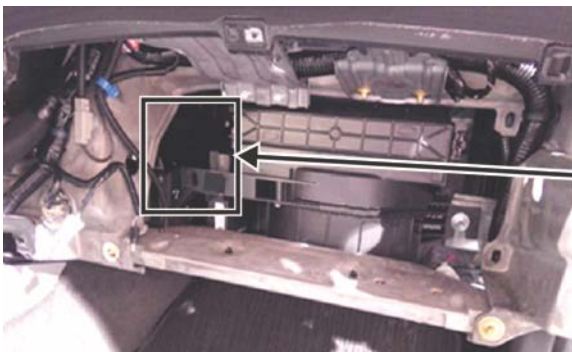
3. Install the self-tapping screw (P/N 90132-SR3-003), into the defrost damper door shaft on the passenger side of the heater case. Start the screw by hand to minimize the chance of dropping and losing it. Tighten the screw until the head is seated against the plastic heater case.

NOTE: Do not over torque the screw or you can damage the heater case.

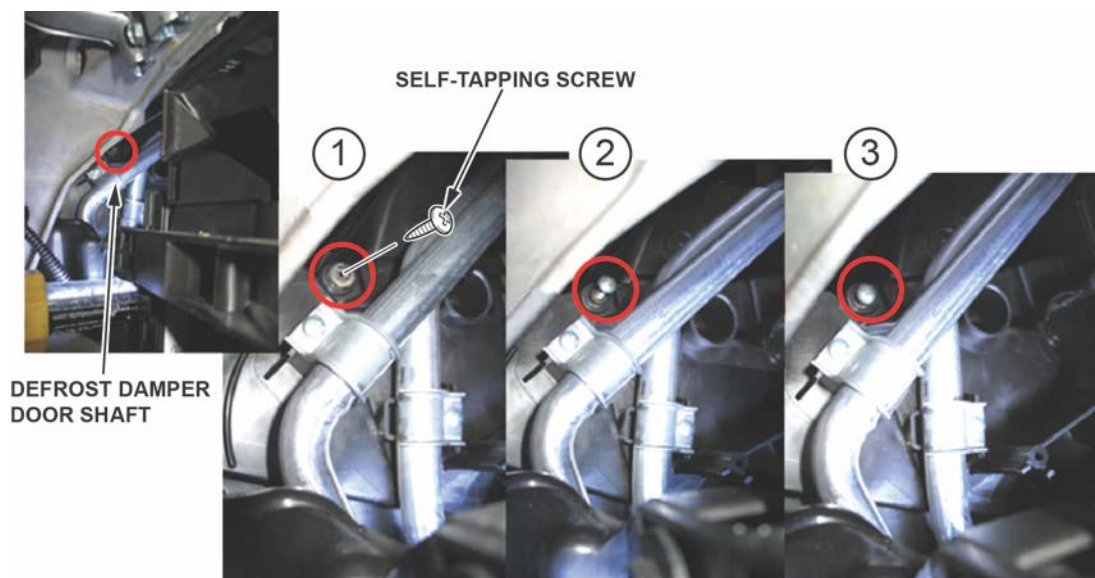
View of Heater Case with Defrost Damper Door Shaft
