ATB 51811-01884 Version 12

Safety Recall: Front Passenger's Airbag Inflator Can Be Over-Pressurized

Supersedes 14-040, dated August 14, 2015 to revise the information highlighted in **yellow**

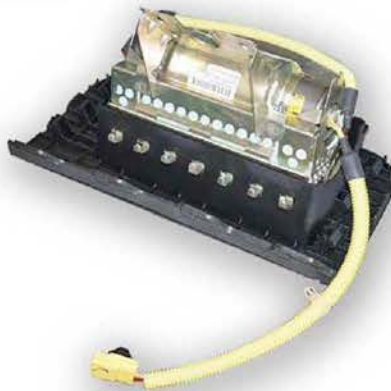
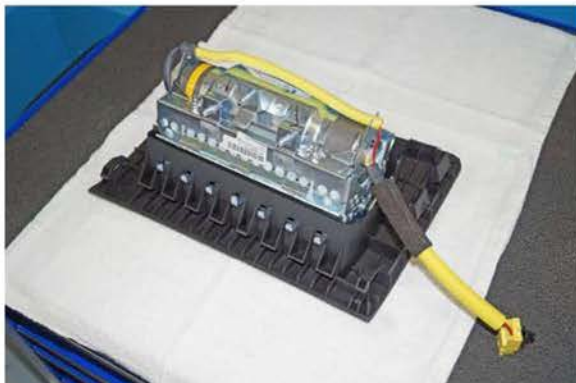
4. Place the airbag face-down on a clean shop towel as shown.

- The orientation of the airbag is critical because if the inflator is installed incorrectly, the harness will be too short when you reinstall the airbag.
- The brackets between the various models are similar but may differ from the example shown in the procedure.

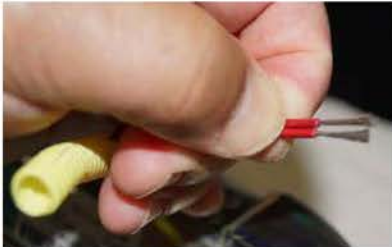
- Strip away about 1 inch of the wire insulation, then twist the wires together.

- Tape the twisted ends with electrical tape.

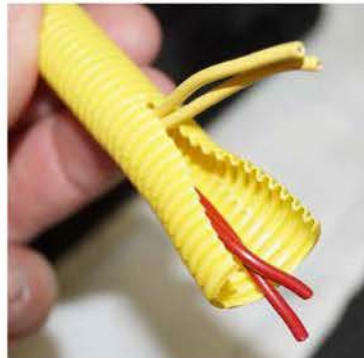
- Cut about 2 inches of the corrugated tube, then pull out the yellow wires.

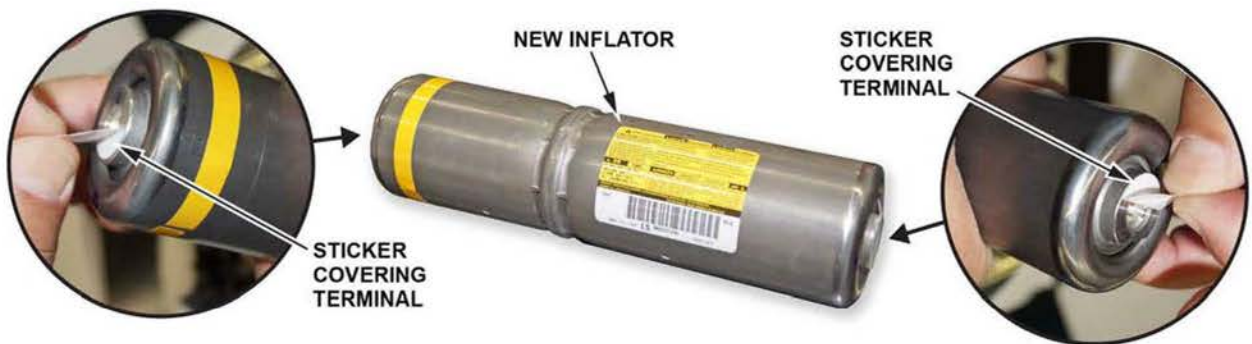
15. Remove the stickers covering the terminals on both sides of the new inflator.

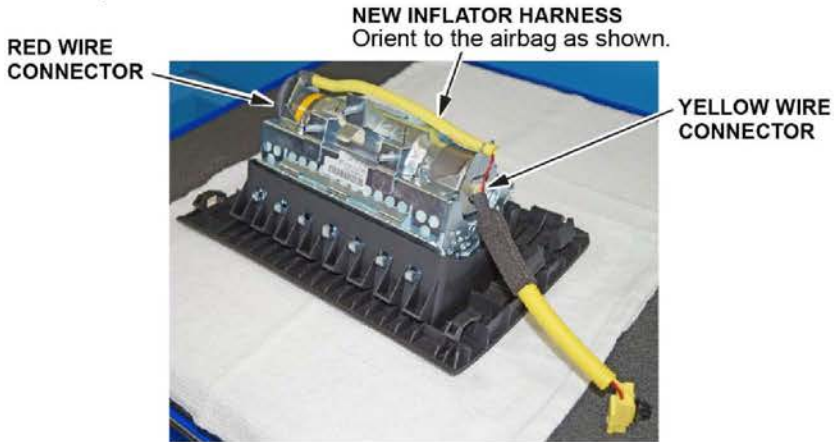
- Make sure the airbag and harness are aligned as shown.

- **Make sure you have the orientation correct as shown below.** If you connect the harness incorrectly, the harness cannot be removed, and you will not be able to reinstall the airbag because the harness will be too short.
- On the replacement inflators with plastic collars, connect the red wire connector to the connector with the red dot.
- On the replacement inflators without plastic collars, connect the red wire connector to the connector nearest the yellow band.

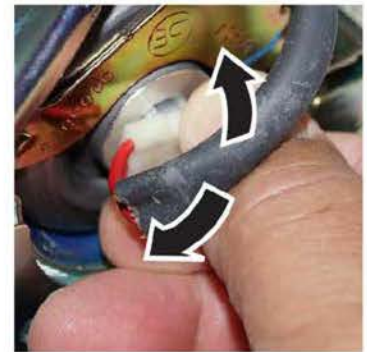
③ Wiggle the connector to make sure it's secure.

- After you hear each connector click, wiggle it to make sure it is secure.
NOTE: If the connector is not properly aligned, it will come out.
