September 16, 2015

00407-01886 Version 7

Safety Recall: Front Passenger's Airbag Inflator May Produce Excessive Pressure After Long-Term Exposure To High Absolute Humidity

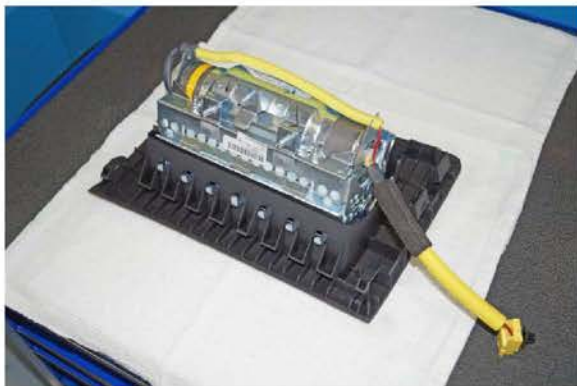
3. Remove the front passenger's airbag by referring to the applicable electronic service manual.
 4. Place the airbag, face-down, on a clean shop towel.

- The orientation of the airbag is critical because if the inflator is installed incorrectly, the harness will be too short when you reinstall the airbag.
- The brackets between the various models are similar but may differ from the example shown.

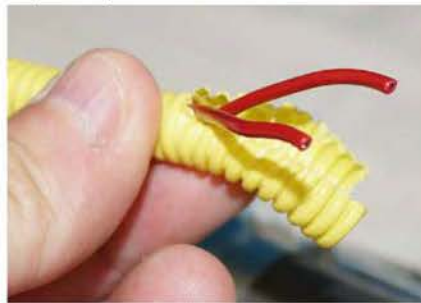
- Cut about 2 inches of the corrugated tube, then pull out the two red wires.

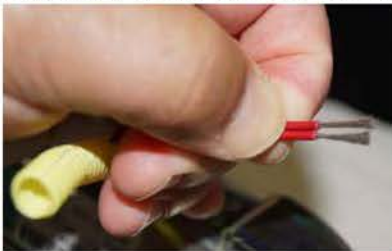
- Strip away about 1 inch of the wire insulation, then twist the wires together.

- Tape the twisted ends with electrical tape.

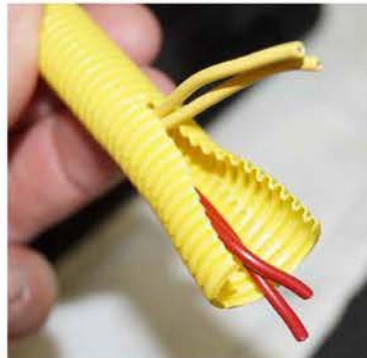
- Cut about 2 inches of the corrugated tube, then pull out the yellow wires.

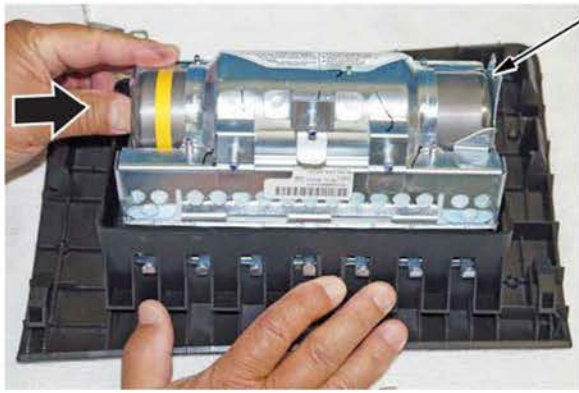
No gap.

- Slide the inflator in until the “D” aligns with the tab on the inflator bracket. There should be no space or gap between the inflator and bracket.

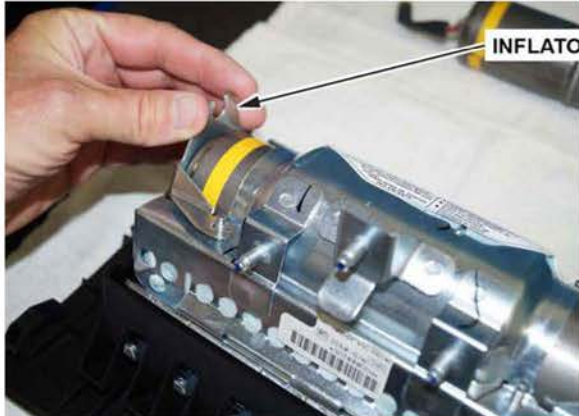
- Reinstall the inflator bracket. There should be no space or gap between the bracket and inflator.

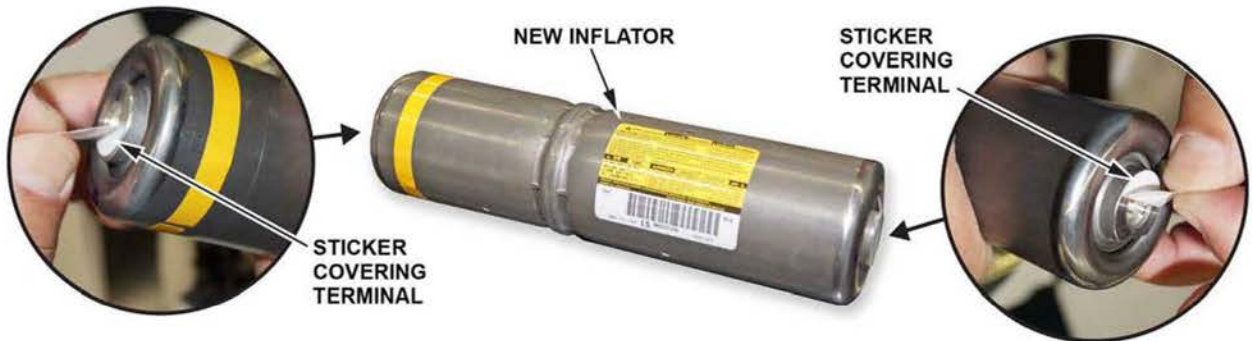
15. Remove the stickers covering the terminals on both sides of the new inflator.

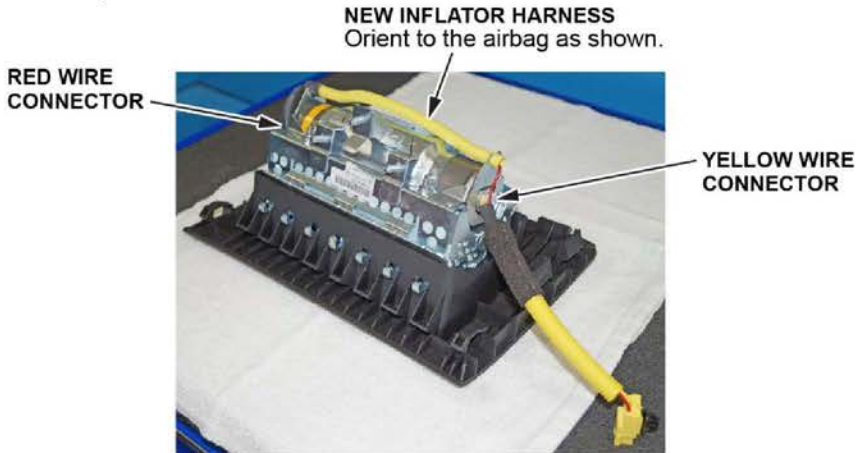
16. Install the new inflator harness.

- Make sure the airbag and harness are aligned as shown.

- **Make sure you have the orientation correct as shown below.** If you connect the harness incorrectly, the harness cannot be removed, and you will not be able to reinstall the airbag because the harness will be too short.
- On the replacement inflators with plastic collars, connect the red wire connector to the connector with the red dot.
- On the replacement inflators without plastic collars, connect the red wire connector to the connector nearest the yellow band.

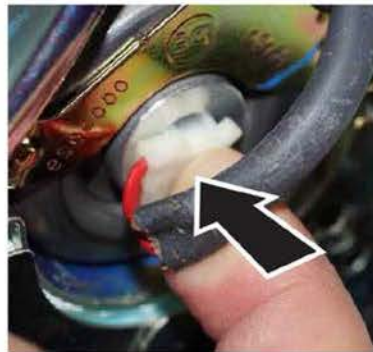
② Press the connector into place until it clicks.

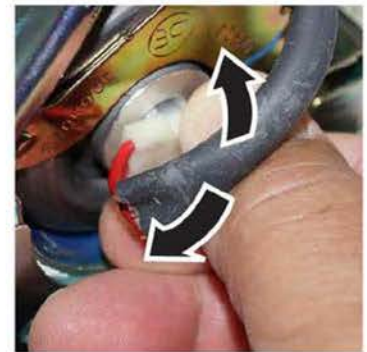
③ Wiggle the connector to make sure it's secure.

- After you hear each connector click, wiggle it to make sure it is secure.

NOTE: If the connector is not properly aligned, it will come out.
