September 15, 2015

51969-01908 Version 8

Recall: Front Passenger's Airbag Inflator May Produce Excessive Pressure After Long-Term Exposure To High Absolute Humidity

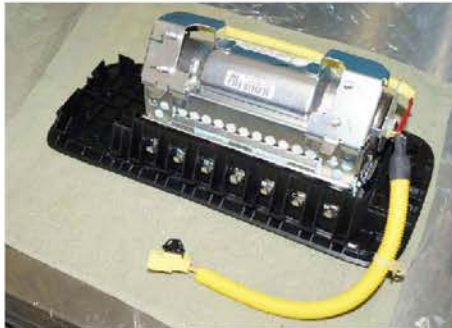
4. Place the airbag face-down on a clean shop towel as shown.

- The orientation of the airbag is critical because if the inflator is installed incorrectly, the harness will be too short when you reinstall the airbag.
- The brackets between the various models are similar but may differ from the example shown.

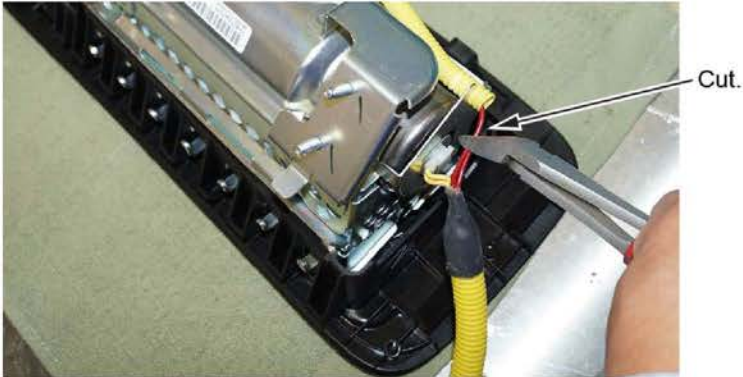
- Cut the red wires as shown.

8. Short the red wires.

NOTE: You must cut and short the wires as indicated to prevent accidental deployment.

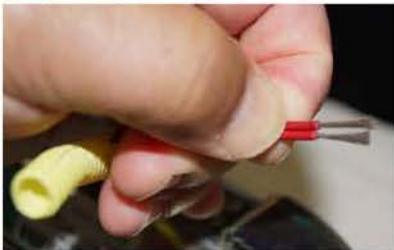
- Strip away about 1 inch of the wire insulation, then twist the wires together.

- Tape the twisted ends with electrical tape.

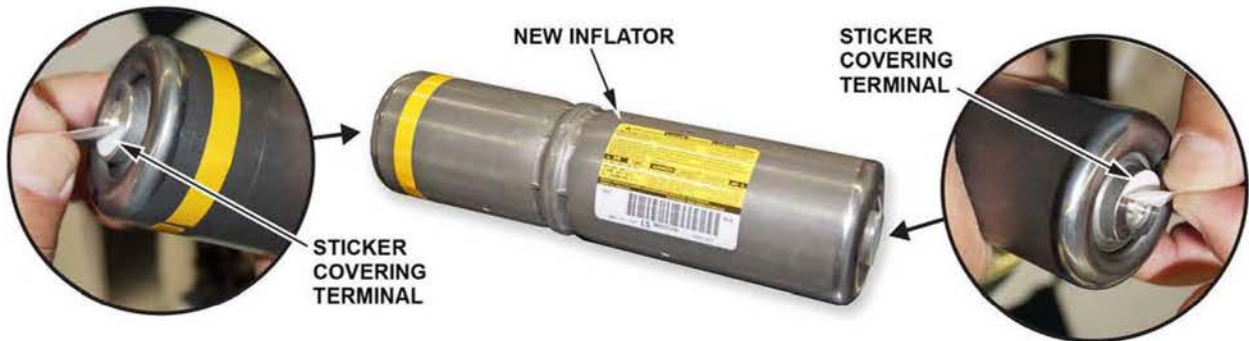
15. Remove the stickers covering the terminals on both sides of the new inflator.
