September 16, 2015

00406-01910 Version 4

Safety Recall: Front Passenger's Airbag Inflator May Produce Excessive Pressure After Long-Term Exposure To High Absolute Humidity

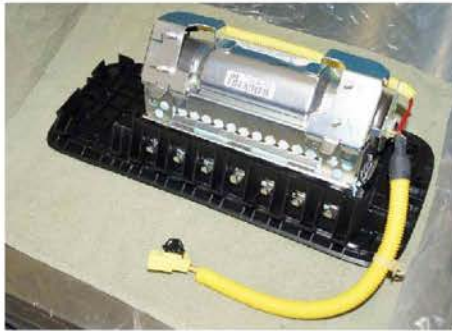
3. Remove the front passenger's airbag by referring to the applicable electronic service manual.
 4. Place the airbag face-down on a clean shop towel as shown.

- The orientation of the airbag is critical because if the inflator is installed incorrectly, the harness will be too short when you reinstall the airbag.
- The brackets between the various models are similar but may differ from the example shown.

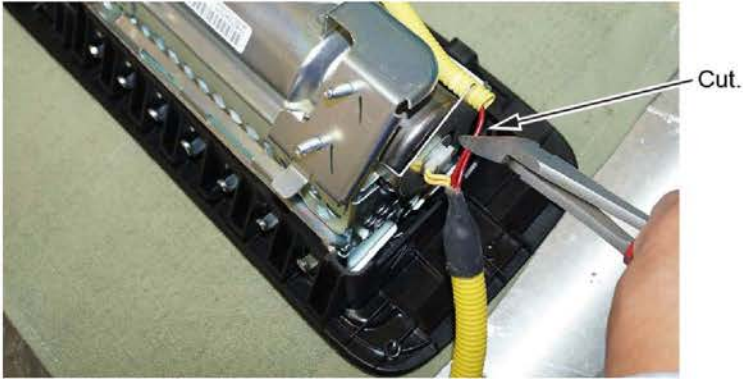
8. Short the red wires.

NOTE: You must cut and short the wires as indicated to prevent accidental deployment.

- Cut the red wires as shown.

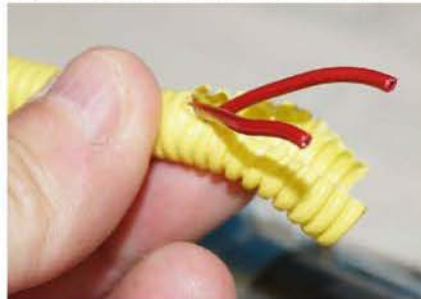
- Cut about 2 inches of the corrugated tube, then pull out the two red wires.

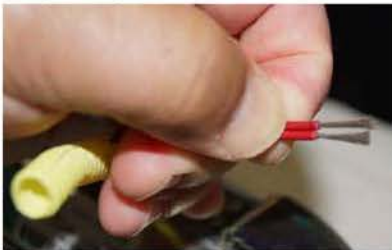
- Strip away about 1 inch of the wire insulation, then twist the wires together.

- Tape the twisted ends with electrical tape.

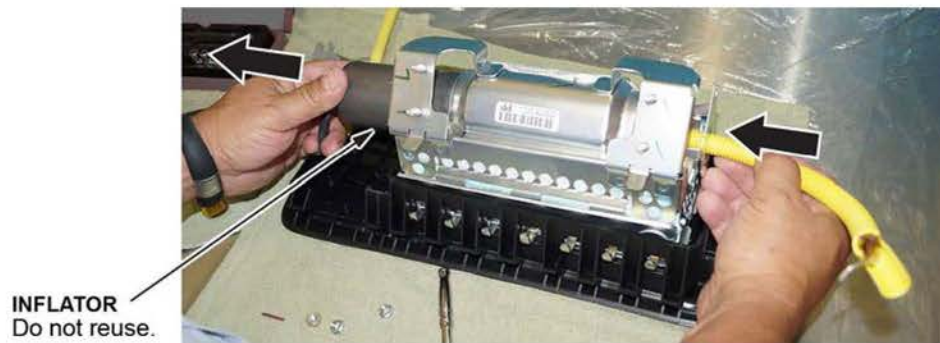
12. Remove the inflator by pushing it out.

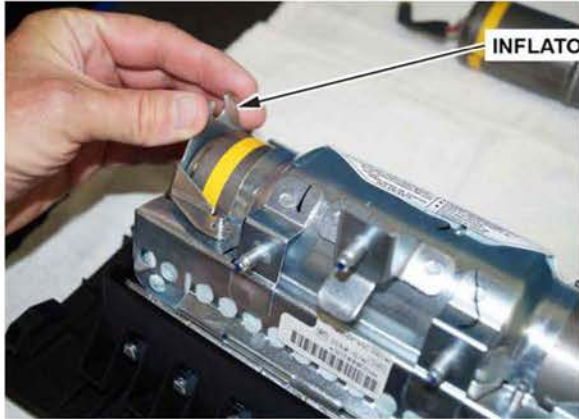
- Reinstall the inflator bracket. There should be no space or gap between the bracket and inflator.

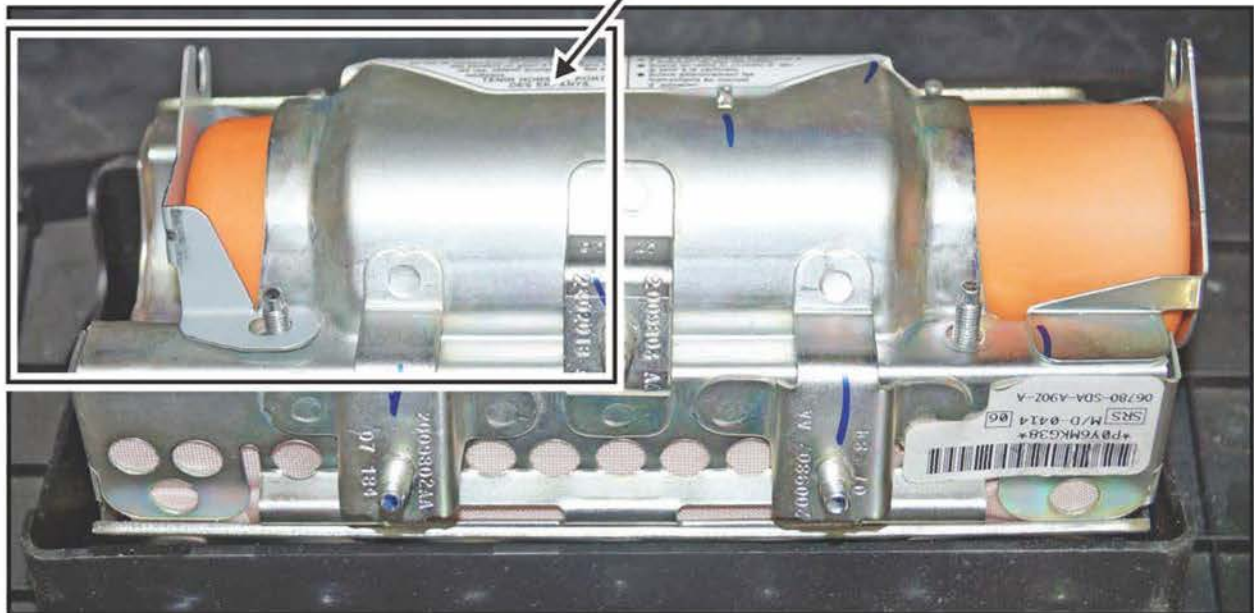
**ADJUSTABLE
BRACKET END**

- Install the bracket included in the kit onto the airbag module. There should be a red dot visible on the end of the plastic connector. There should be no space or gap between the inflator and bracket.

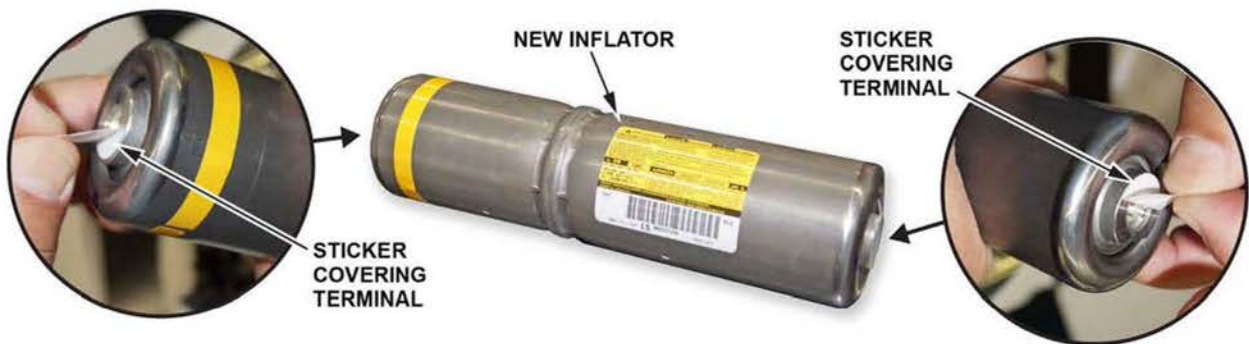
15. Remove the stickers covering the terminals on both sides of the new inflator.

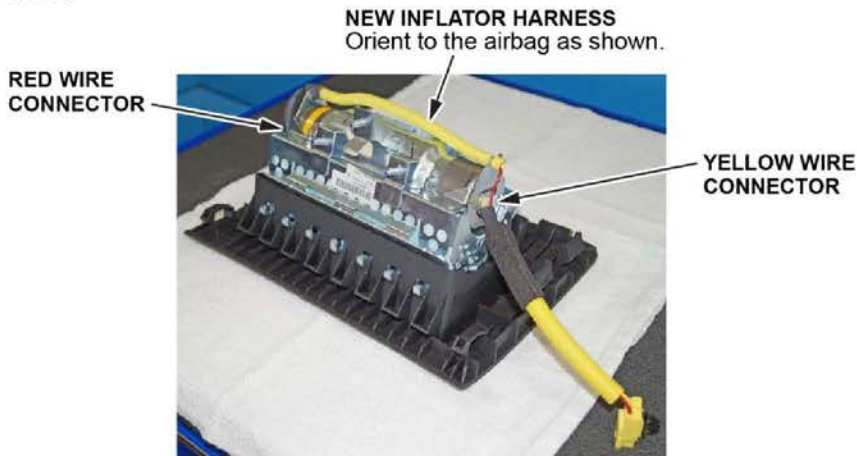
16. Install the new inflator harness.

- Make sure the airbag and harness are aligned as shown.
NOTE: Make sure you have the orientation correct as shown below. If you connect the harness incorrectly, the harness cannot be removed, and you will not be able to reinstall the airbag because the harness will be too short.
