September 17, 2015

02111 Version 3

Safety Recall: A/C Compressor Clutch (Center) Bolt

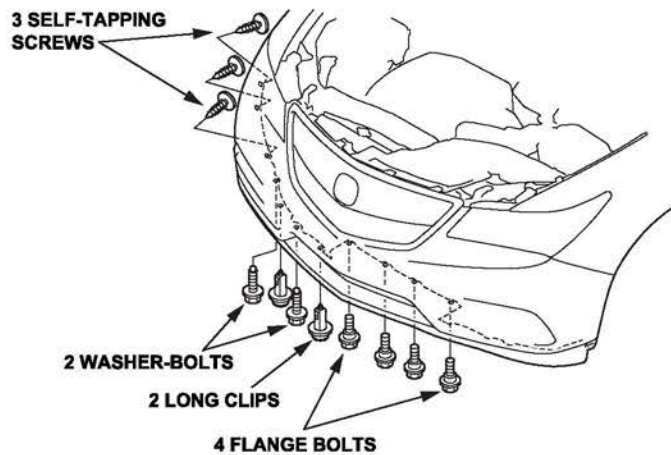
1. Raise the vehicle on a lift.
2. Remove the right front wheel.
3. Remove the screws, bolts, and clips as shown from the front bumper and the front bumper air spoiler.

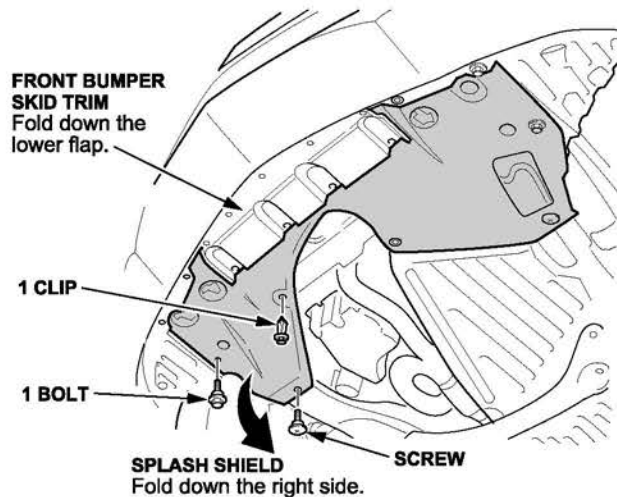
4. Remove the bolt, the clip, and the screw as shown from the splash shield and move it out of the way.

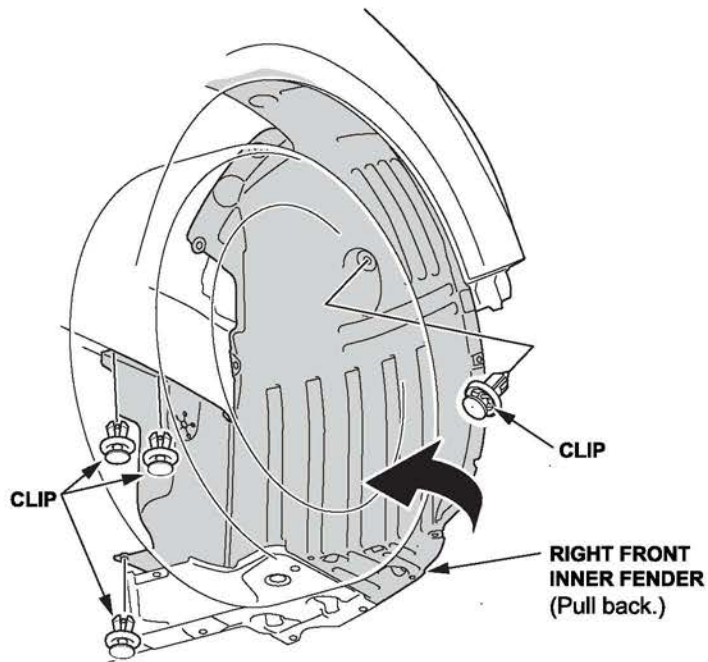
5. Remove the clips and pull back the inner fender and splash shield to access the A/C compressor.

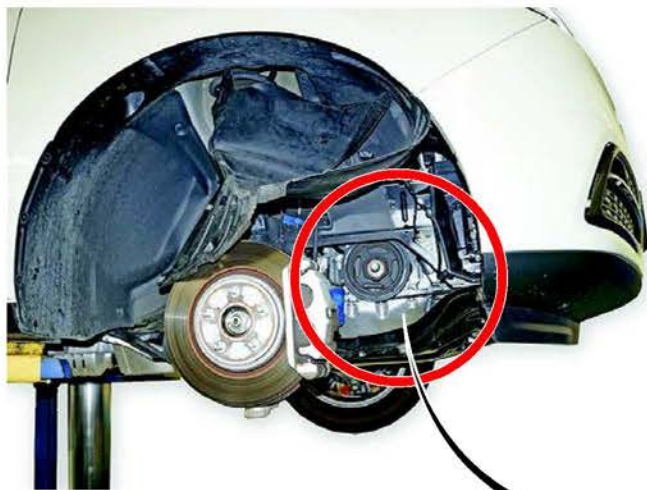
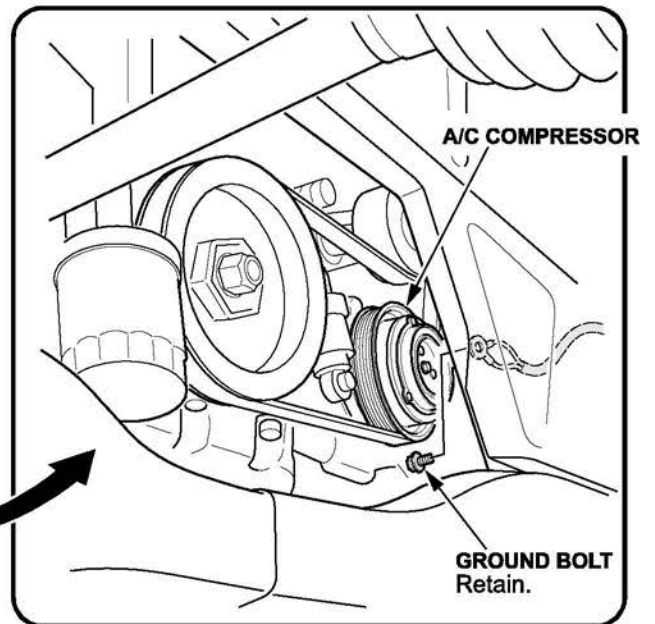
6. Remove the G202 ground bolt.

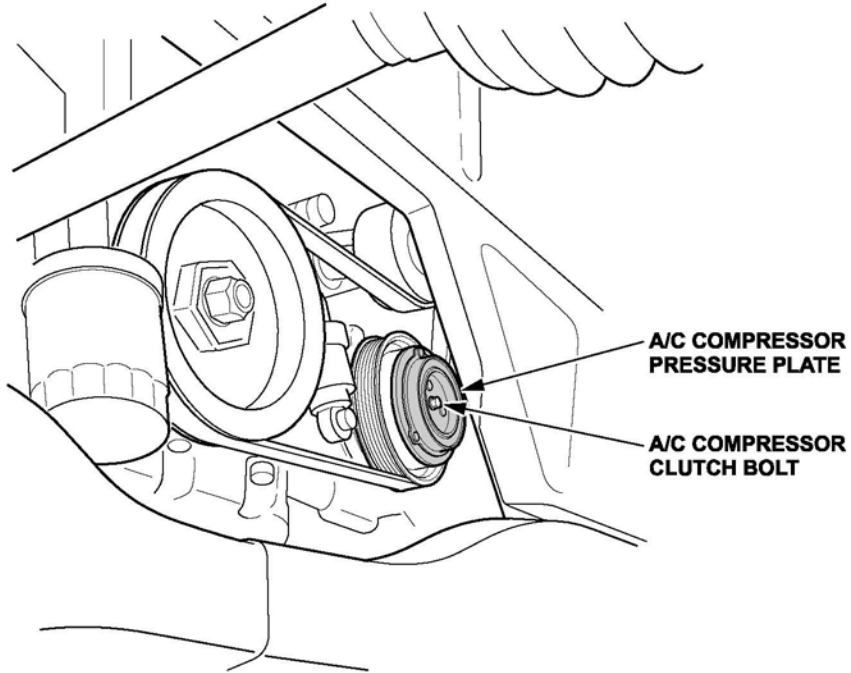
7. Check to see if the A/C compressor pressure plate is present.
 - If the pressure plate is present, go to step 8.
 - If the pressure plate is missing, go to REPAIR PROCEDURE C.

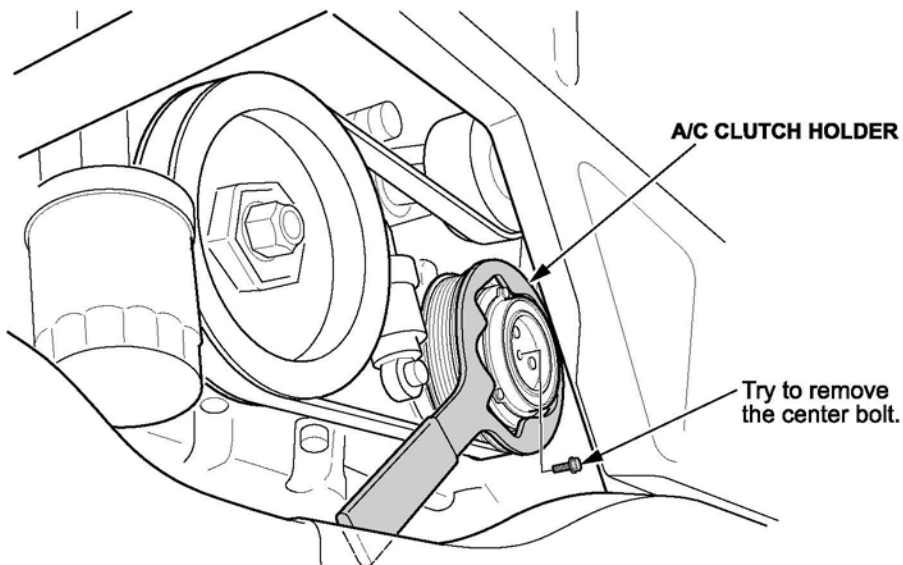
8. Inspect the A/C compressor clutch bolt.
 - If the bolt is OK, go to REPAIR PROCEDURE A.
 - If the bolt is missing, go to REPAIR PROCEDURE A.
 - If the bolt is broken, go to step 9.
9. Try to remove the broken bolt.
 - If the bolt can be removed, go to REPAIR PROCEDURE A.
 - If the bolt can't be removed, go to REPAIR PROCEDURE B.

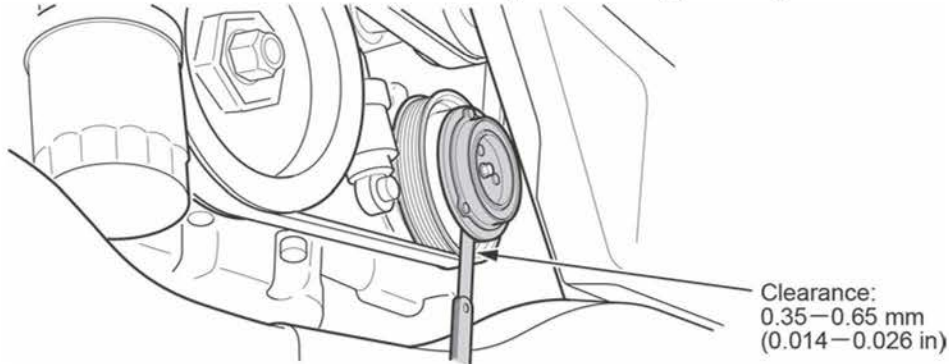
3. If the bolt was loose or missing, check the pressure plate and pulley friction surfaces for damage or wear.

- **If the friction surfaces are damaged or worn**, replace the A/C compressor clutch set and adjust the clearance to 0.35–0.65 mm (0.014–0.026 in.), then go to step 4.
- **If the friction surfaces are not damaged or worn**, go to step 4.

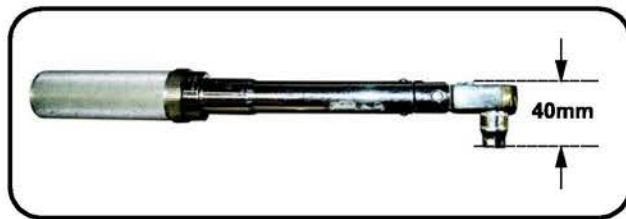
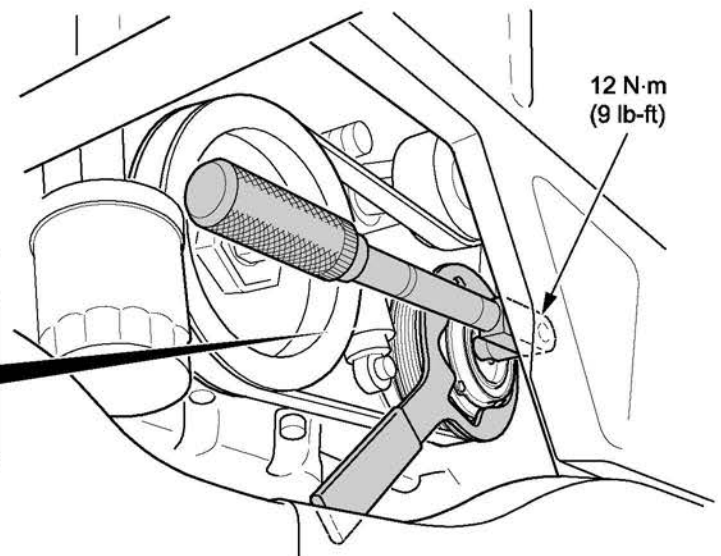
4. Install the new A/C compressor clutch bolt using T/N OTCJ33027A and torque the bolt to **12 N·m (9 lb-ft)**.

- Make sure you torque the bolt to 12 N·m (9 lb-ft); do not use a higher value or you may break the bolt.
- **The A/C compressor clutch bolt is a one time use bolt.** If after installing the bolt, you need to remove it for any reason, including setting the compressor clutch clearance, you need to replace it with a new one.

For clearance, the distance from the tip of the socket to the back of the torque wrench should not exceed 40mm.

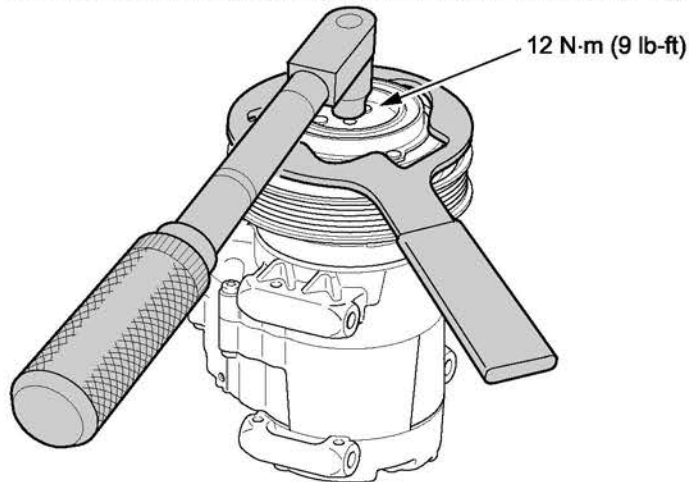
- Transfer the A/C compressor clutch and coil even if the broken bolt cannot be removed. In rare cases, the A/C compressor clutch and coil cannot be transferred to the new unit. In these cases, replace the A/C compressor clutch and coil.
 - **The A/C compressor clutch bolt is a one time use bolt.** If after installing the bolt, you need to remove it for any reason, including setting the compressor clutch clearance, you need to replace it with a new one.
3. Install the new A/C compressor clutch bolt, then torque the bolt to **12 N·m (9 lb-ft)** using T/N OTCJ33027A.

NOTE: Make sure you torque the bolt to **12 N·m (9 lb-ft)**; **do not use a higher value or you may break the bolt.**

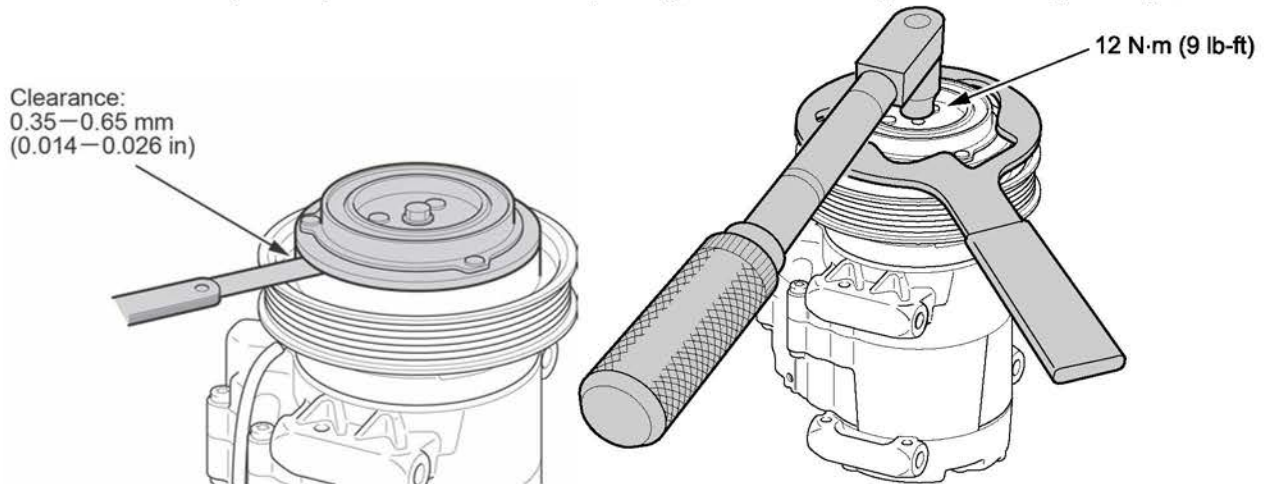
- Transfer the A/C compressor coil even if the broken bolt cannot be removed. In rare cases, you may not be able to transfer the coil. In these cases, replace it with a new one.
 - **The A/C compressor clutch bolt is a one time use bolt.** If after installing the bolt, you need to remove it for any reason, including setting the compressor clutch clearance, you need to replace it with a new one.
4. Use compressed air to blow any debris out of the shaft threads.
 5. Replace the clutch set.
 6. Adjust the A/C compressor clutch clearance to 0.35–0.65 mm (0.014–0.026 in.) using the shims supplied with the clutch set, then torque the A/C compressor clutch bolt to **12 N·m (9 lb-ft)** using T/N OTCJ33027A.

NOTE: Make sure you torque the bolt to **12 N·m (9 lb-ft)**; do not use a higher value or you may break the bolt.
