Subject: DRIVER SEAT GRADUALLY MOVES DOWN BY ITSELF	Bulletin No: 09-006/15
	Last Issued: 02/13/2015

2013-2015 CX-5 vehicles without power seats with VINs lower than JM3KE*****548562 (produced before Oct. 31, 2014)

DESCRIPTION

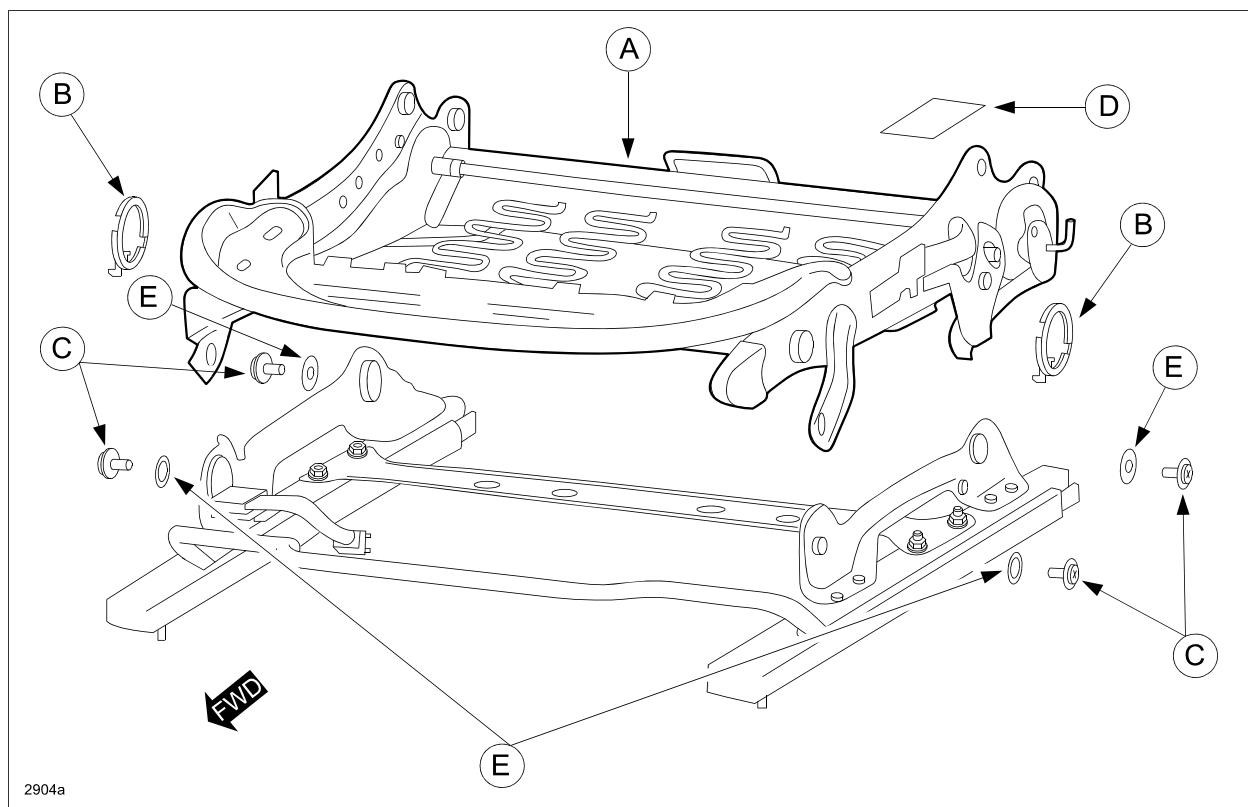
Service Parts kit includes:

- (A) Seat Lift Unit
- (B) Balance Spring, Rear (2)
- (C) Torx T30 Bolt (4)
- (D) Black Tape

NOTE: Be sure to save and re-use all washers (E). New washers are NOT included in the Service Parts kit.

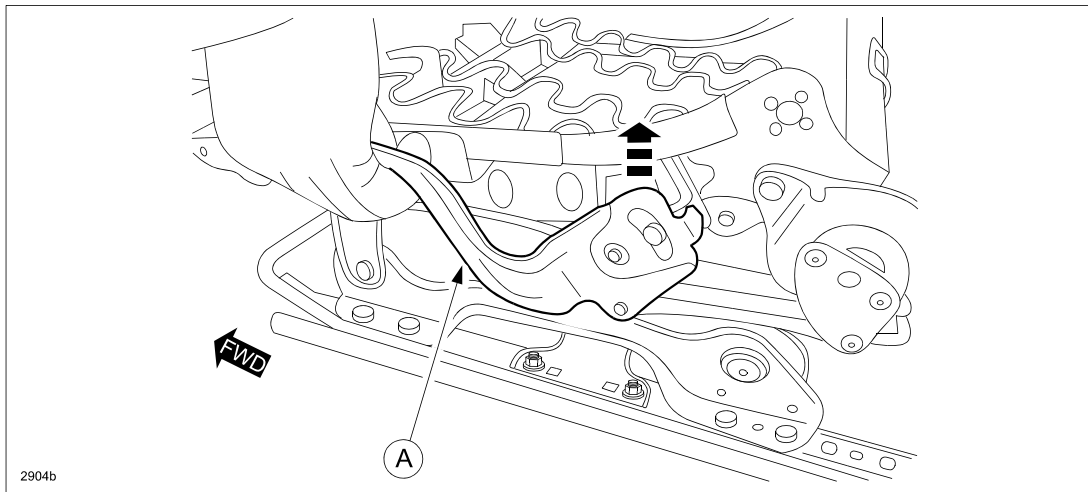
1. Lift the seat lift unit to the highest position using the lift lever (A).

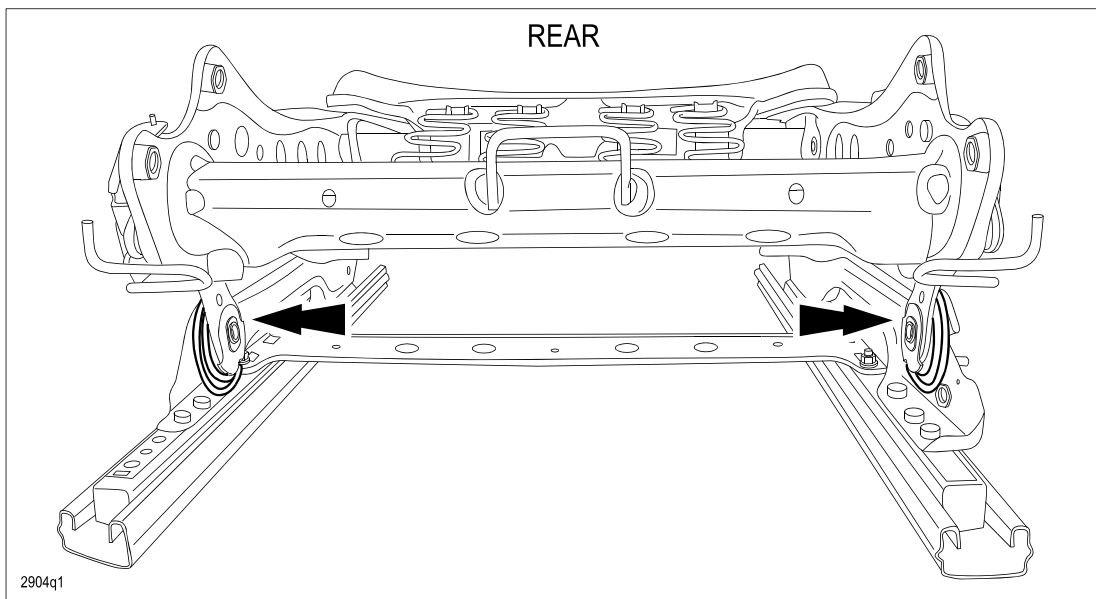
2. Starting with the **REAR** of the seat adjuster unit (as shown below), attach a piece of masking tape onto the inner sides of the left and right sliders to avoid scratch damage during the repair.

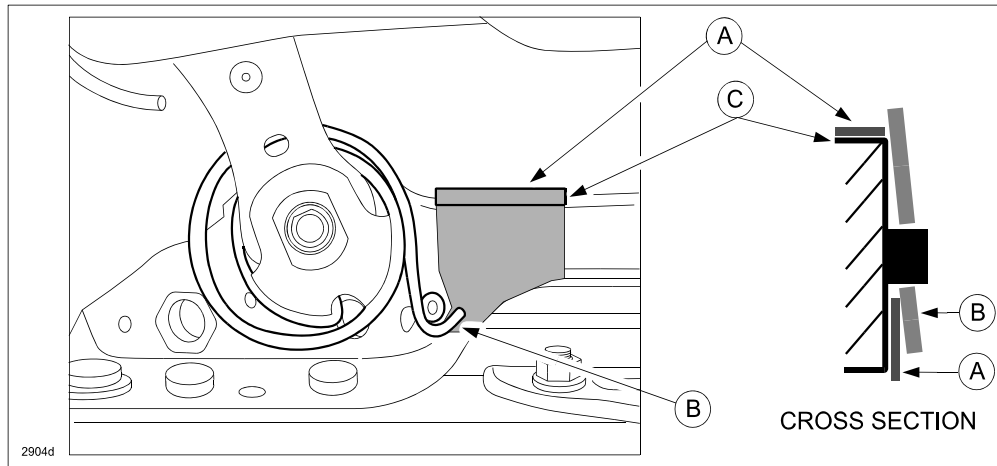
NOTE: Attach the masking tape (A) under the balance spring hook (B) and over the top of the slider (C).

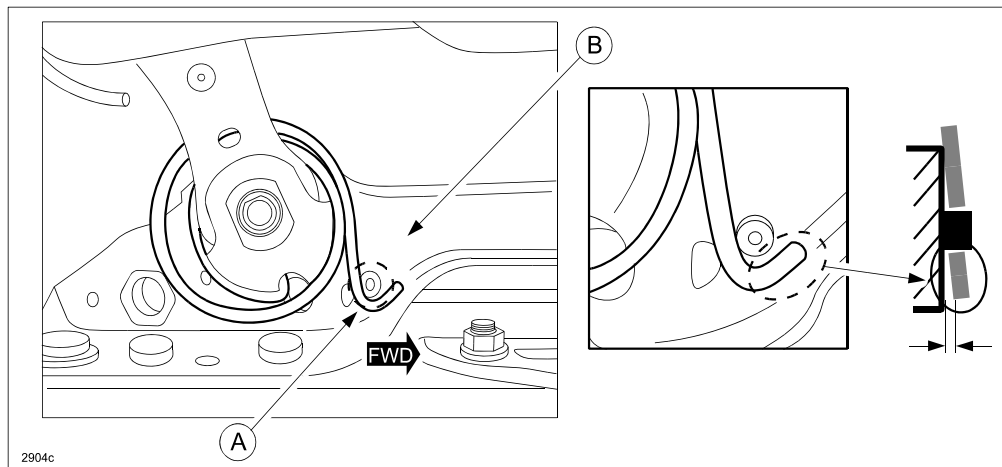
3. Using a flat-blade screwdriver with masking tape on the tip, gently pry the balance spring hook (A) away from the slider surface (B).

WARNING: Be careful not to pinch your fingers.

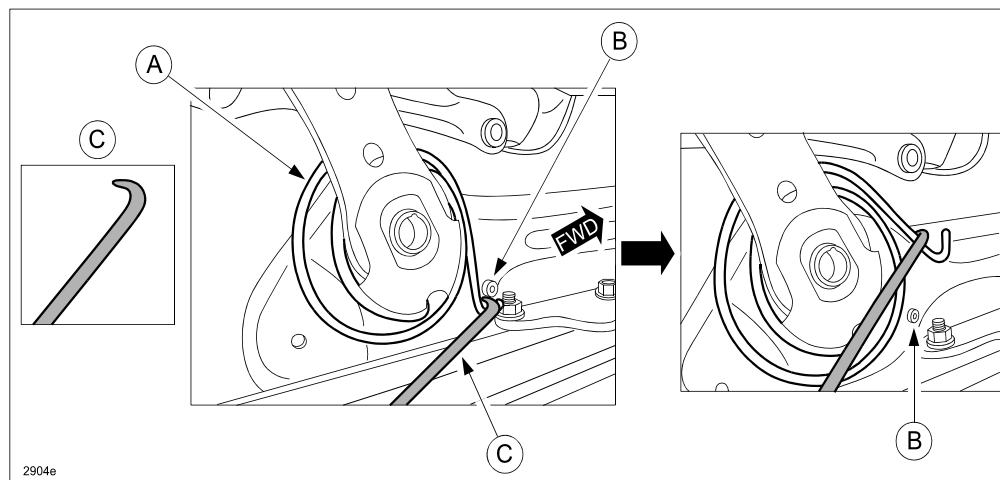
4. Release the rear balance spring (A) hook from the pin (B) using a tool with a hooked end (C) (as shown below) or with needle-nose pliers.

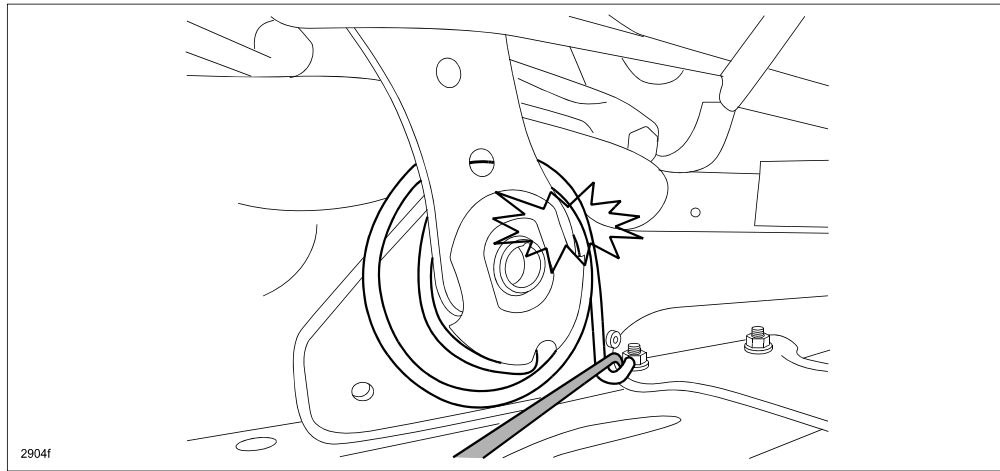
WARNING: The balance spring may jump out suddenly during removal, so keep your hands and face away from the balance spring to avoid injury.

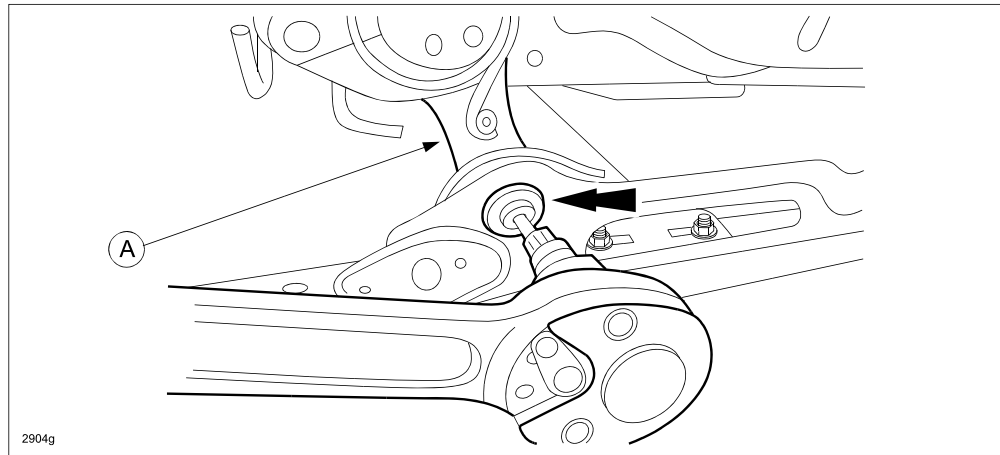
5. Repeat Steps 3 - 4 on the opposite side rear balance spring.
6. Remove four (4) Torx T30 bolts that secure each link (A).

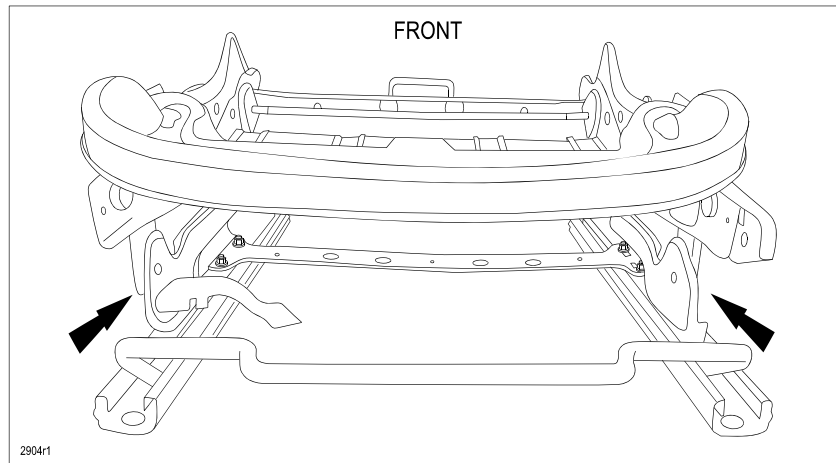
7. Move to the **FRONT** of the seat adjuster unit.

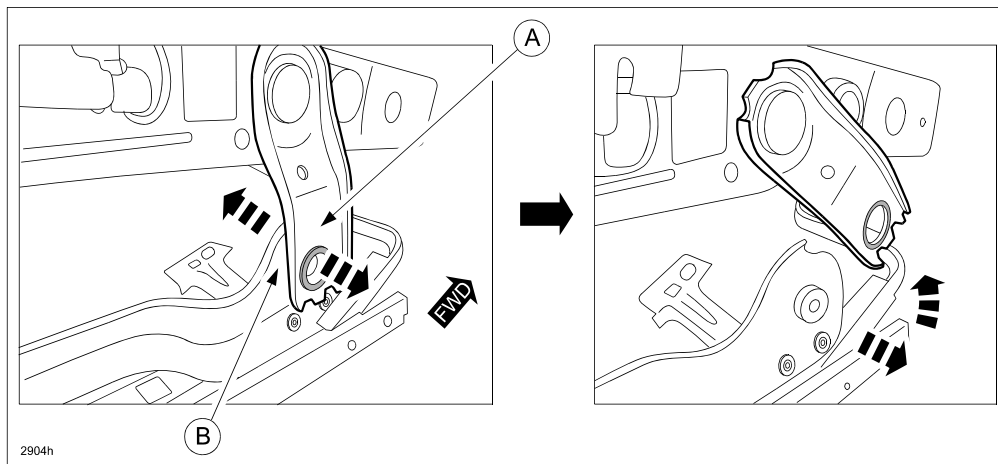
8. Detach the inner link (A) from the slider (B) by gently bending the slider outward and the link inward.

CAUTION: DO NOT bend the slider too much as it may become deformed and cause improper operation.

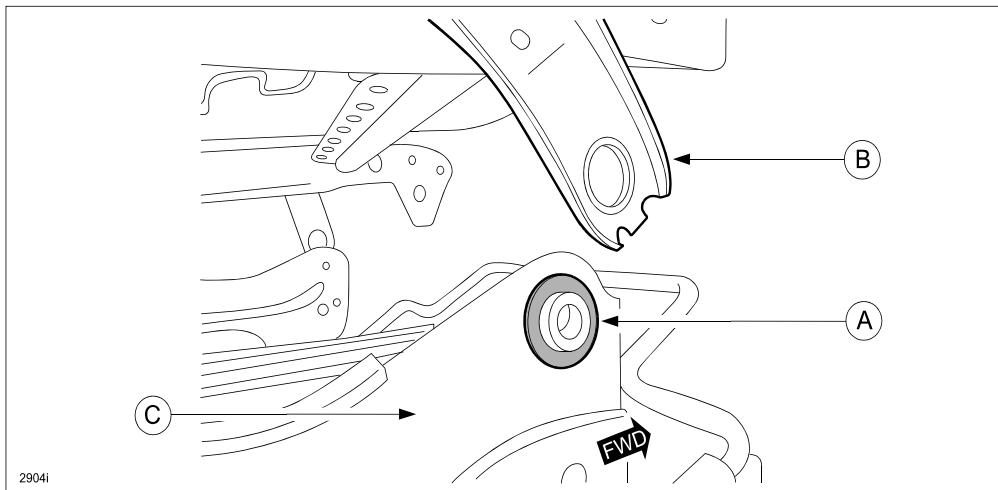
NOTE: Depending on specific production date of the vehicle, some CX-5 models may have plastic washers (A) installed between the front link (B) and the slider (C). **ALWAYS BE SURE TO RE-USE THE PLASTIC WASHERS** when installing the new seat adjuster lift unit.

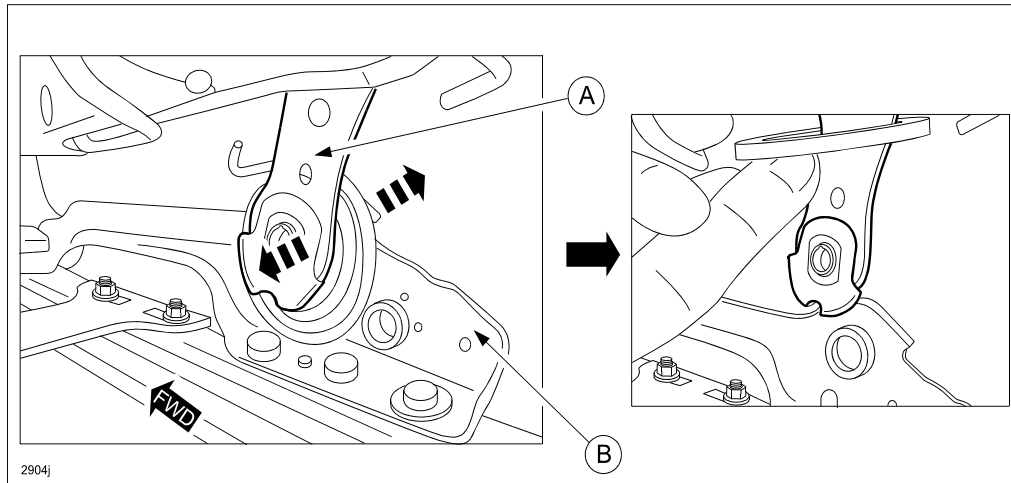
11. Detach the inner link (A) from the slider (B) by gently bending the slider outward and the link inward.

CAUTION: DO NOT bend the slider too much as it may become deformed and cause improper operation.

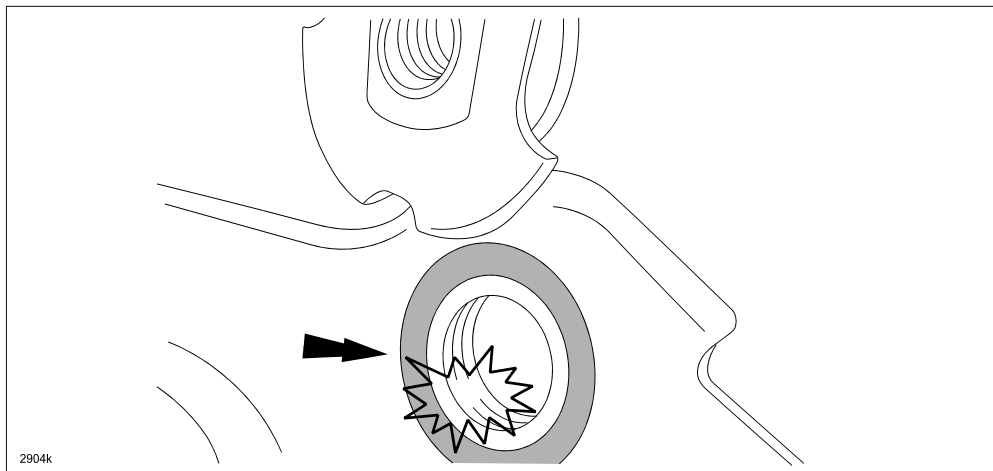
CAUTION: DO NOT damage the bushing during link removal.

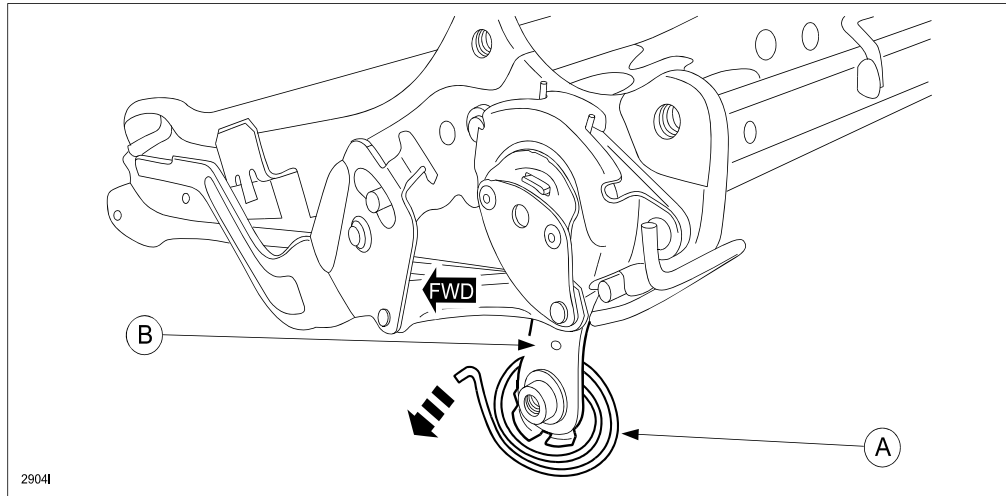
LEFT REAR:

1. Working from the **REAR** of the seat adjuster unit, place the new rear balance springs (A) around the left and right seat adjuster unit links (B).

NOTE: IT IS VERY IMPORTANT TO CORRECTLY POSITION THE NEW REAR BALANCE SPRINGS around the rear seat adjuster unit links before assembly.

NOTE: The end of each balance spring must be facing outward (as shown below).

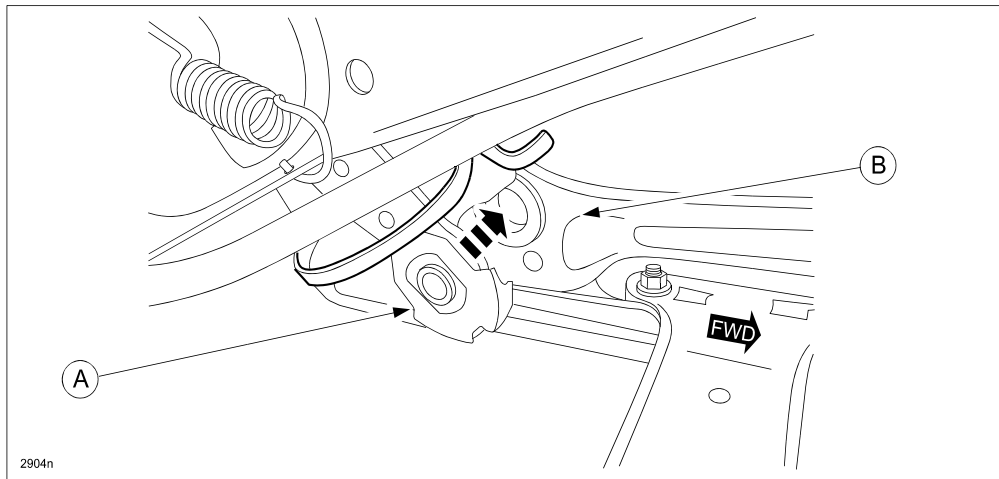
2. Rear-Outer: Install the link (A) onto the slider (B).

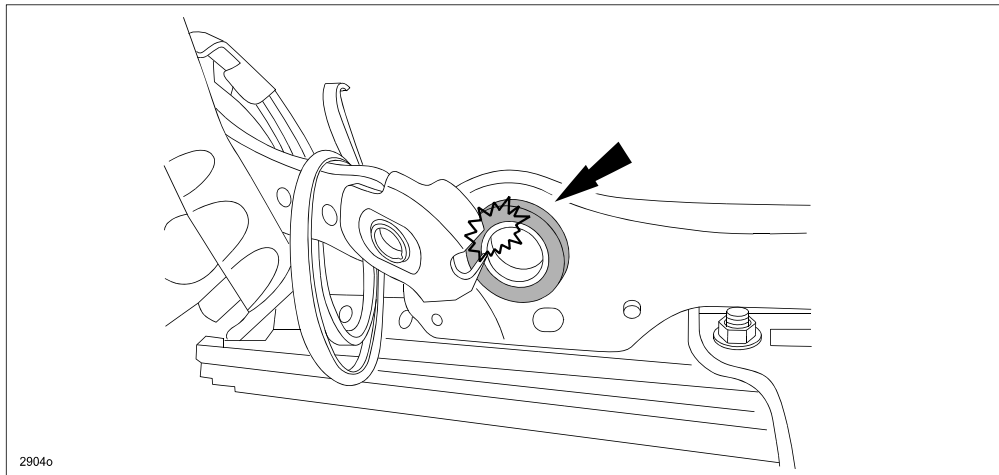
CAUTION: DO NOT damage the bushing during link installation.

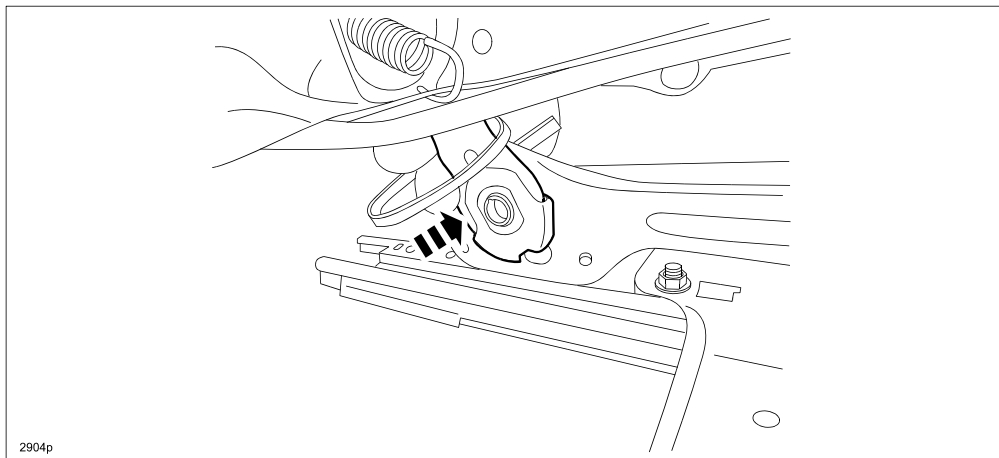
3. Push the link into proper position.

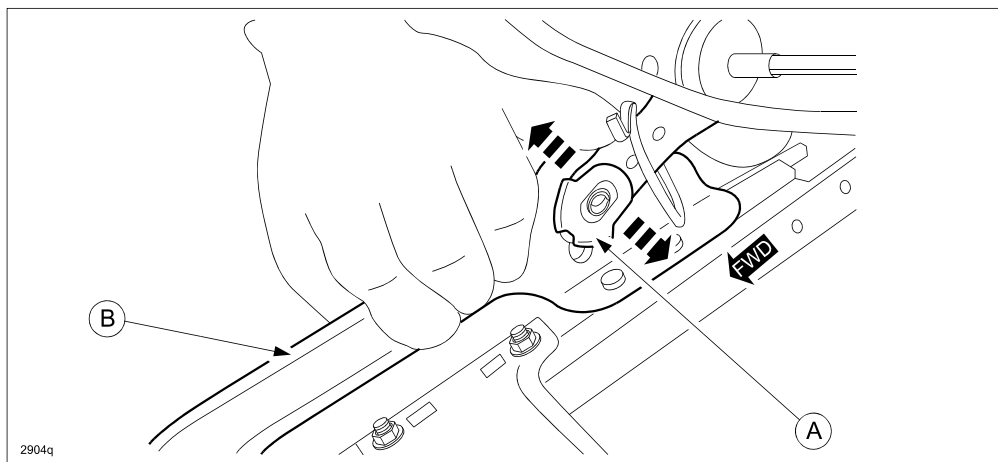
4. **Rear-Inner:** Install the link (A) onto the slider (B) while bending the slider outward and the link inward.

CAUTION: DO NOT bend the slider too much as it may become deformed and cause improper operation.

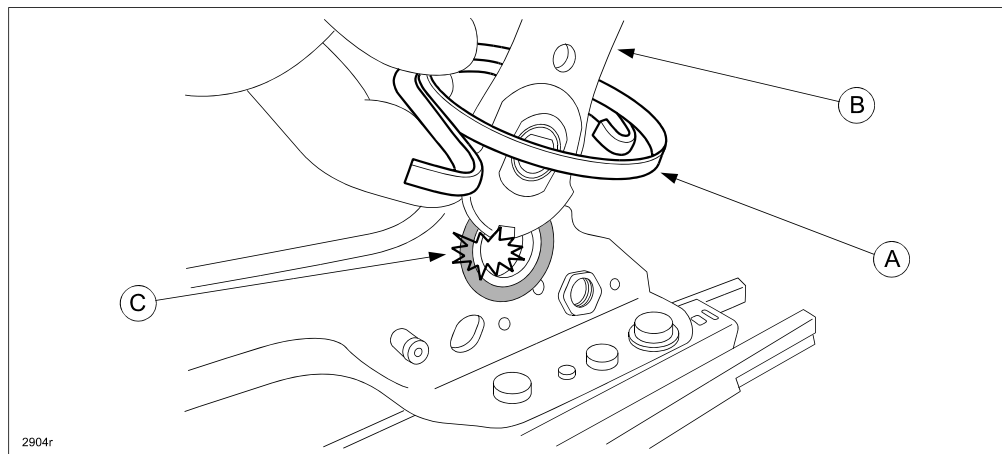
NOTE: Verify that the rear balance spring (A) has been properly positioned around the link (B).

CAUTION: DO NOT damage the bushing during link installation.

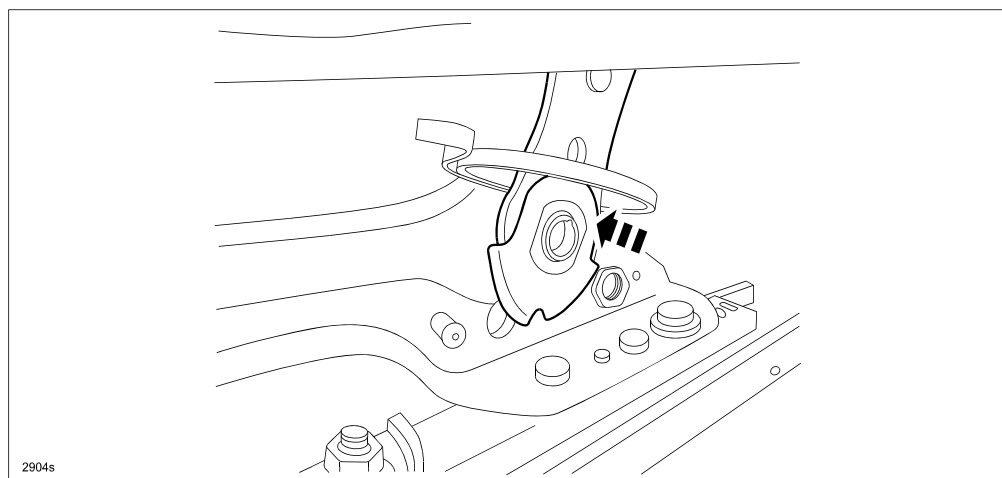
5. Push the link into proper position.

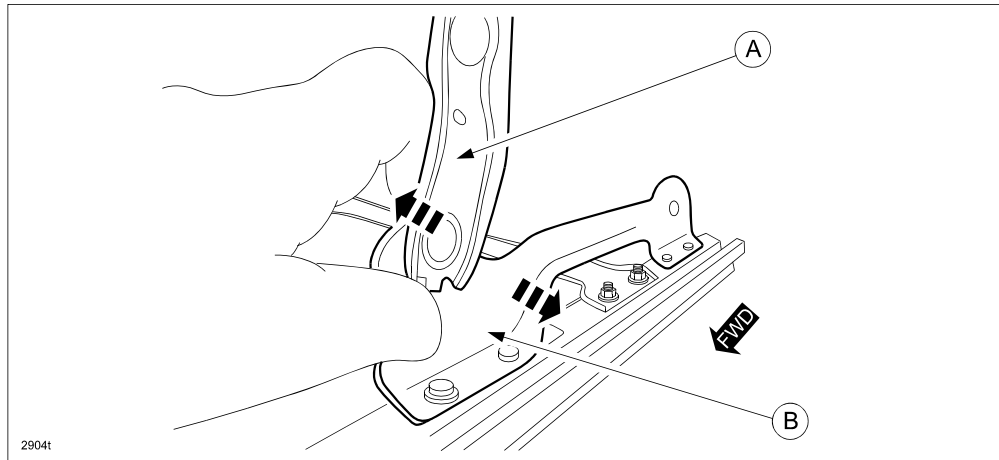
6. **Front-Outer:** Install the link (A) to the slider (B) while bending the slider inward and the link outward.

CAUTION: DO NOT bend the slider too much as it may become deformed and cause improper operation.

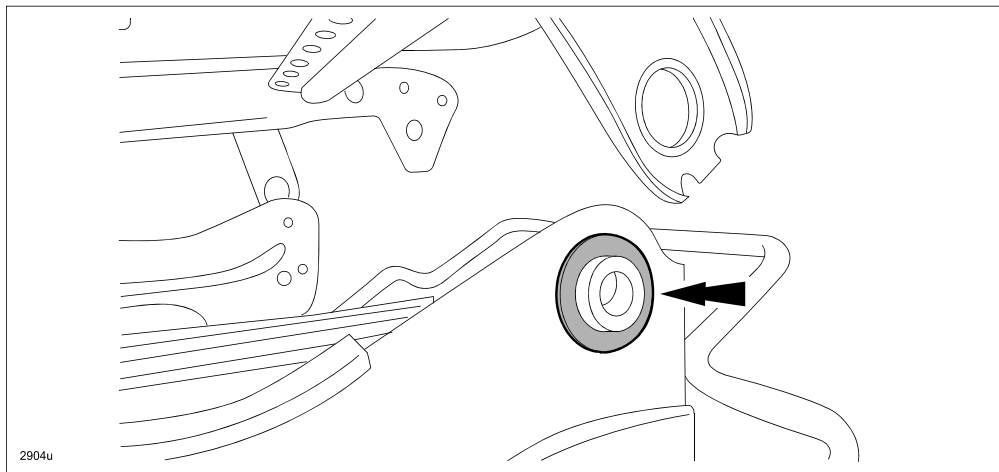
NOTE: Be sure to re-install the plastic washer if originally installed.

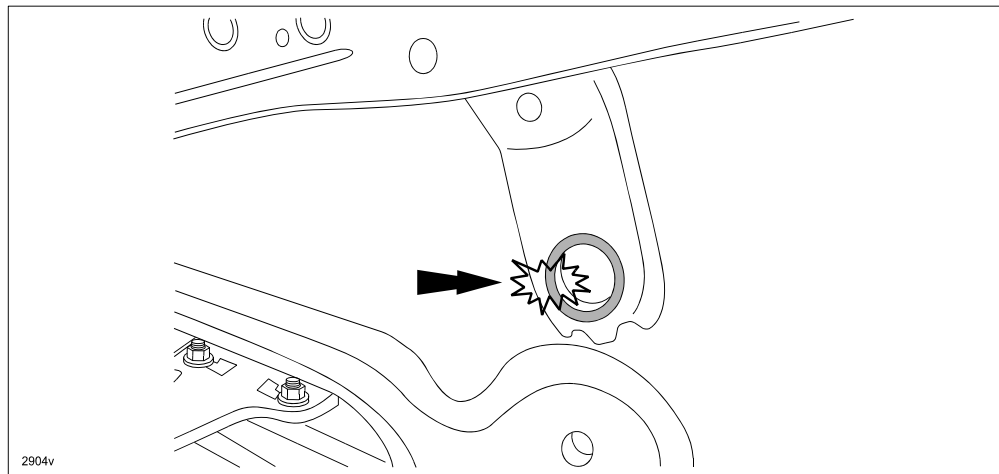
CAUTION: DO NOT damage the bushing during link installation.

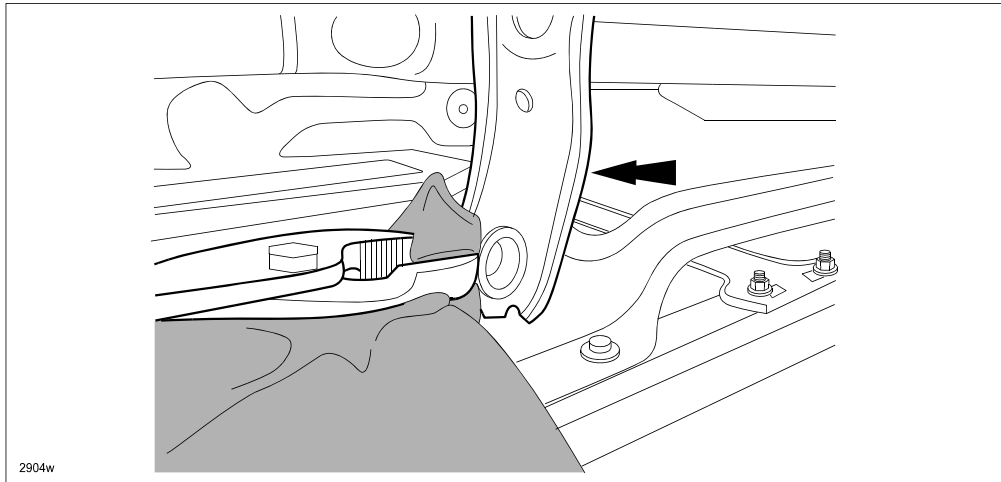
7. Install the link to the proper position using pliers and a shop rag.

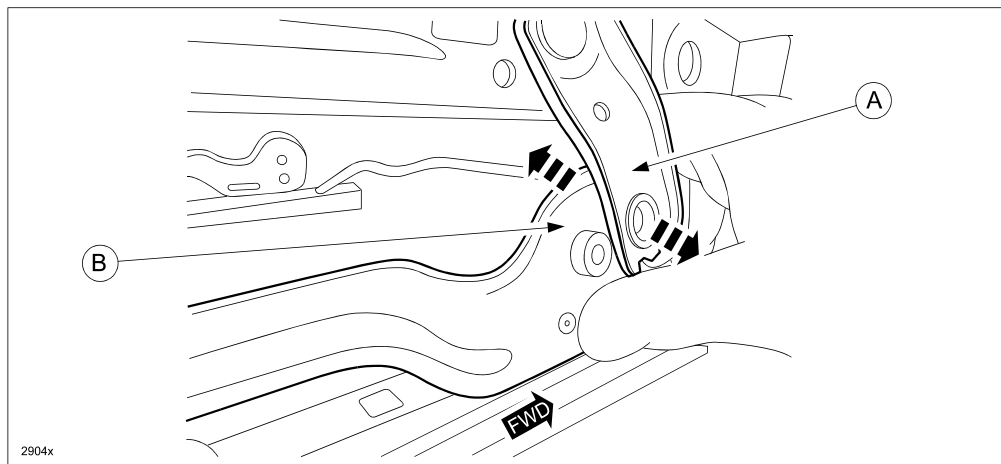
8. **Front-Inner:** Install the link (A) to the slider (B) while bending the slider inward and the link outward.

CAUTION: DO NOT bend the slider too much as it may become deformed and cause improper operation.

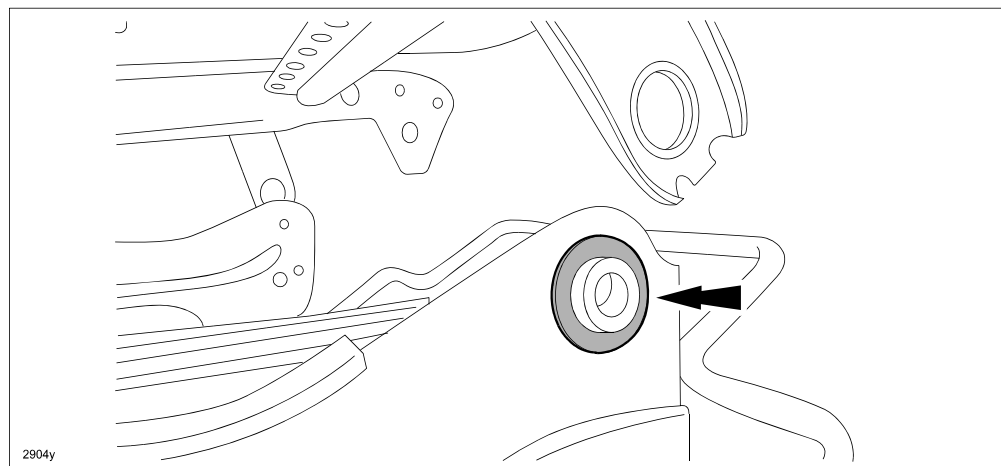
NOTE: Be sure to re-install the plastic washer if originally installed.

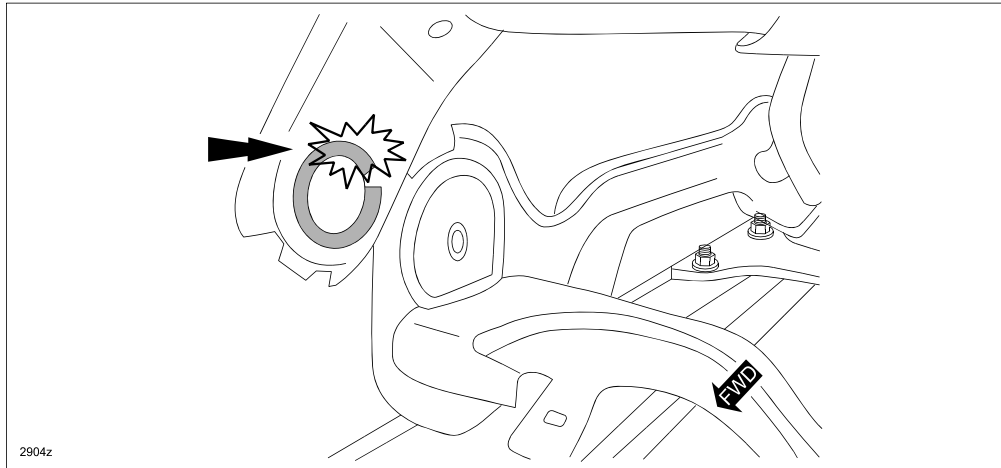
CAUTION: DO NOT damage the bushing during link installation.

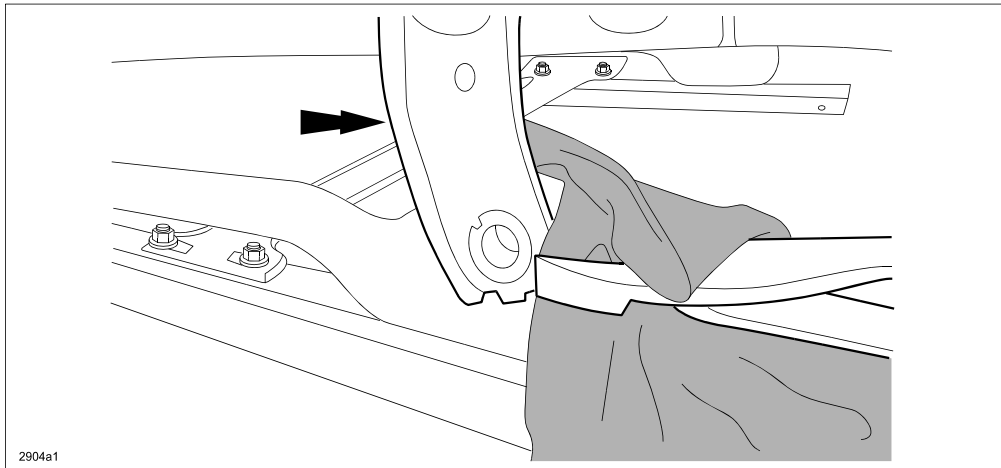
9. Install the link to the proper position using pliers and a shop rag.

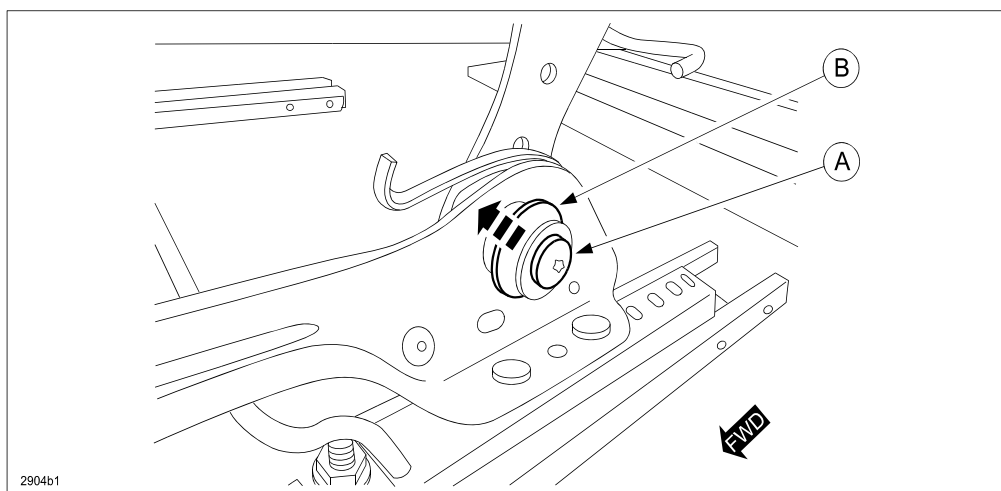
10. Tighten four (4) Torx T30 bolts to the specified torque.
Tightening Torque: (15.7 - 22.6 Nm)
REAR: Tighten bolt (A) with washer (B).

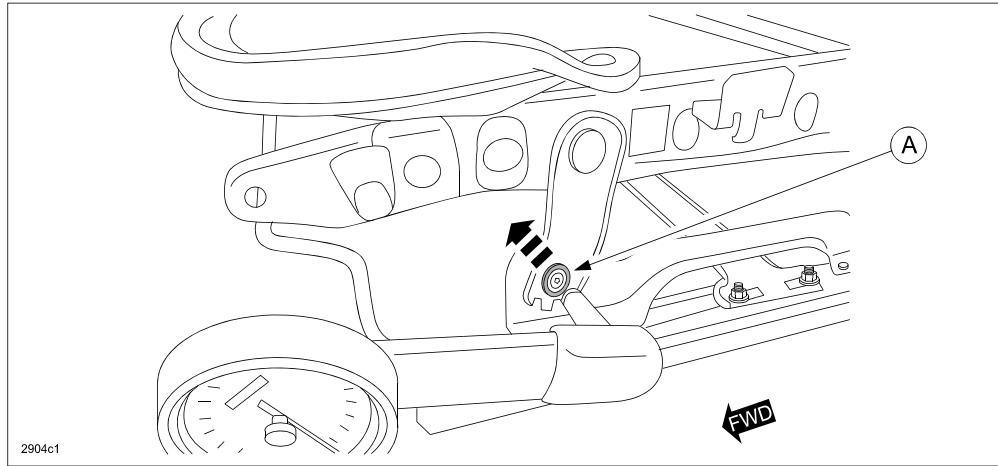
FRONT: Tighten bolt (A) without washer.

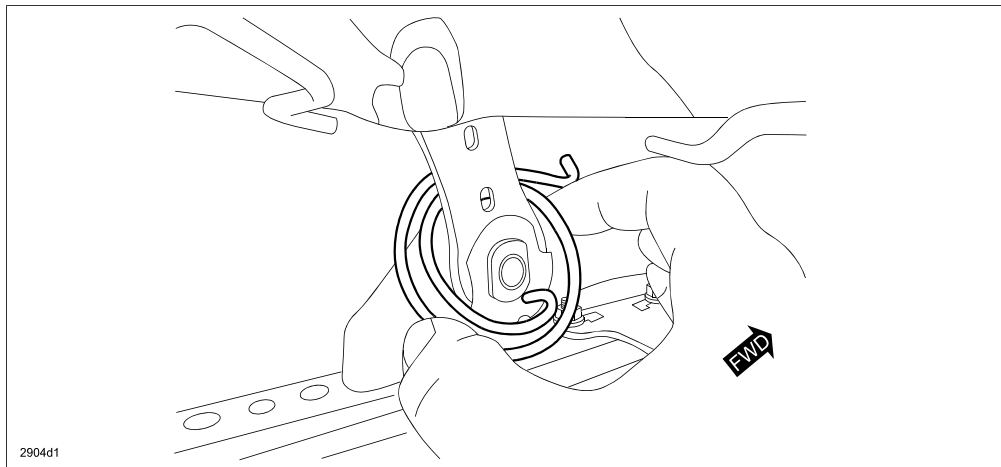
- DO NOT pinch the spring between the link and slider while tightening the bolts.
- Verify that the spring moves freely after all the bolts have been tightened.

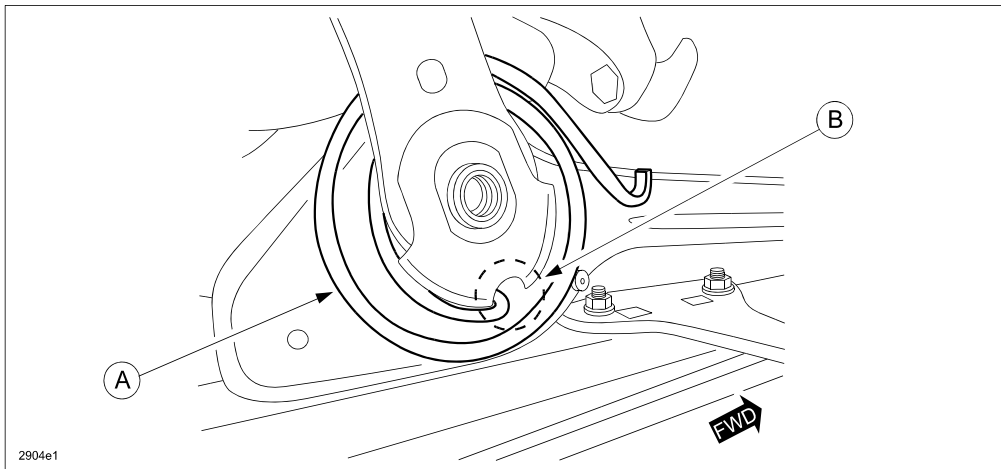
11. OUTER-SIDE: Install the balance spring (A) by hooking the end of the spring into the opening (B).

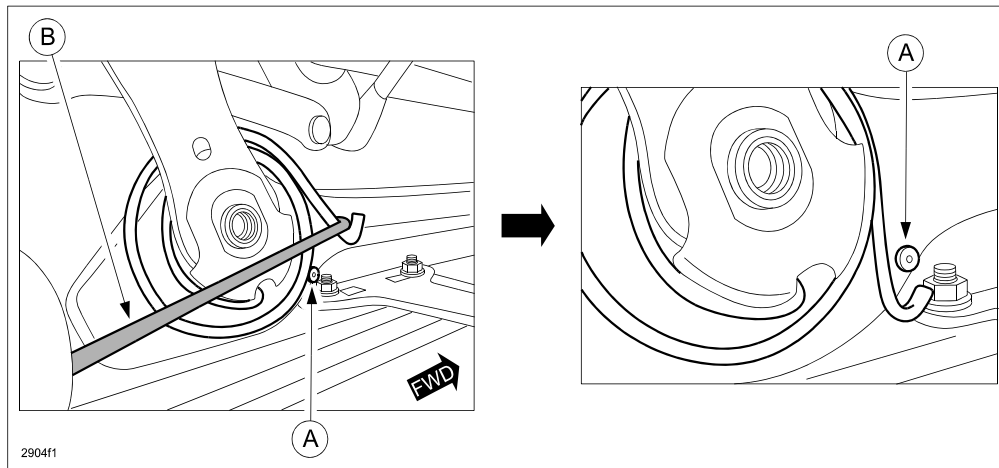
12. Hook the other end of the balance spring around the pin (A) using the hook tool (B) or with needle-nose pliers.

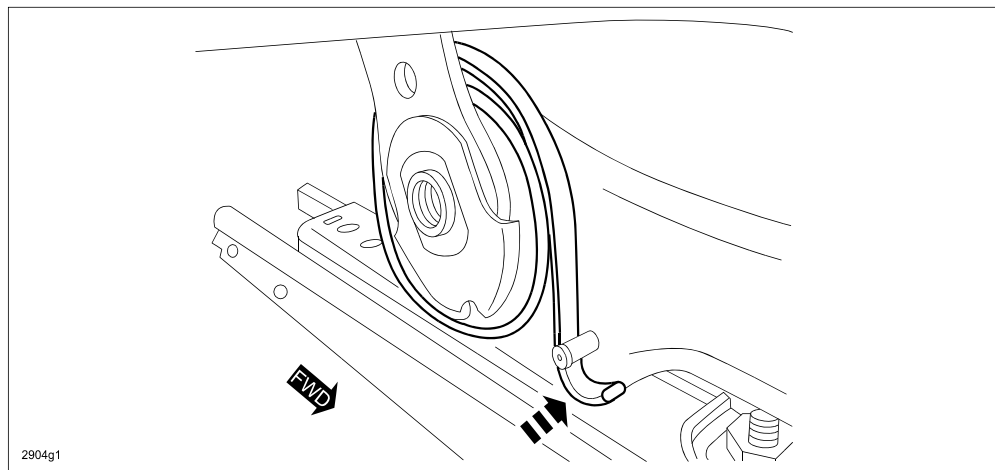
14. Push the end of the balance spring inward until it contacts the slider.

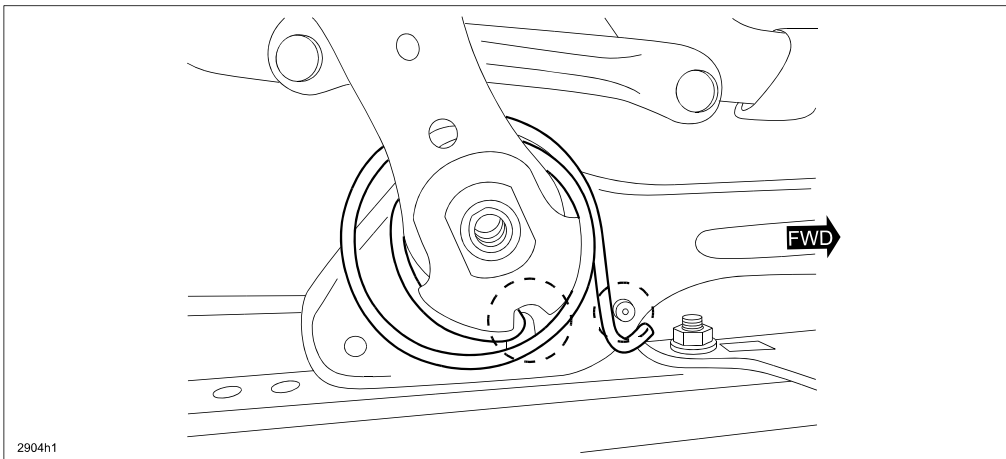
15. Verify that both ends of the balance spring are securely hooked into position.

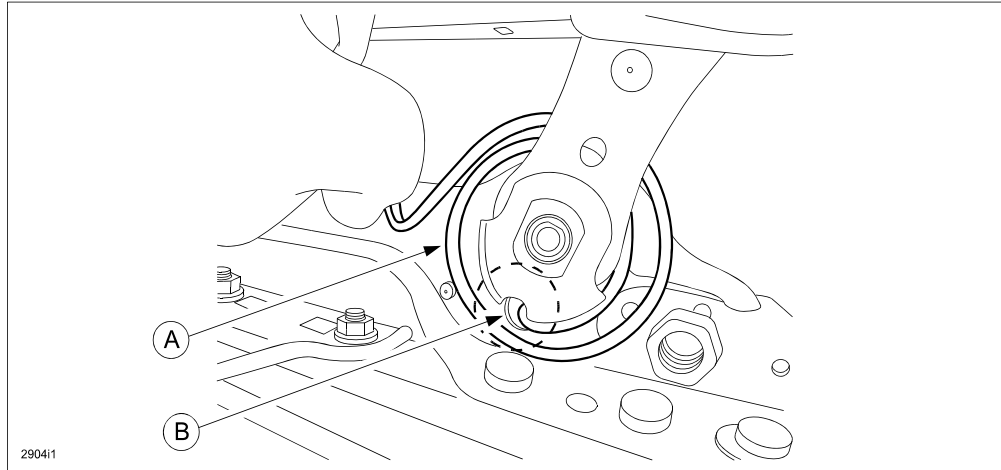
16. **INNER-SIDE:** Install the balance spring (A) by hooking the end of the spring into the opening (B).

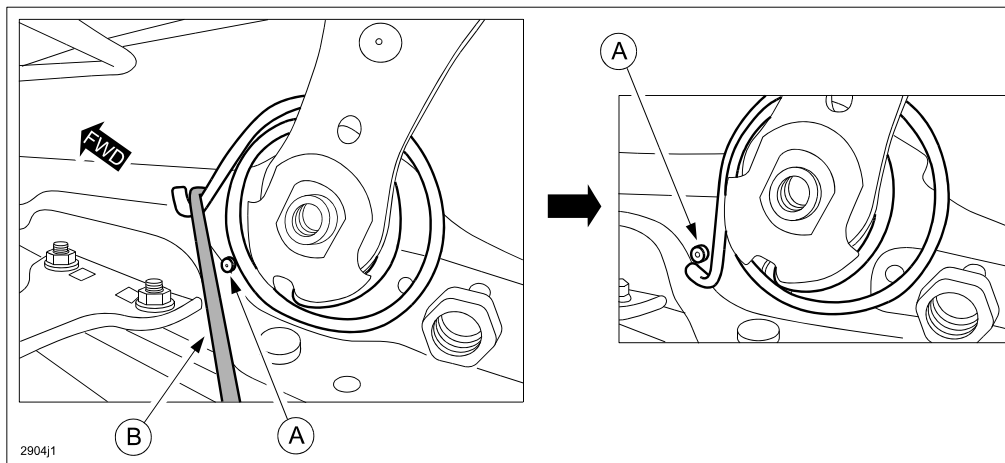
17. Hook the other end of the balance spring around the pin (A) using the hook tool (B) or with needle-nose pliers.

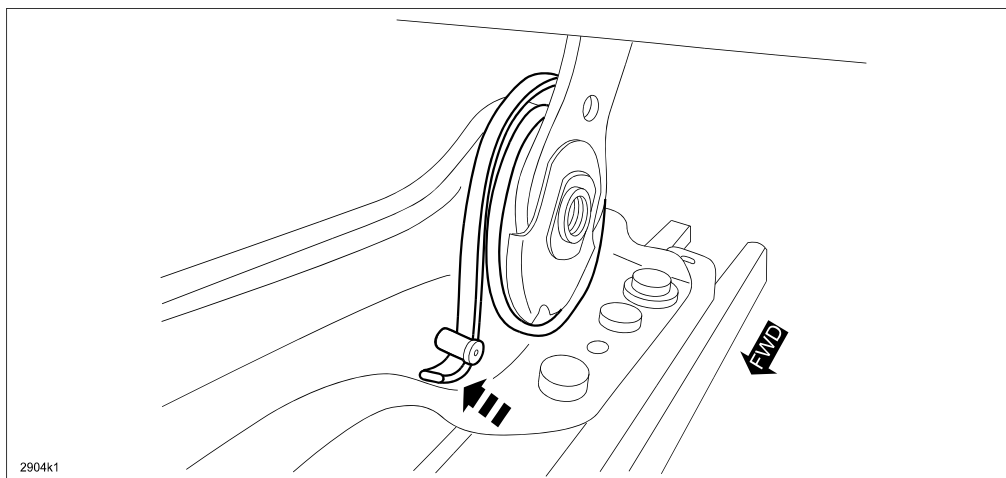
19. Push the end of the balance spring inward until it contacts the slider.

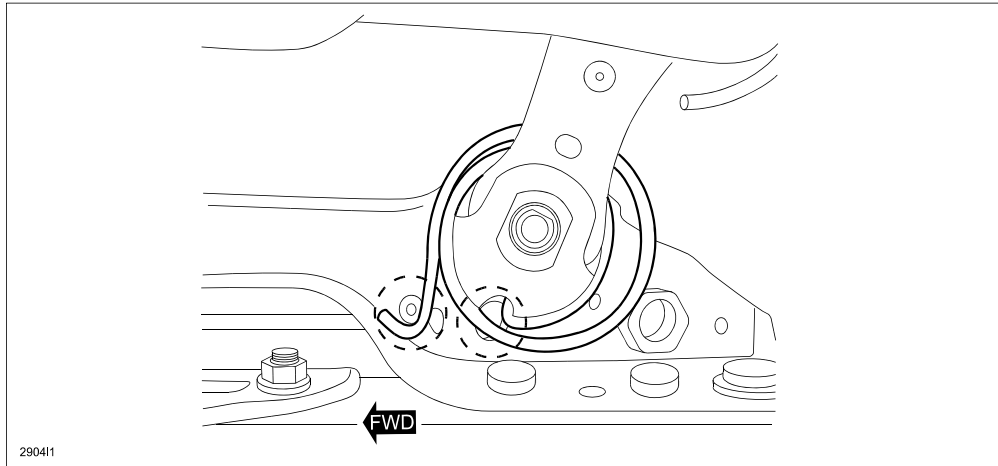
20. Verify that both ends of the balance spring are securely hooked into position.

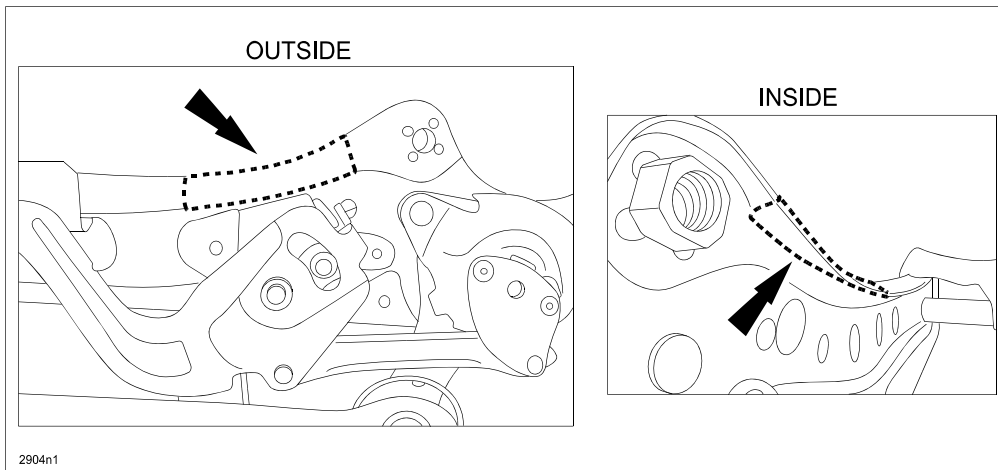
21. Degrease the upper seat frame area with a clean shop rag.

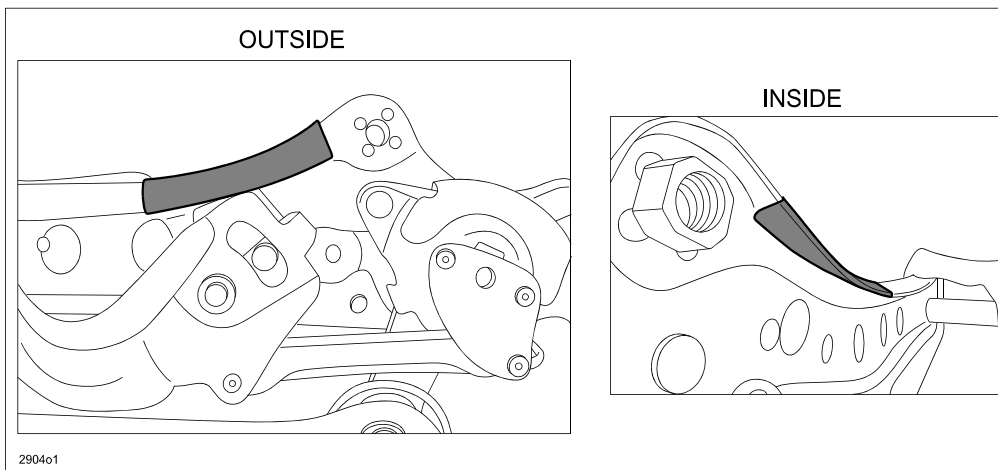
22. After degreasing the upper seat frame area, attach the piece of black tape (from kit) as shown below.

NOTE: When looking from the space between the seat cushion and the cover, the silver color of the seat lift frame is visible. By attaching the black tape to the upper frame, the silver color is covered up.
