Reference	SSM65557
Models	LR2 / L359 LR4 / L319 Range Rover Sport / L320
Title	Seat Switch,Recline Button Cap Replacement
Category	Body
Last modified	16-Mar-2015 00:00:00
Symptom	101000 Seating
Attachments	1Seat Switch.pdf

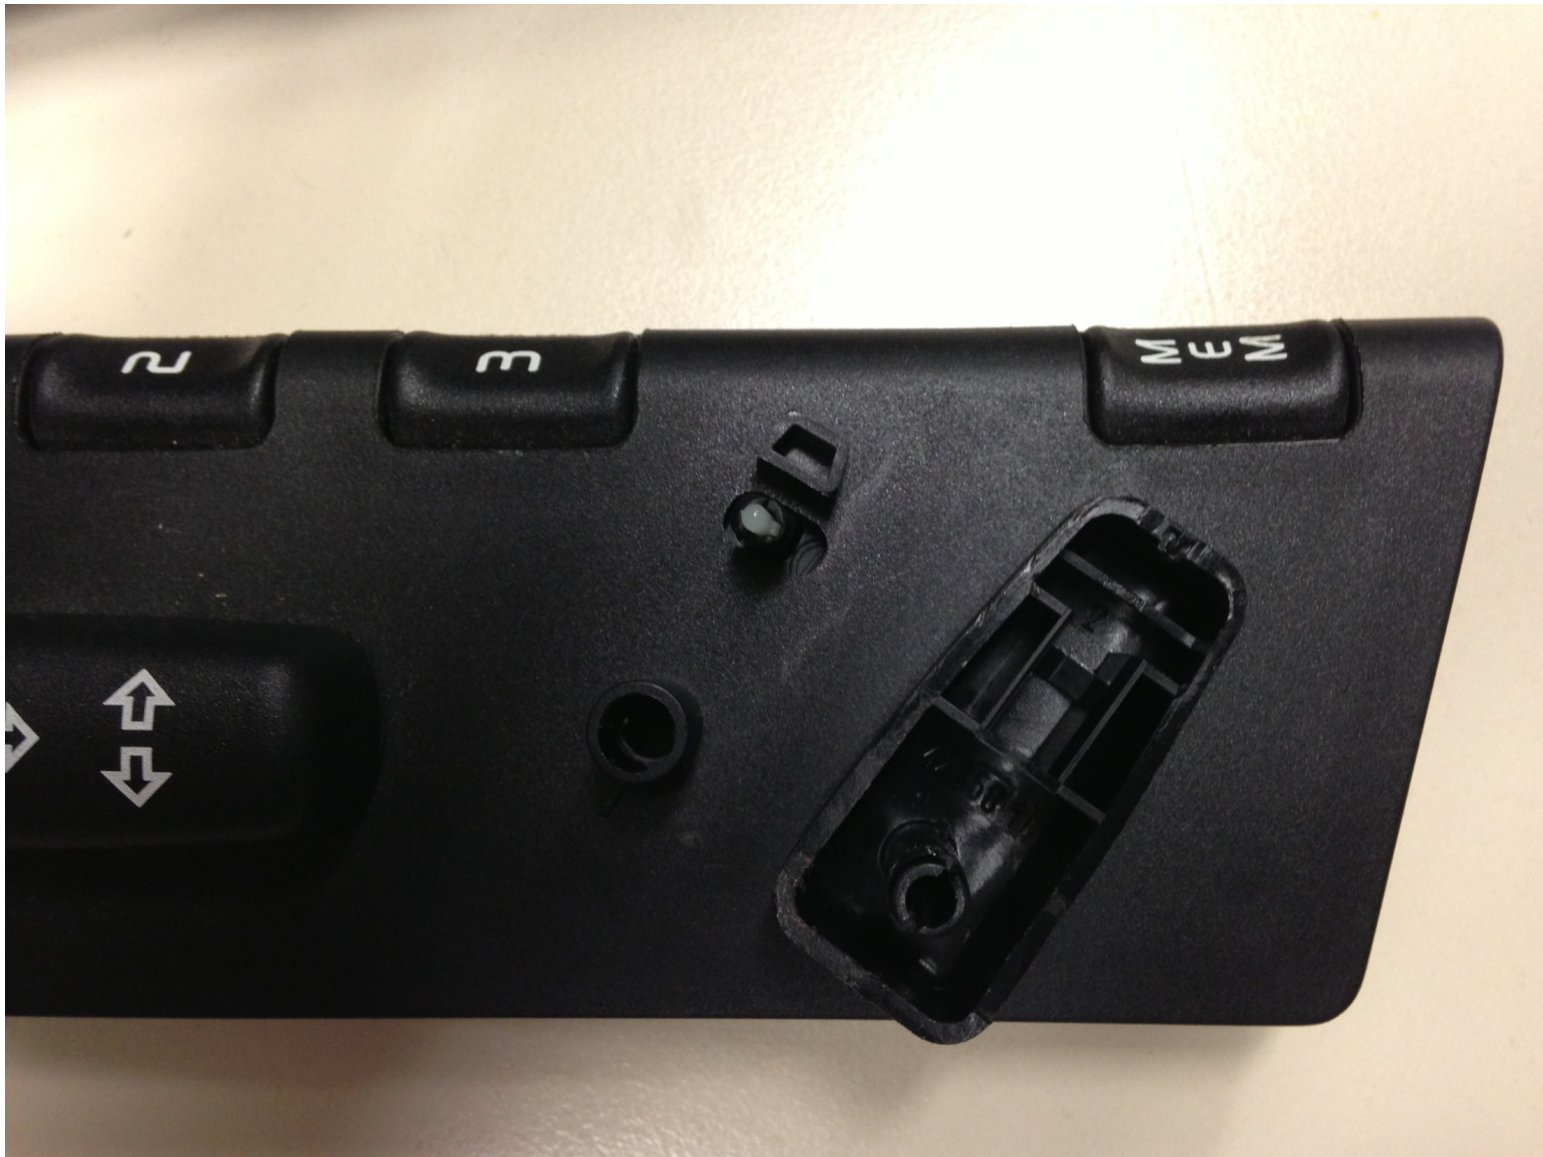
Fig 1

Seat Switch Pack Recline Button cap is damaged or has broken / fallen off in service. (See fig.1)
