Reference	SSM72405
Models	Range Rover Sport / L494
Title	Gear Lever Park Button Poor Finish
Category	Driveline
Last modified	03-Sep-2015 00:00:00
Symptom	504330 Automatic Shift Level/Linkage Concerns
Attachments	Gear Lever Park Button Finish.pdf (Gear Lever Park Button Finish.pdf)

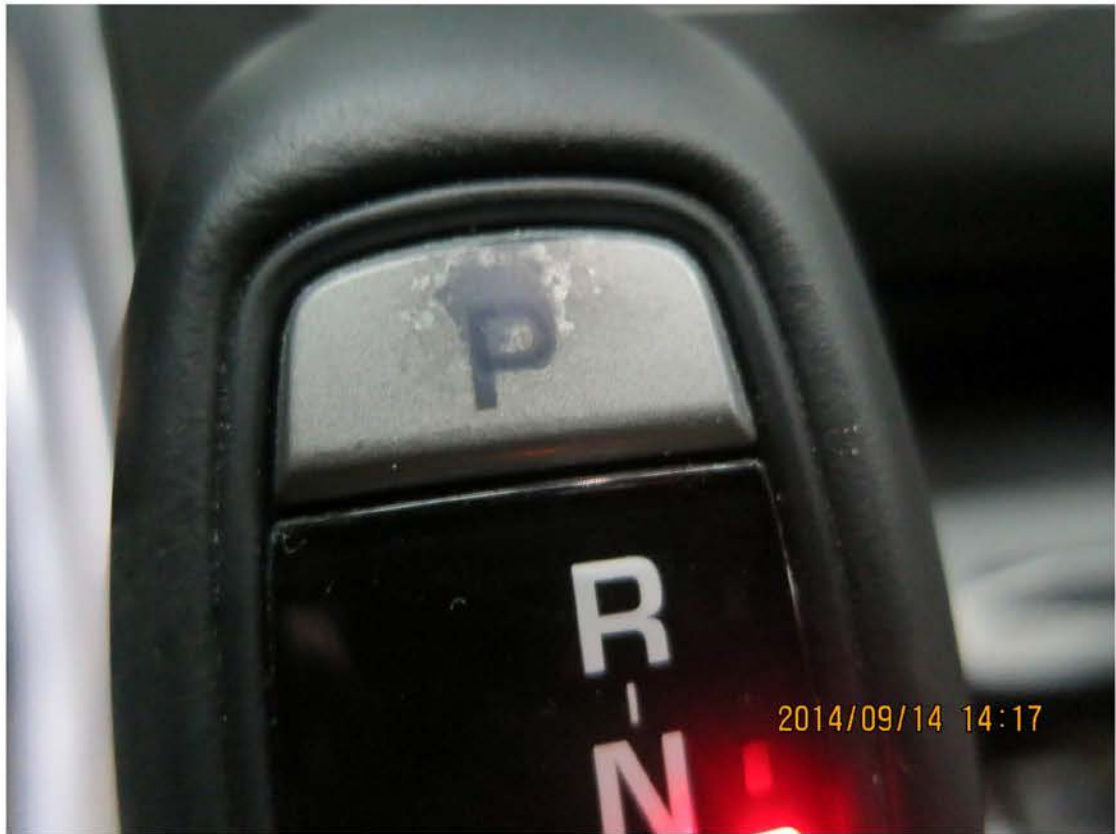
Content **Issue:** A customer may report that the surface of the 'P' Button on the gear shift lever is wearing with loss of definition of the paint finish. Please view attachment that shows the condition.

Cause: Paint surface finish process

Action: If the concern has been reported by the customer, please replace the gear lever part number LR077066.

Note: A new paint refinish process has been introduced to prevent deterioration of the 'P' button on the gear shift lever from Vehicle Identification Number EA391028 onwards. Please only submit ePQR reports for this concern on vehicles post the above VIN.
