September 10, 2015

02380 Version 1

Noncompliance Recall: RDX Emission Label

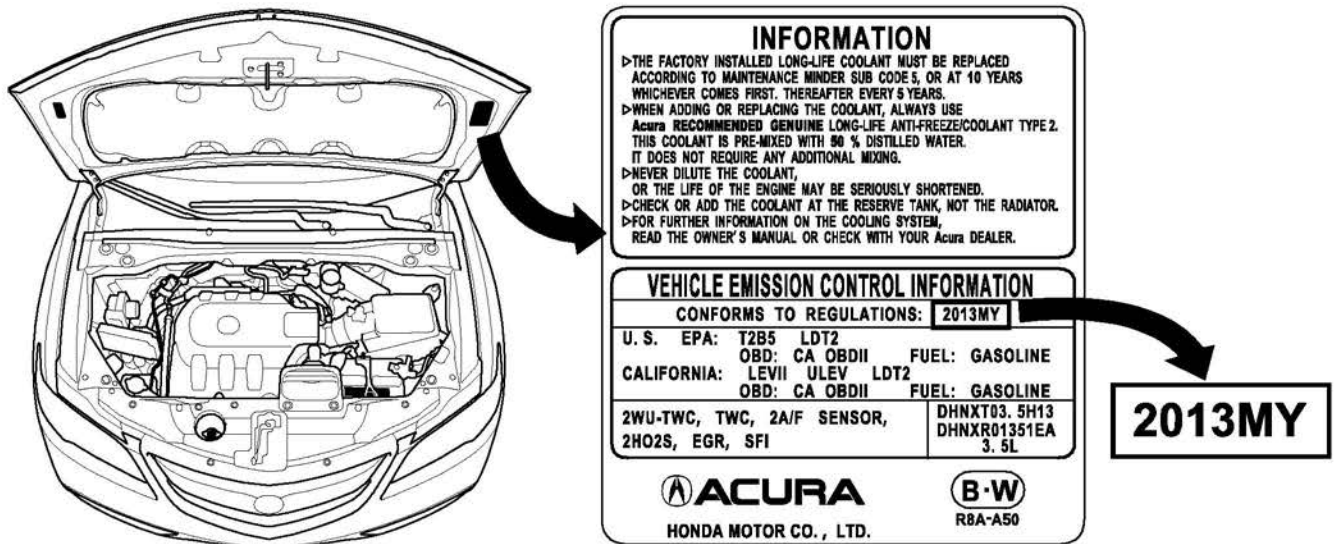
1. Inspect the emission label to confirm **2013** is the model year listed as shown.

- If the correct model year is listed, the vehicle is OK.
- If the wrong model year is listed, replace it with the correct one.
 - Remove the existing emissions label and use 3M adhesive remover to clean any remaining adhesive residue.
 - Using isopropyl (rubbing) alcohol and a clean shop towel, clean the hood area where the emissions label is placed. Allow the area to dry.
 - Peel off the backing from the new emissions label and apply it to the hood. Press the label firmly to make sure it sticks.
