August 14, 2015

ATB 51811-01884 Version 11

Safety Recall: Front Passenger's Airbag Inflator Can Be Over-Pressurized

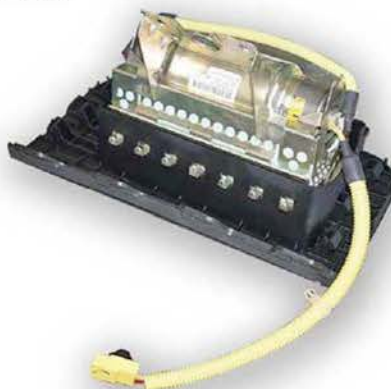
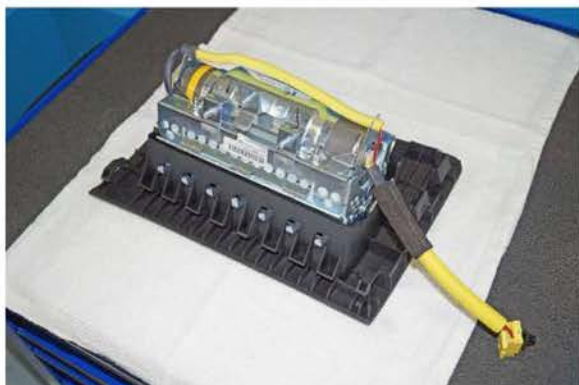
4. Place the airbag face-down on a clean shop towel as shown.

- The orientation of the airbag is critical because if the inflator is installed incorrectly, the harness will be too short when you reinstall the airbag.
- The brackets between the various models are similar but may differ from the example shown in the procedure.
