June 30, 2015

49387-01883 Version 10

Safety Recall: Front Passenger's Airbag Inflator Can Be Over-Pressurized

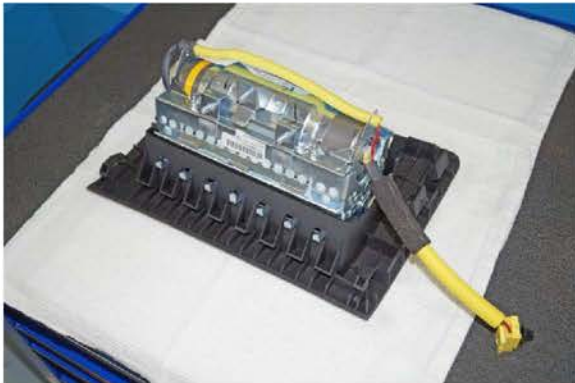
3. Remove the front passenger's airbag by referring to the applicable electronic service manual.
 4. Place the airbag, face-down, on a clean shop towel.

- The orientation of the airbag is critical because if the inflator is installed incorrectly, the harness will be too short when you reinstall the airbag.
- The brackets between the various models are similar but may differ from the example shown.

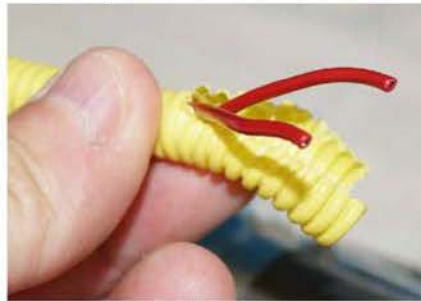
- Cut about 2 inches of the corrugated tube, then pull out the two red wires.

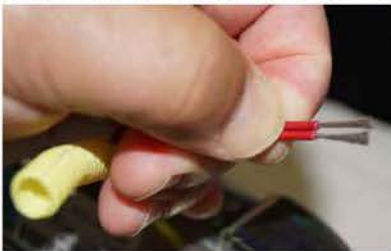
- Strip away about 1 inch of the wire insulation, then twist the wires together.

- Tape the twisted ends with electrical tape.

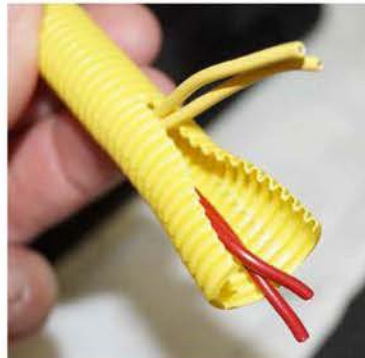
- Cut about 2 inches of the corrugated tube, then pull out the yellow wires.

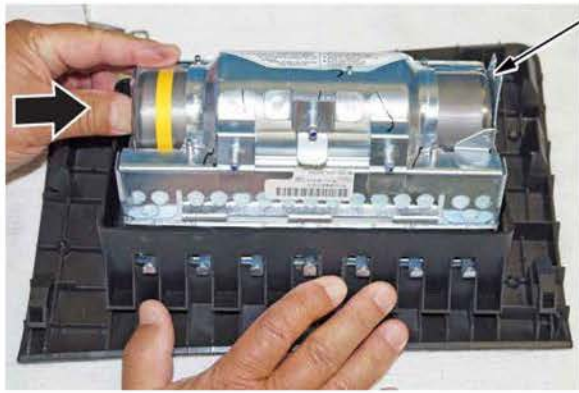
- Slide the inflator in until the “D” aligns with the tab on the inflator bracket. There should be no space or gap between the inflator and bracket.

No gap.

TAB ON BRACKET

“D” SHAPED END

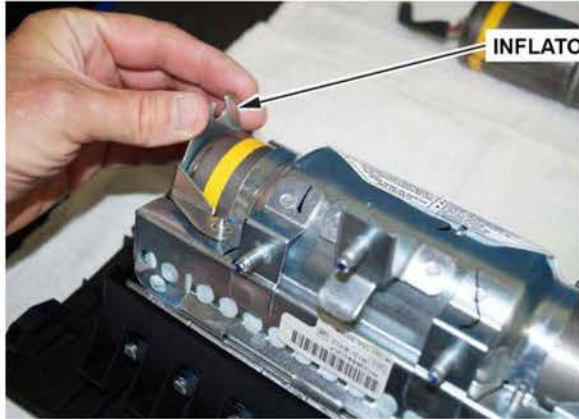
INFLATOR BRACKET

- Reinstall the inflator bracket. There should be no space or gap between the bracket and inflator.

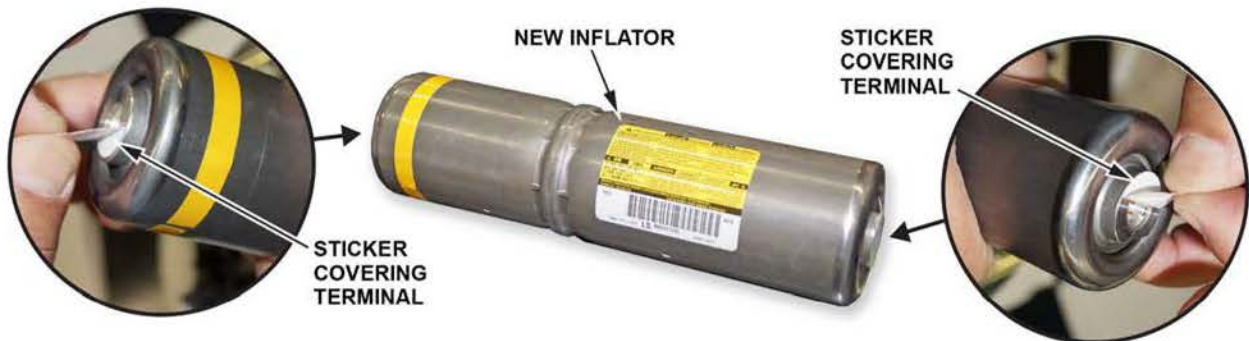
15. Remove the stickers covering the terminals on both sides of the new inflator.

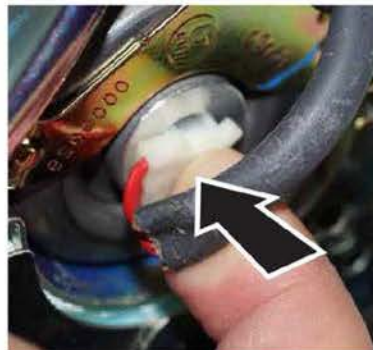
② Press the connector into place until it clicks.

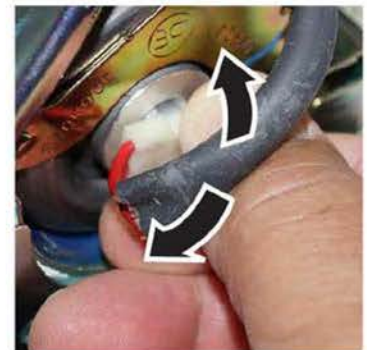
③ Wiggle the connector to make sure it's secure.

- After you hear each connector click, wiggle it to make sure it is secure.

NOTE: If the connector is not properly aligned, it will come out.
