51807-01909 Version 5

## Safety Recall: Front Passenger's Airbag Inflator Can Be Over-Pressurized

### AFFECTED VEHICLES

Year	Model	Trim	VIN Range
2003	MDX	ALL	Check the iN VIN status for eligibility

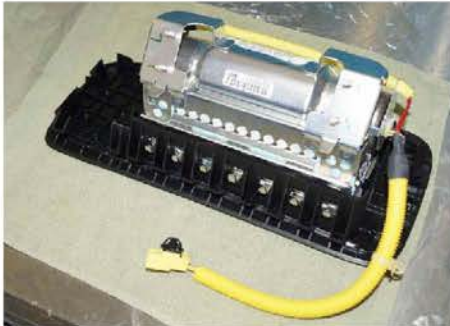
3. Remove the front passenger's airbag by referring to the applicable electronic service manual.
  4. Place the airbag face-down on a clean shop towel as shown.

- The orientation of the airbag is critical because if the inflator is installed incorrectly, the harness will be too short when you reinstall the airbag.
- The brackets between the various models are similar but may differ from the example shown.

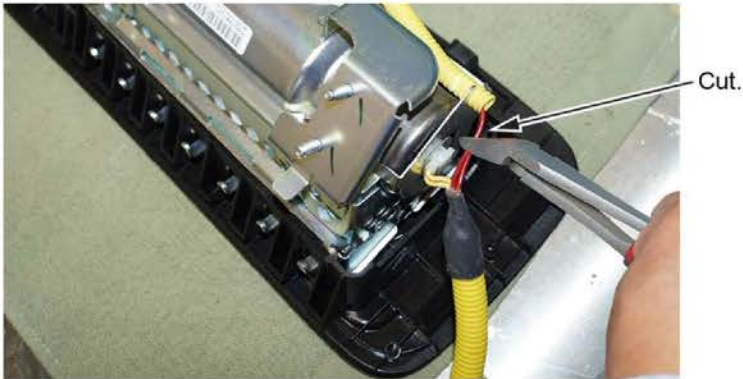
8. Short the red wires.

NOTE: **You must cut and short the wires** as indicated to prevent accidental deployment.

- Cut the red wires as shown.

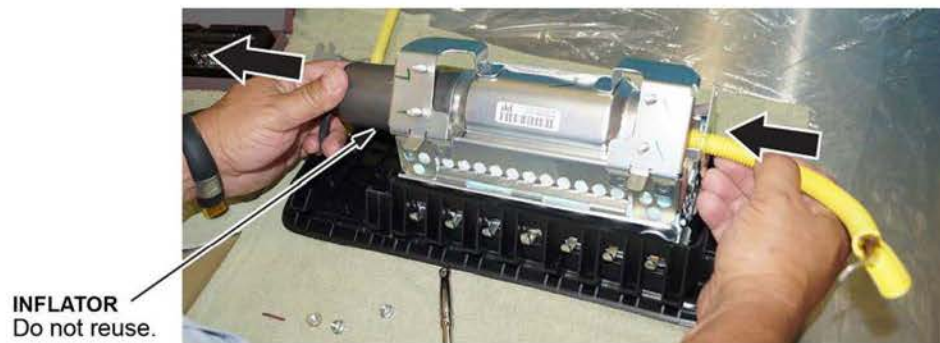
12. Remove the inflator by pushing it out.

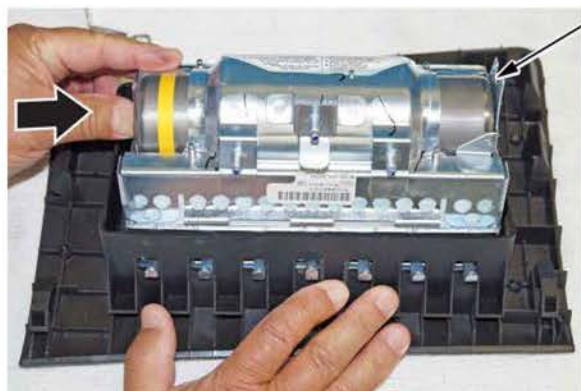
No gap.

- Slide the inflator in until the “D” aligns with the tab on the inflator bracket. There should be no space or gap between the inflator and bracket.

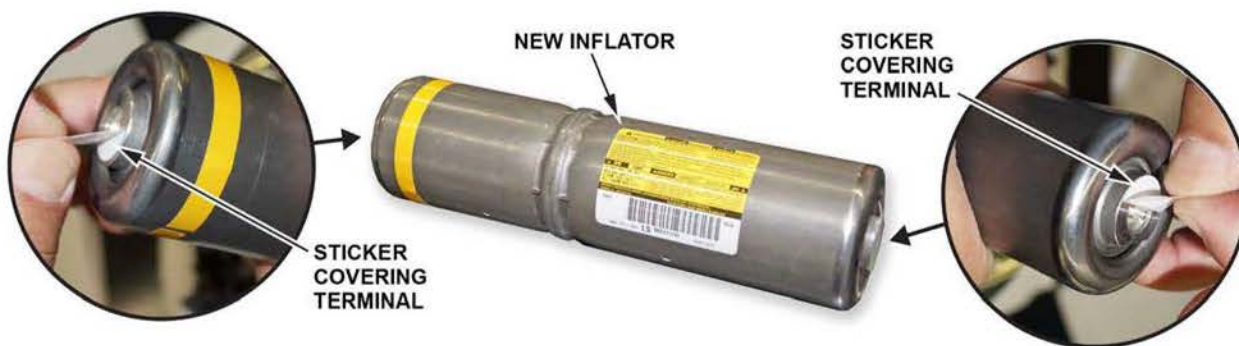
15. Remove the stickers covering the terminals on both sides of the new inflator.

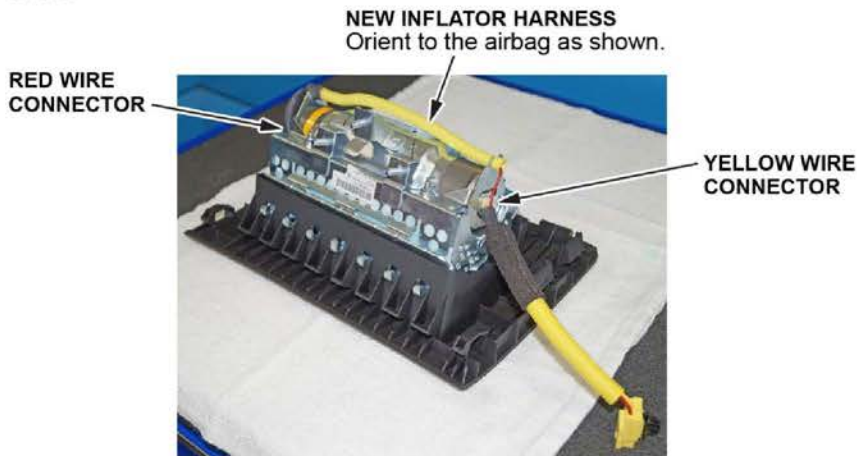
- Make sure the airbag and harness are aligned as shown.

**NOTE: Make sure you have the orientation correct as shown below.** If you connect the harness incorrectly, the harness cannot be removed and you will not be able to reinstall the airbag because the harness will be too short.

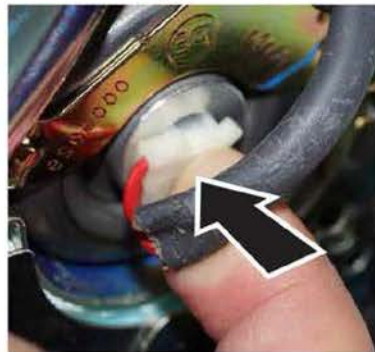
② Press the connector into place until it clicks.

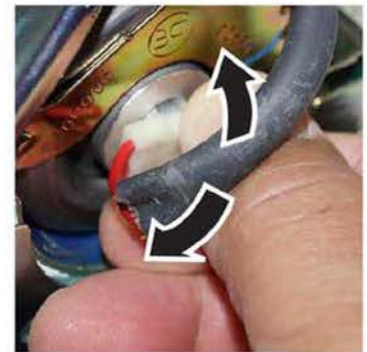
③ Wiggle the connector to make sure it's secure.

- After you hear each connector click, wiggle it to make sure it is secure.  
**NOTE: If the connector is not properly aligned, it will come out.**
