**June 23, 2015**02096 Version 1

## Safety Recall: 2016 Pilot Third Row Seat Belt Inspection

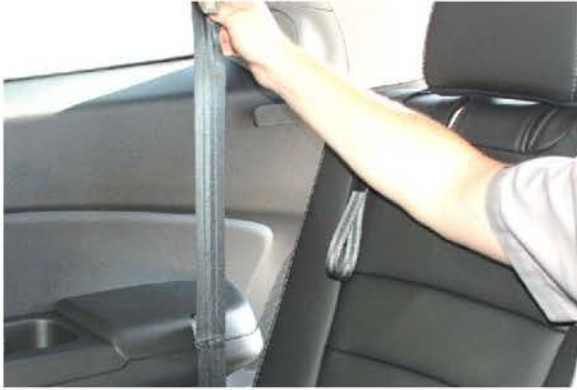
1. Make sure the third row seats are in the upright position. If the third row seat belts are buckled, unbuckle them, and pull them straight up making sure they are fully retracted.

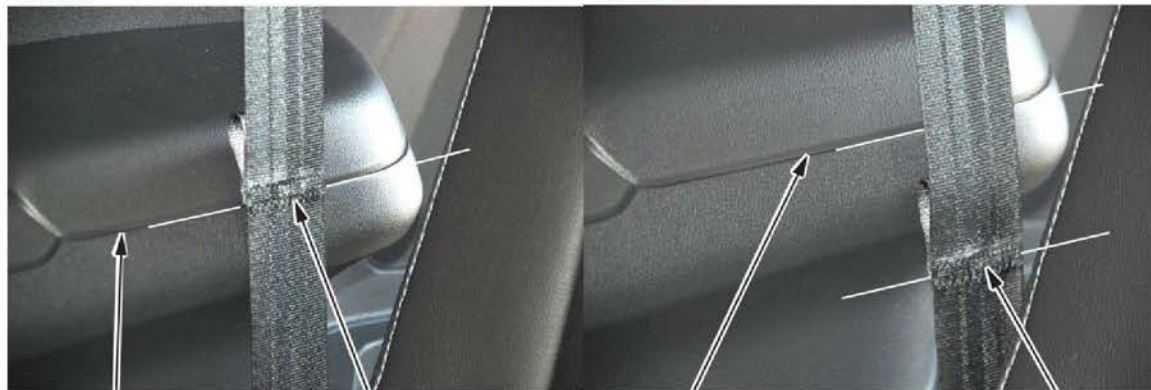
2. Compare the stitching on the seat belt with the edge of the third row side panel arm rest.

- If the seat belt stitching lines up with the edge of the third row arm rest as shown, the seat belt is Good.
- If the seat belt stitching DOES NOT line up with the edge of the third row arm rest, go to step REPAIR PROCEDURE.

GOOD

NO GOOD

SEAM ON  
INTERIOR TRIM

STITCHING ON  
SEAT BELT

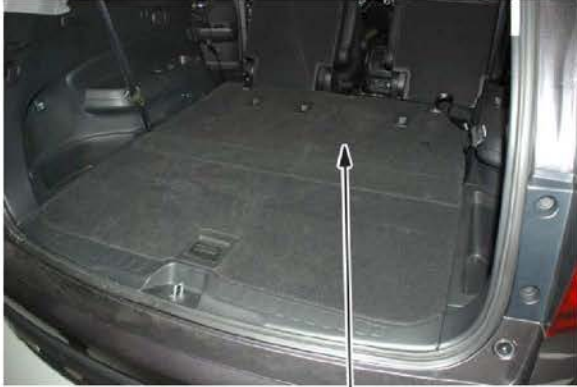
THIRD ROW  
SEATS

1. Fold the third row seat down.

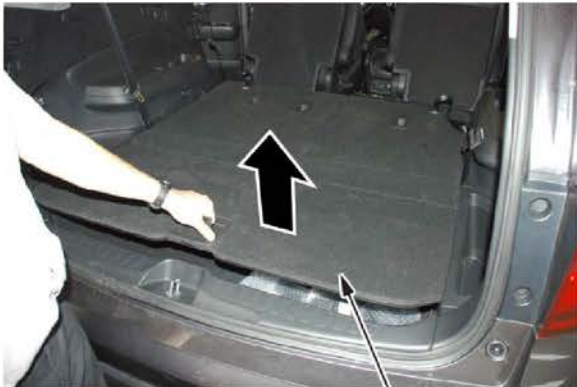
CARGO LID

2. Remove the cargo lid.

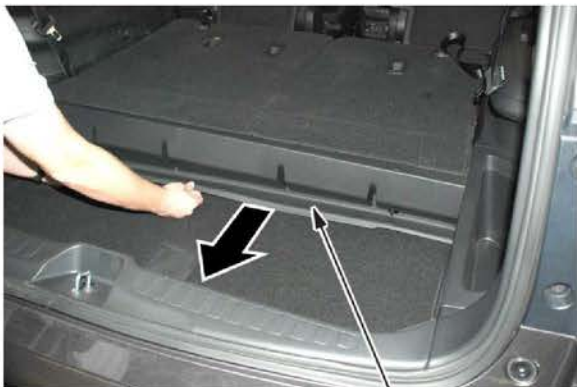
CARGO AREA TRIM

3. Remove the cargo area trim.

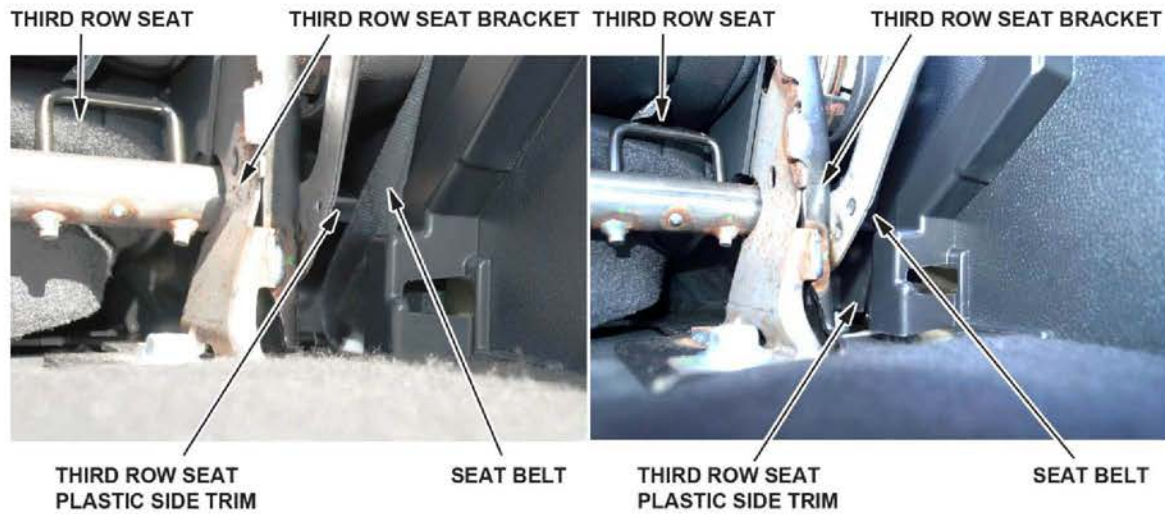
**NO GOOD**

**GOOD**

4. While pulling up on the seat belt, maneuver the seat belt from beneath the third row seat side trim to release the belt.

5. Reinstall the parts in the reverse order of removal.
