**SUBJECT: DELIVERY HOLD - Customer Satisfaction Program 16B02**  
Certain 2012-2016 Model Year Focus Electric Vehicles  
High Voltage Lower Battery Connector Corrosion

## CERTAIN 2012-2016 MODEL YEAR FOCUS ELECTRIC VEHICLES — HIGH VOLTAGE LOWER BATTERY CONNECTOR CORROSION

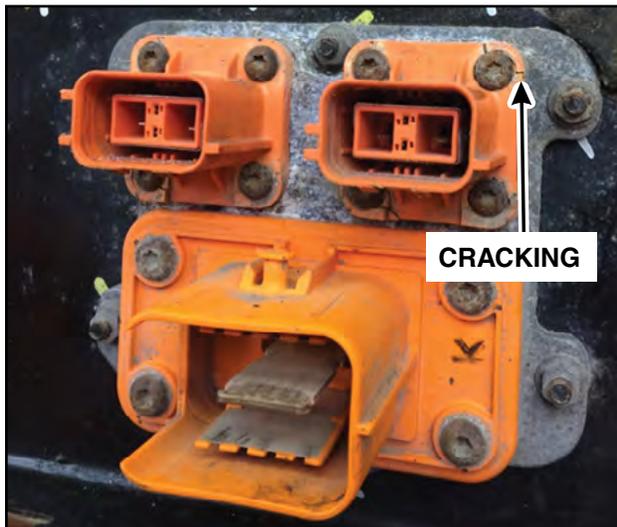
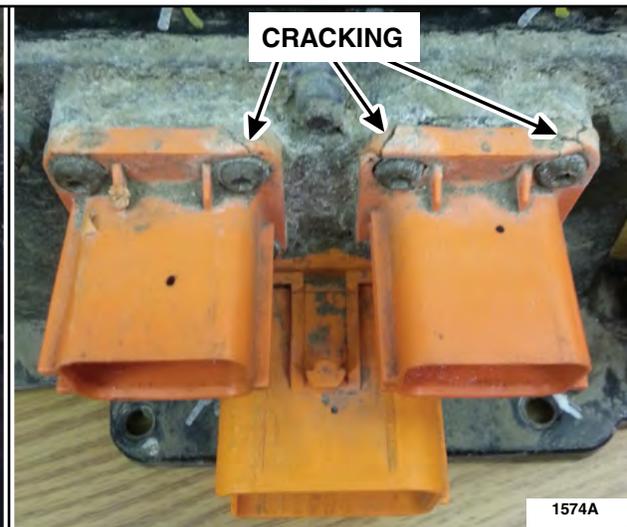
FIGURE 1a

1. Remove the high voltage lower battery. Please follow the Workshop Manual (WSM) procedures in Section 414-03A.
2. Inspect the three connectors on the LH side of the high voltage lower battery for cracking. See Figures 1a and 1b.
  - Are cracks present on any of the three connector bodies?
    - YES - The high voltage lower battery must be shipped to Piston Group for repair. Proceed to Battery Repair Process on Page 6.
    - NO - Proceed to Step 3.

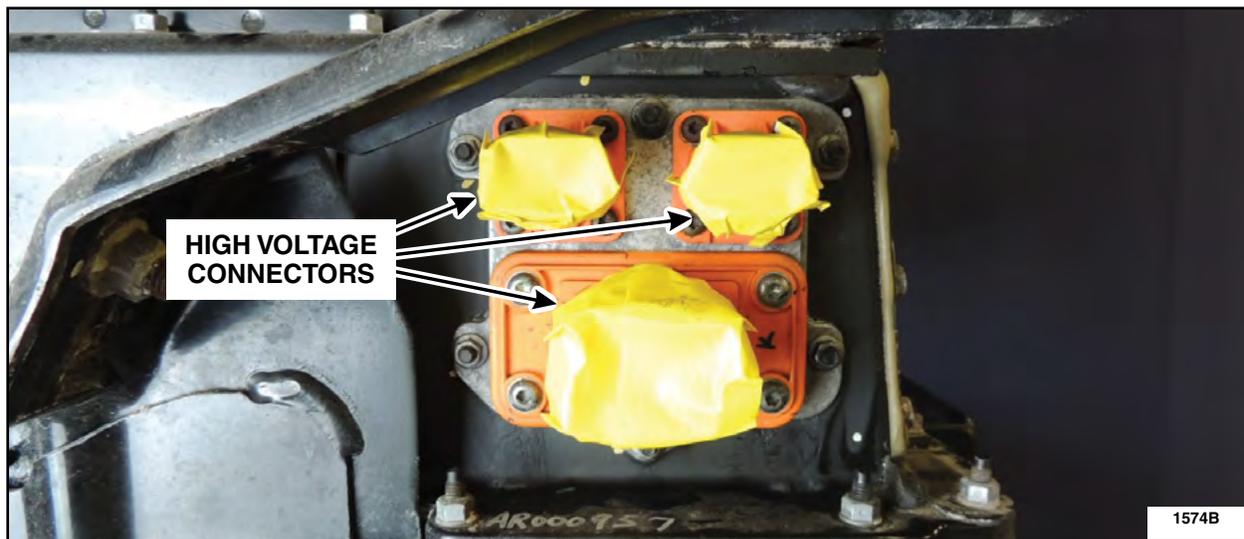
FIGURE 2

3. Apply tape (masking, electrical or duct) to the connector faces to protect the terminals and keep the connector housing clean. See Figure 2.

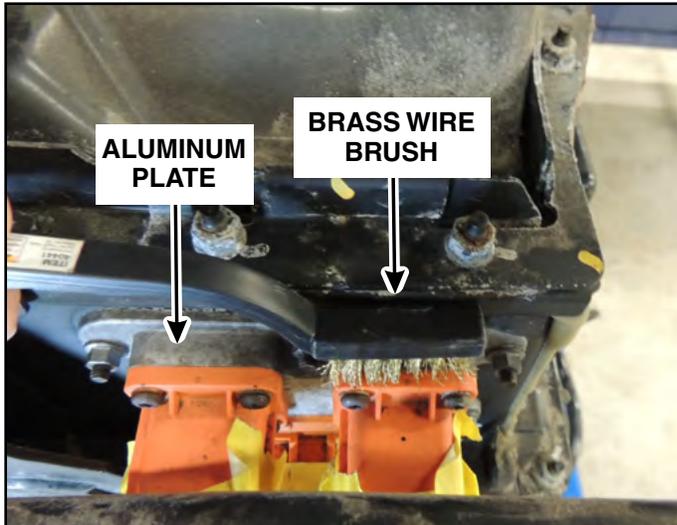
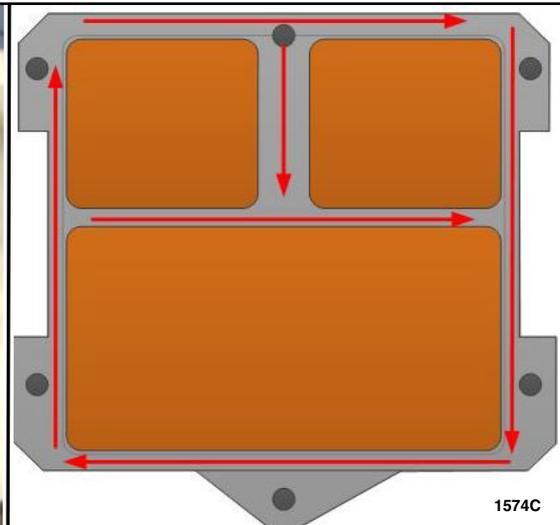
FIGURE 3a

- Using a brass wire brush, thoroughly clean the areas surrounding the three high voltage connectors to aluminum plate mating surfaces. Using compressed air, clean the loose debris from the connectors. See Figures 3a and 3b.

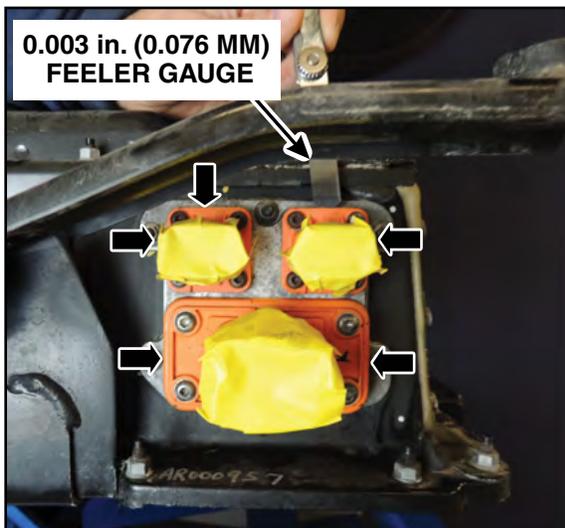
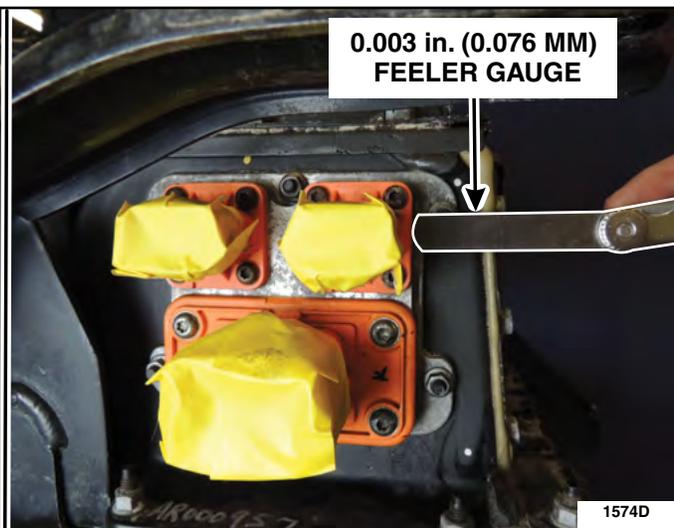
FIGURE 4a

- Attempt to insert a 0.003 in. (0.076 mm) feeler gauge between the aluminum plate and the top and sides of the two smaller high voltage connectors and the sides of the large high voltage connector. See Figures 4a and 4b.

- Does the feeler gauge fit between the aluminum plate and the connectors at one or more of the locations indicated in Figure 4a?
  - YES - The high voltage lower battery must be shipped to Piston Group for repair. Proceed to Battery Repair Process on Page 6.
  - NO - Proceed to Step 6.

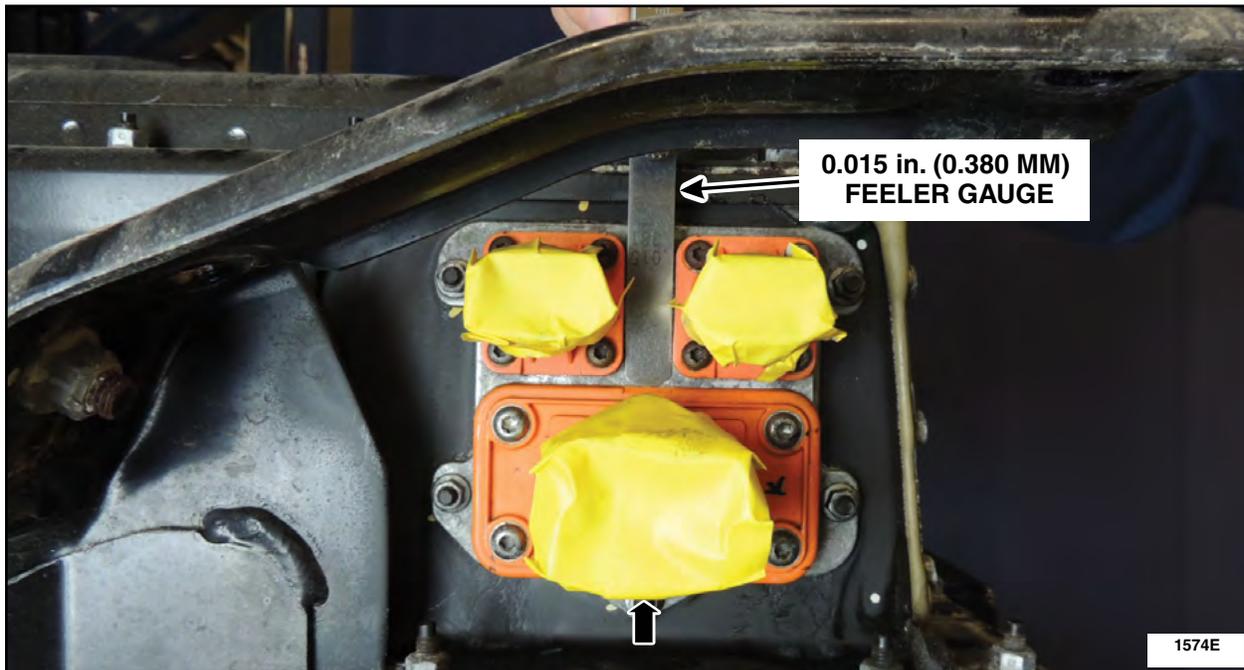
FIGURE 5

6. Attempt to insert a 0.015 in. (0.380 mm) feeler gauge between the aluminum plate and the top and bottom of the large high voltage connector. See Figure 5.

- Does the feeler gauge fit between the aluminum plate and the large high voltage connector?
  - YES - The high voltage lower battery must be shipped to Piston Group for repair.  
Proceed to Battery Repair Process on Page 6.
  - NO - Proceed to Apply Corrosion Protection below.

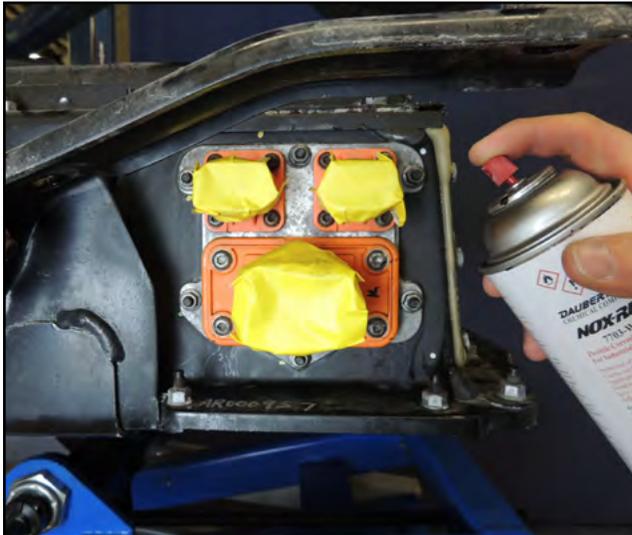
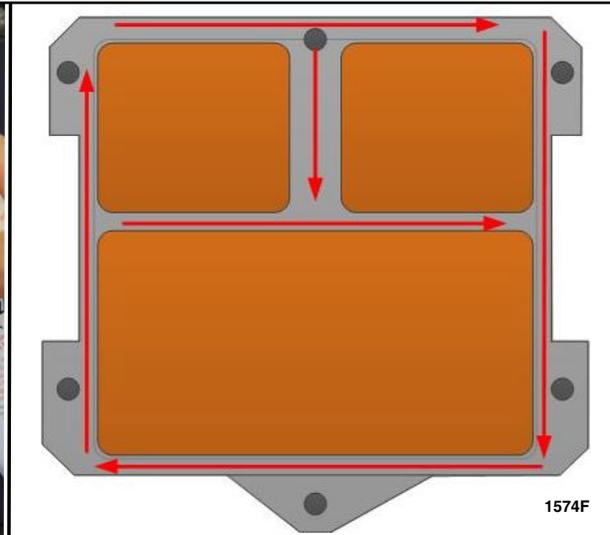
FIGURE 6a

1. Ensure the tape is completely covering the connector faces. See Figure 6a.
2. Spray Daubert NOX-RUST® 7703-W generously around the perimeter of all three connector to aluminum plate mating surfaces. See Figure 6b.
  - Allow the corrosion protection to penetrate for a minimum of ten minutes.
3. Apply a second coat of corrosion protection.
4. Install the high voltage lower battery into the vehicle. Please follow the WSM procedures in Section 414-03A.
5. Proceed to High Voltage Lower Battery Connector Shield Installation on Page 7.

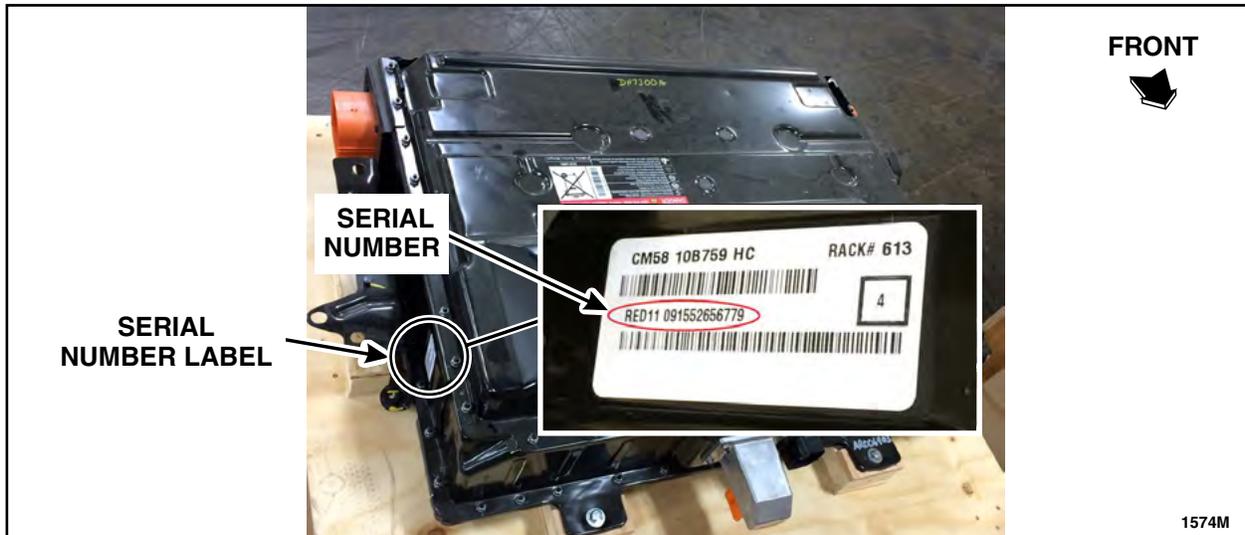
**FIGURE 7**

1. Locate and record the high voltage lower battery serial number. See Figure 7.

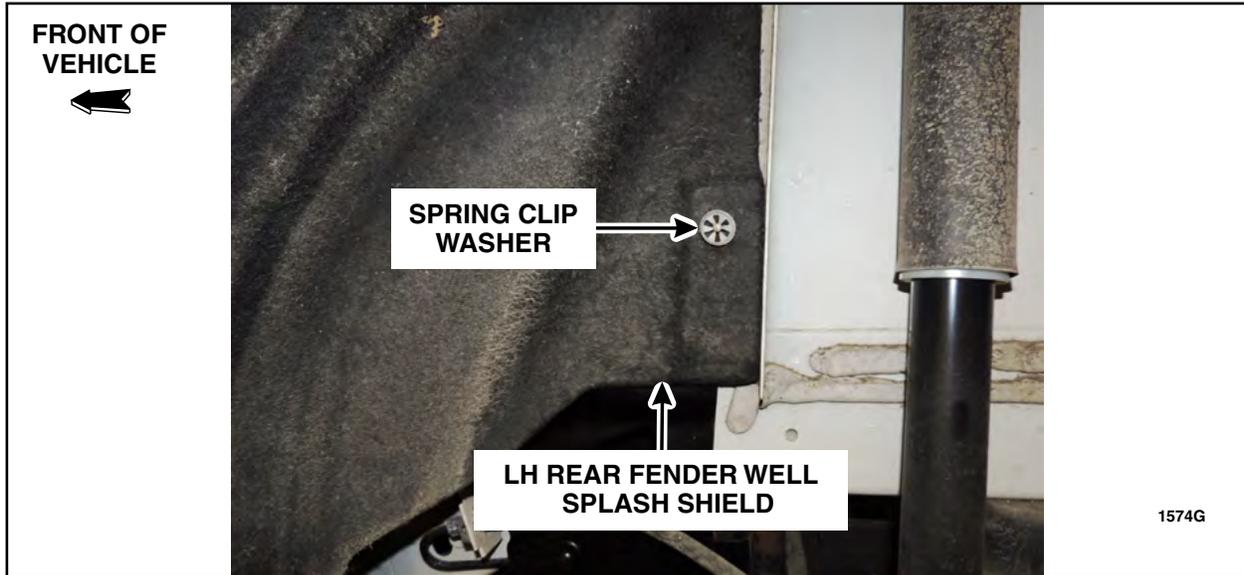
FIGURE 8

1. Remove the LH wheel and tire. Please follow the procedures in WSM Section 204-04A.
2. Remove the LH rear fender well splash shield spring clip washer. See Figure 8.

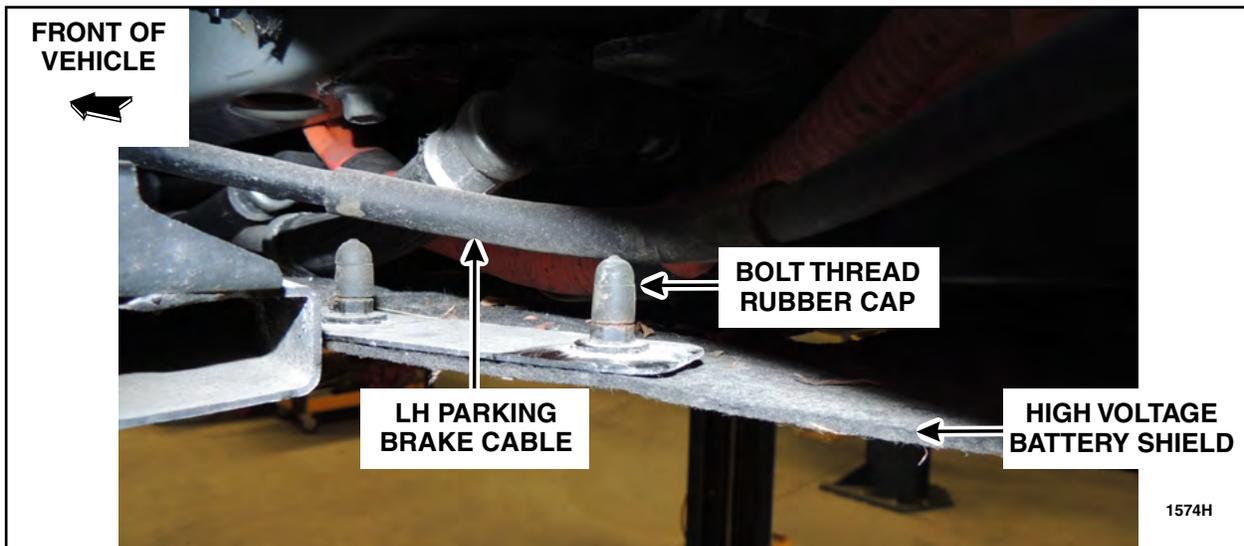
FIGURE 9

3. Remove the bolt thread rubber cap. See Figure 9.

**NOTE:** The bolt thread rubber cap must be reinstalled. Failure to install the cap may result in parking brake cable damage.

8. Install the bolt thread rubber cap. See Figure 9.

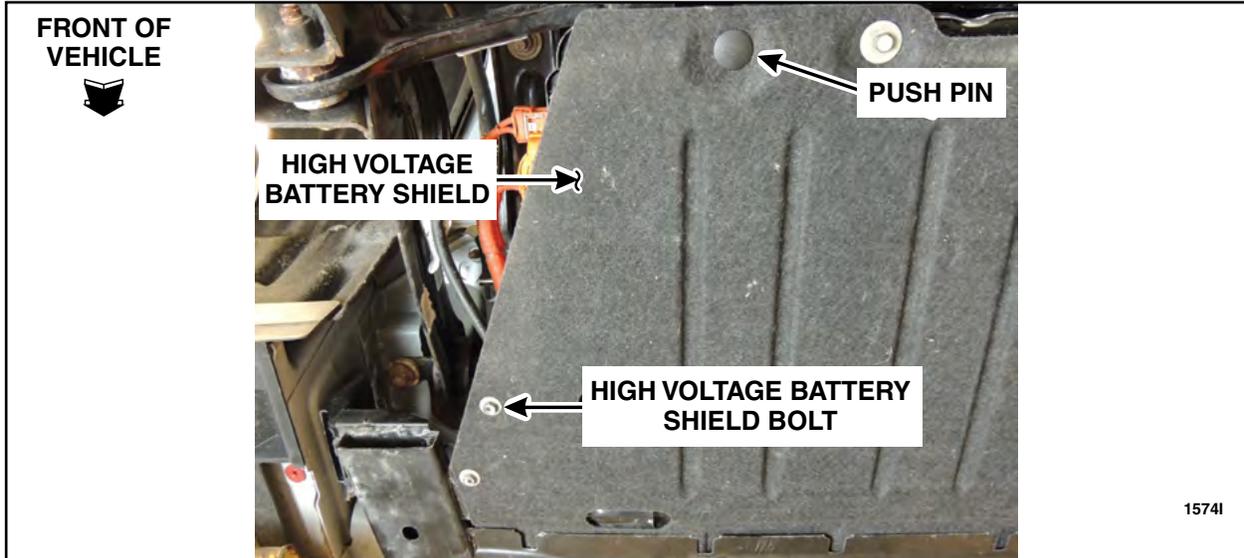
FIGURE 10

4. Remove the high voltage battery shield bolt and push pin. See Figure 10.

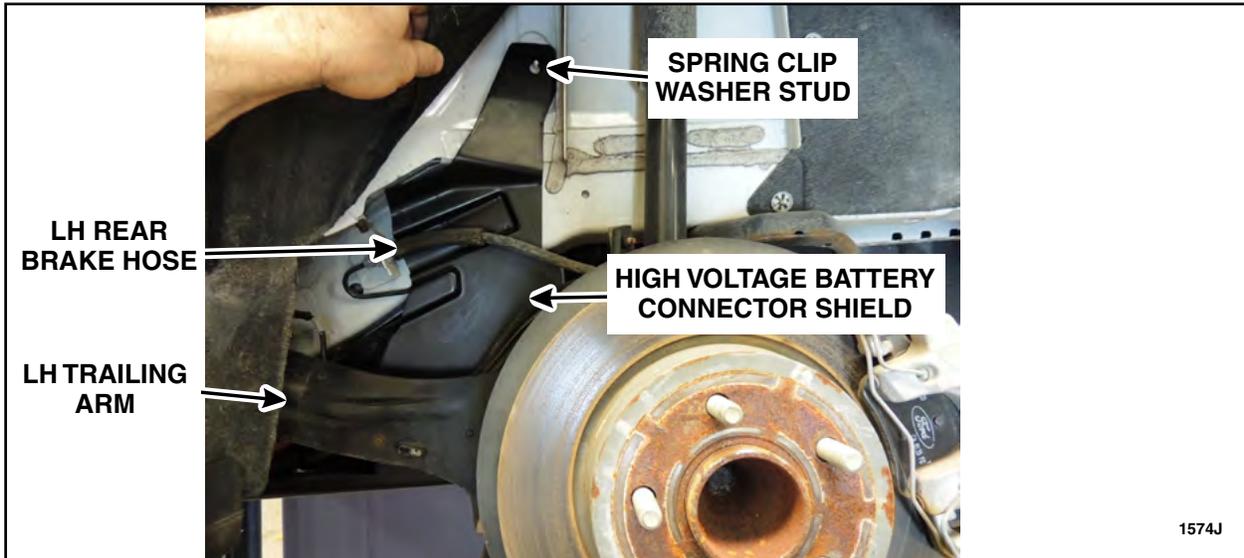
FIGURE 11

5. Position the top of the high voltage battery connector shield behind the LH rear brake hose and trailing arm. See Figure 11.

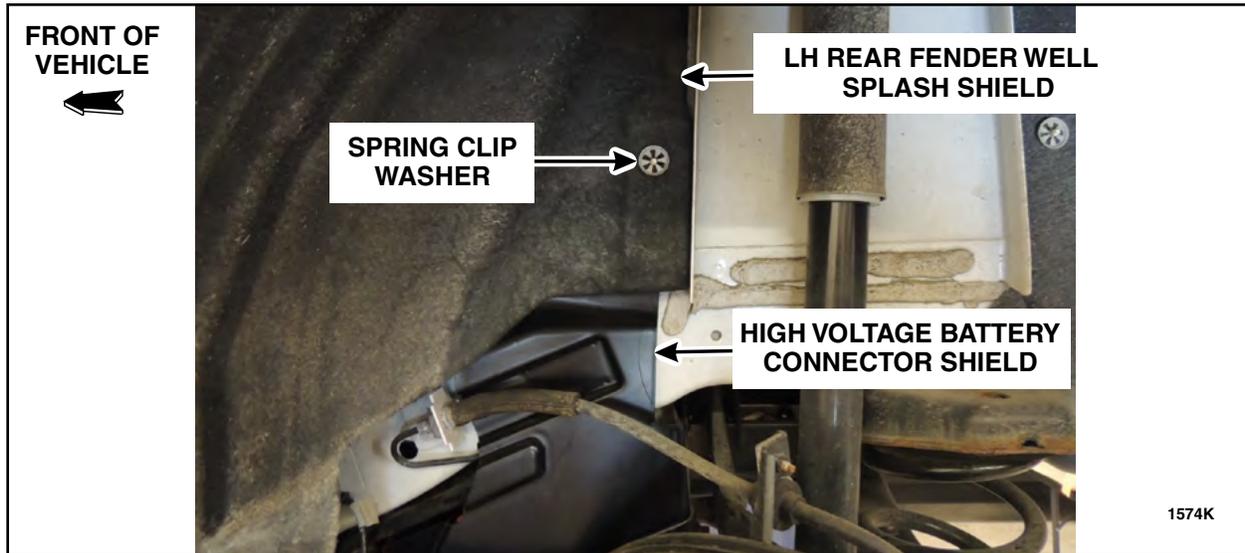
FIGURE 12

6. Install the LH rear fender well splash shield spring clip washer. See Figure 12.

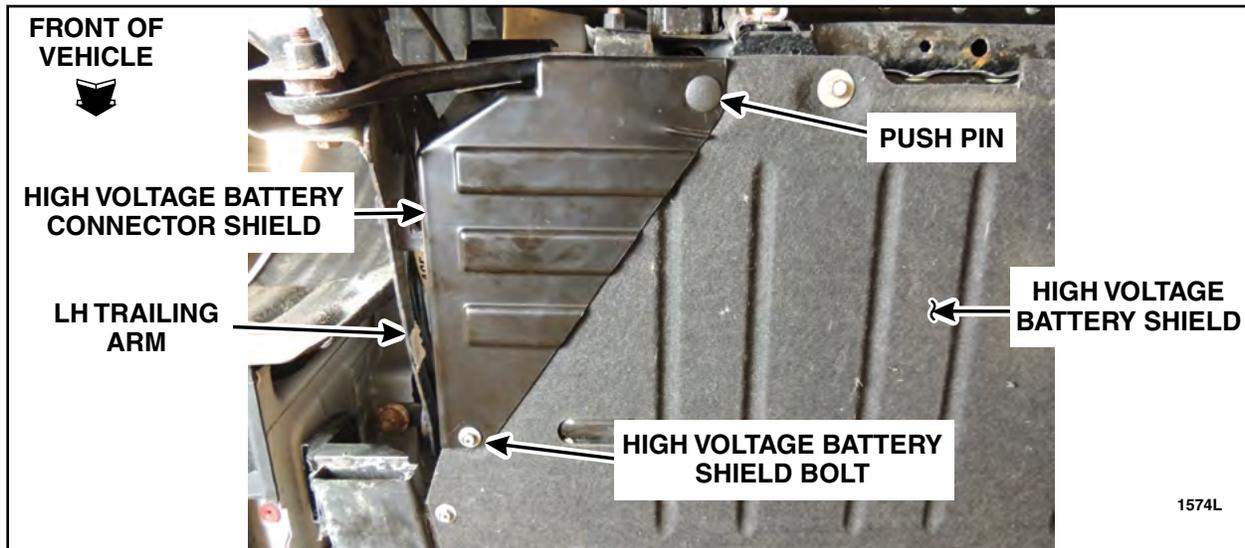
FIGURE 13

7. Install the high voltage battery shield bolt and push pin. See Figure 13.

- Tighten the high voltage battery shield bolt to 20 lb.ft (27 Nm).
