RE: 579.5 Notices, bulletins, customer satisfaction campaigns, consumer advisories, and other communications for the month of December, 2015.

SUBJECT: 2016 Indian Scout Motorcycles – VECI Decal Replacement

SUBJECT: 2015 GEM SEAT BELT REPLACEMENT

SUBJECT: 2015 Victory Motorcycles – Idle Air Control Replacement / ECM Reflash

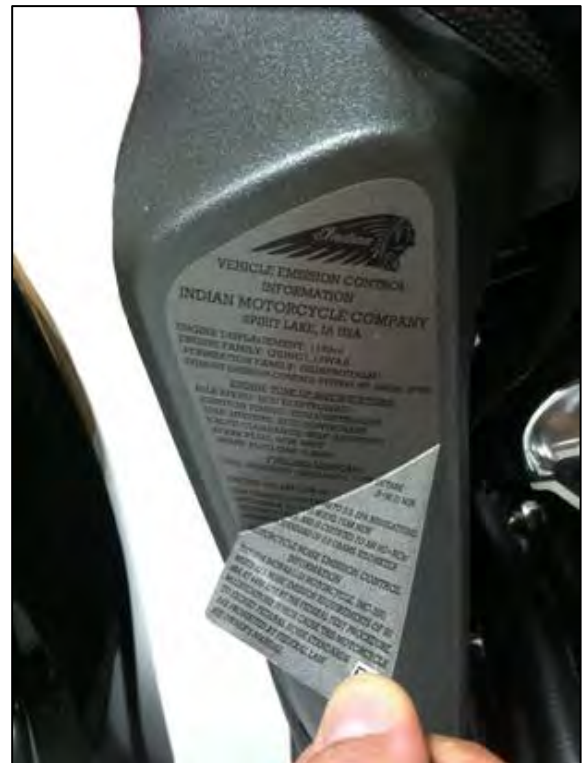
3. Remove decal completely from front frame. Clean residual adhesive from the decal installation site with a decal adhesive cleaner (commercially available). Warm the replacement decal and motorcycle to room temperature. Install replacement decal in same orientation as the original decal. Air bubbles trapped beneath decal can be pressed toward edges to remove.

1. **49 State: Single VECI decal ① on LH radiator support. Replace decal with 7184386.**
2. **50 State: Single VECI decal ①. DO NOT REMOVE CARB DECAL ③.**
3. **CANADA: Two VECI decals English ① and French ②. Replace VECI decals ① with 7184386 and ② 7184388.**
