## **MULTI-MODEL (EQUIPPED WITH IDLE CONTROL VALVE)** *HIGH ENGINE IDLE SPEED*

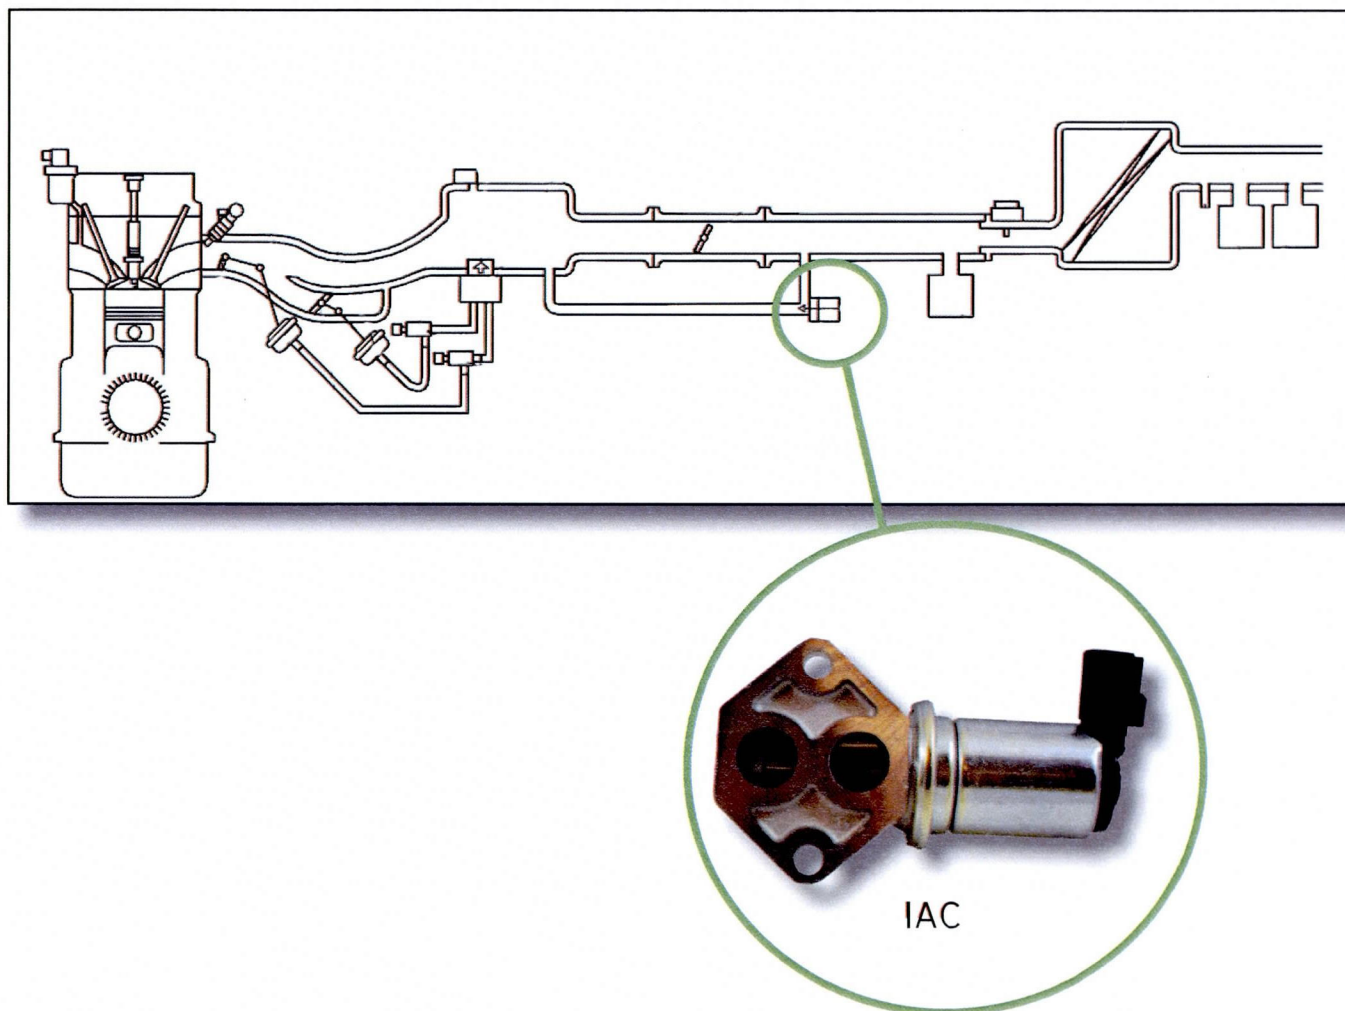
Some customers may complain about a high engine idle speed. A stuck open idle air control valve (IAC) may be the cause.

If normal Workshop Manual diagnosis does not isolate the cause of the high engine idle, check for a stuck open IAC valve.

If the IAC valve is stuck open, replace it to correct customers concern.
