**FORD:**

2015-2016 Transit

**ISSUE**

Some 2015-2016 Transit vehicles built on or before 2/15/2016 may exhibit contact between the front door and fender. This may be due to the front door check arm allowing the door to open far enough to bend the door hinges after repeated full door opening.

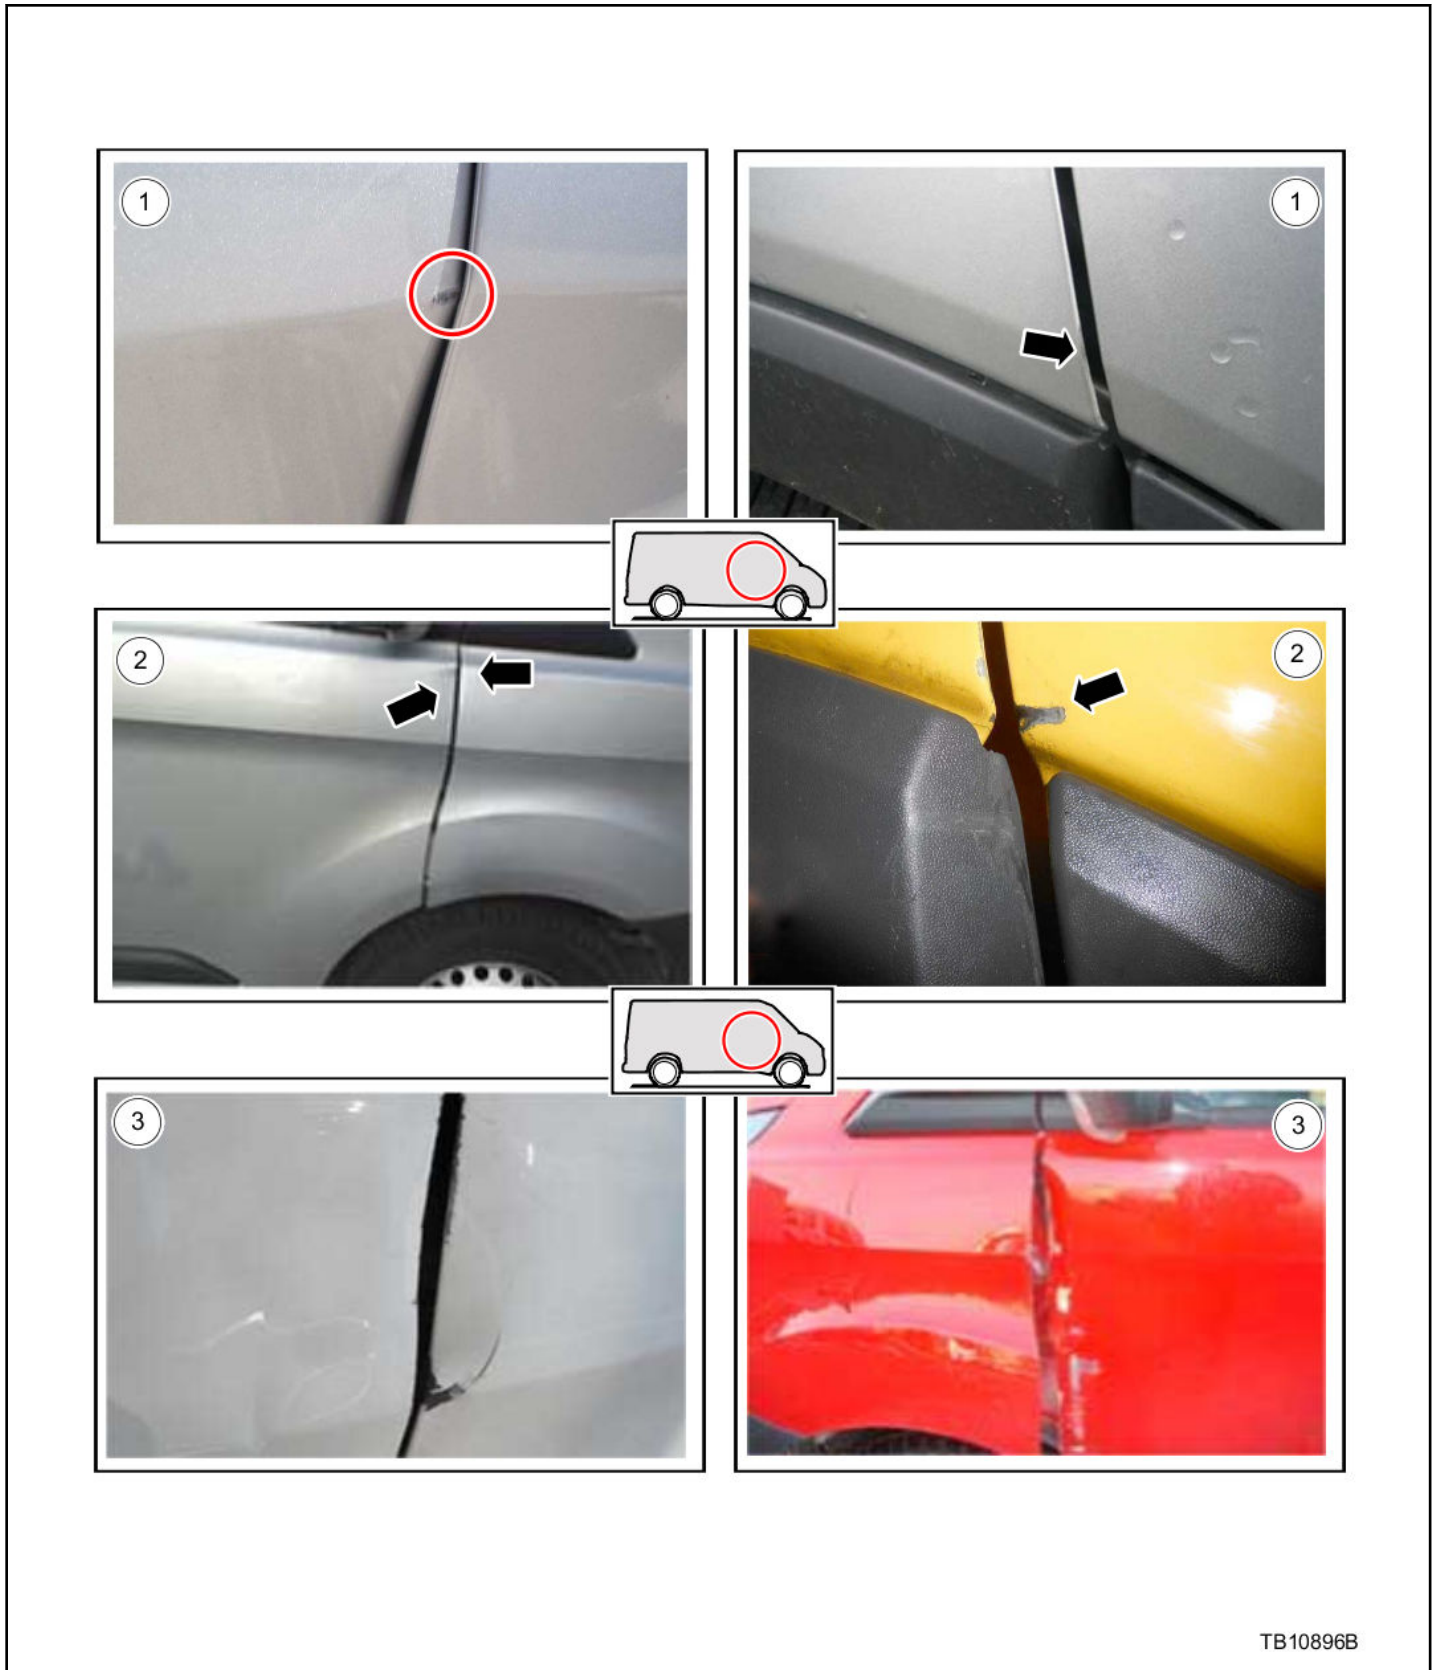
Figure 1 - Article 16-0081

1. Inspect each front door and front fender for signs of door to fender contact. Does the vehicle exhibit signs of door to fender contact? (Figure 1)
  - a. Yes - proceed to Step 2.
  - b. No - this article does not apply.

2. Remove the affected door(s), refer to Workshop Manual (WSM), Section 501-03.

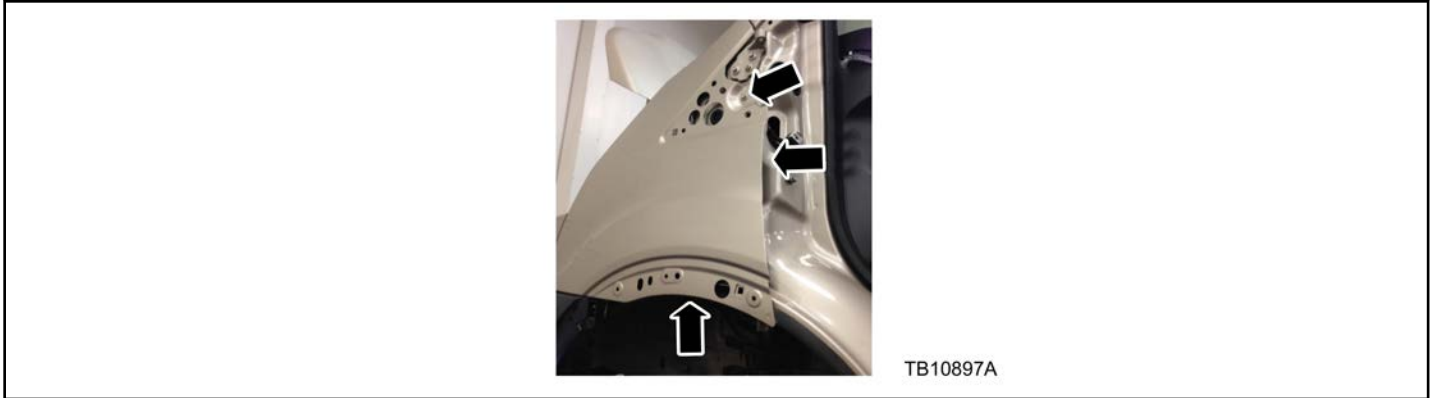
Figure 2 - Article 16-0081

3. Remove the fender splash shield. Refer to WSM Section 501-02.
4. Remove the lower fender bolt, inner fender to body side bolt and fender to body side bolt. (Figure 2)

5. Remove and discard the door hinges from the A-pillar and the door.
6. Repair any metal damage to the fender and door as required.
7. Paint the new door hinges. Paint the door and fender as required.
8. Attach the new hinges to the A-pillar.
  - a. Tighten the hinge to A-pillar bolts. Torque to 35 Nm (26 lb-ft).
  - b. Tighten the hinge alignment pin nut. Torque to 10.5 Nm (93 lb-in).
9. Install the lower fender bolt, inner fender to body side bolt and fender to body side bolt. (Figure 2)
  - a. Tighten the fender bolts. Torque to 9 Nm (80 lb-in).
10. Install the door. Refer to WSM, Section 501-03.
  - a. Tighten the hinge to door bolts. Torque to 62 Nm (46 lb-ft)
11. Replace the front door check arm. Refer to WSM Section 501-03.
12. Adjust the front door alignment. Refer to WSM Section 501-03.
13. Install the fender splash shield.
