FORD:

2015-2016 F-150

ISSUE

Some 2015-2016 F-150 vehicles built on or before 5/1/2016, may exhibit inoperative windshield washer jets when the ambient temperature is below 0 °C (32 °F).

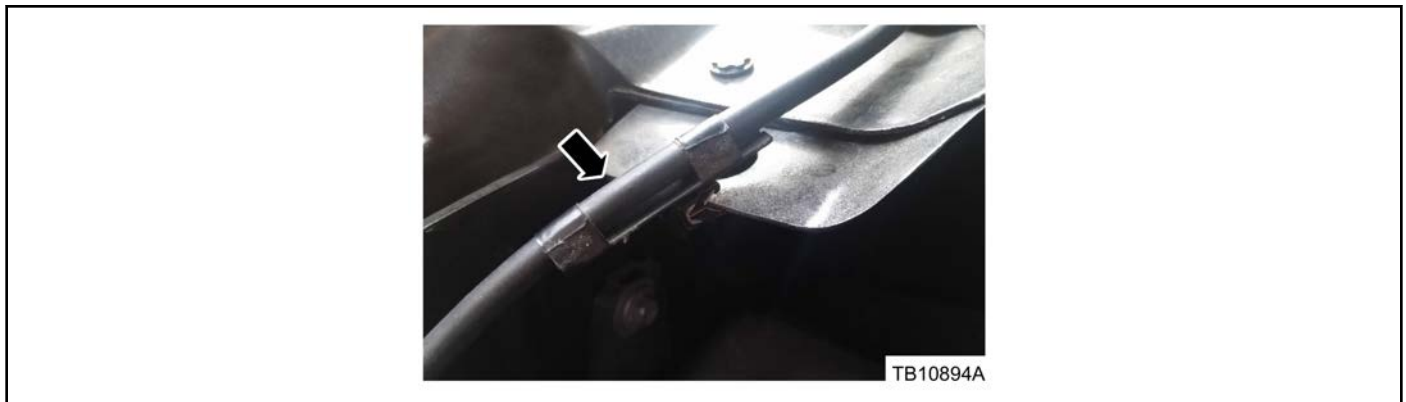
Figure 1 - Article 16-0082

1. Is the customer using the correct type of washer solvent for the temperature conditions present?
 - a. Yes - proceed to Step 2.
 - b. No - this article does not apply. Inform the customer of the correct type of washer solvent to use for the temperature conditions present.
2. Lift up the left and right cowl panel grilles. Refer to Workshop Manual (WSM), Section 501-02.
 - a. It is not necessary to remove the wiper arms.
3. Disconnect and remove the washer hose from the washer jets located in the left and right cowl panel grilles.
 - a. Disconnect the washer hose from the left washer jet by gently twisting the lock ring of the C-lock coupler until it has rotated approximately 90 degrees. Refer to WSM, Section 501-16.
4. Remove the clip from the cowl panel. (Figure 1)

6. Connect the new washer hose to the C-lock coupler at the BJB. (Figure 2)
7. Connect the clip of the new hose to the cowl panel. (Figure 1)
8. Connect the washer hose to the left and right hand cowl trim panels and washer jets.
 - a. Reconnect the C-lock coupler to the left washer jet.
9. Reinstall the right and left cowl panel grilles. Refer to WSM, Section 501-02.

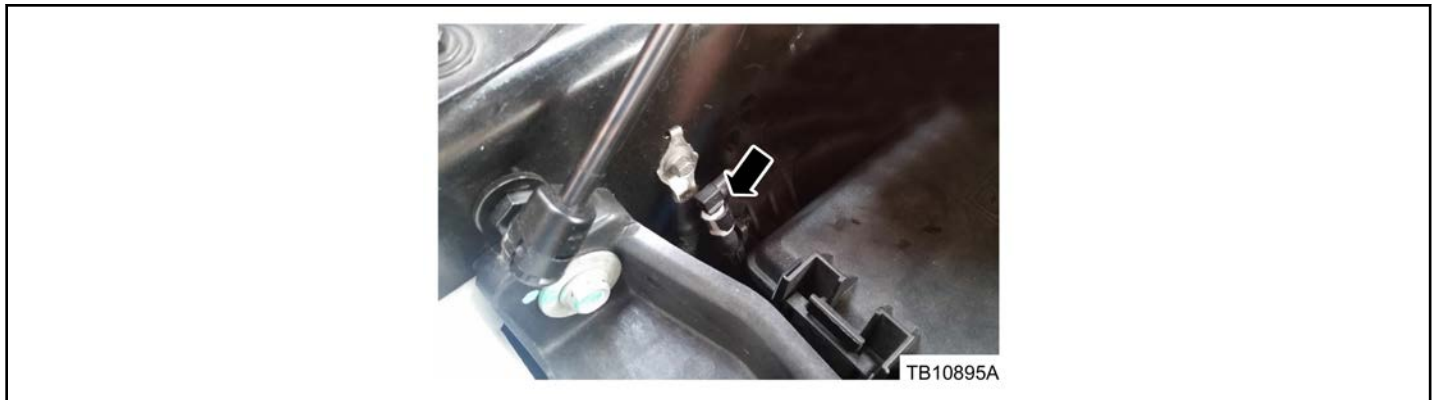
Figure 2 - Article 16-0082

5. Disconnect the washer hose from the C-lock coupler at the battery junction box (BJB). (Figure 2)
