GROUP <b>BOD</b>	MODEL <b>2015~2016MY Sedona (YP)</b>
NUMBER <b>127</b>	DATE <b>January 2016</b>

## TECHNICAL SERVICE BULLETIN

**SUBJECT:** SERVICE ACTION: OVERHEAD CONSOLE INSPECTION AND/OR REPLACEMENT (SA 215)

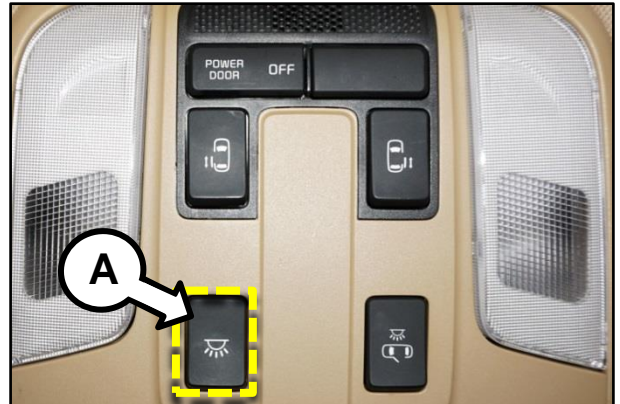
1. To test the Interior Light Control Switch (A) for proper operation, perform the following steps:

1. Press and slowly release the Interior Light Control switch (A) three (3) times, ensuring all the interior lights did alternate (ON/OFF) each time the switch was cycled. **NOTE: Failure to perform the switch test slowly may not identify all defective overhead console switches. Refer to the video link below for detailed information**

2. If the interior lights did NOT alternate between ON/OFF, proceed to the Service Procedure on Page 4.
  3. If all the interior lights did alternate in all 3 switch cycling tests, proceed to step 2.
2. To test the Interior Light Control Switch (B) for proper operation, perform the following steps:
    1. Start with leaving a door open.
    2. Press and slowly release the Interior Light Control (B) switch three (3) times, ensuring all interior lights alternate (ON/OFF) each time the switch was cycled. **NOTE: Failure to perform the switch test slowly may not identify all defective overhead console switches. Refer to the video link below for detailed information.**

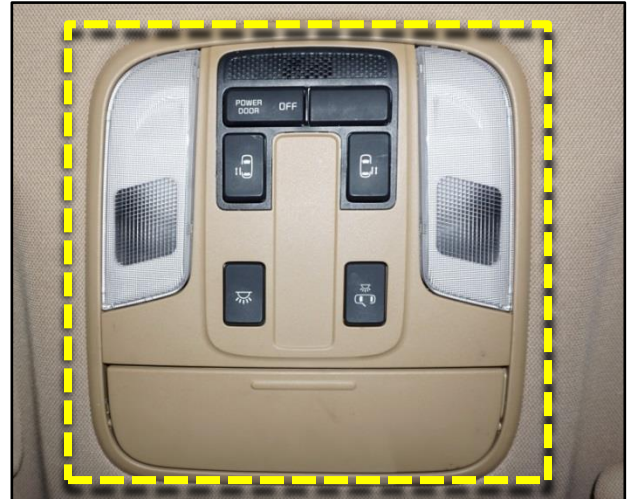
1. Remove the overhead console assembly by referring to “Body Electrical System → Lighting System → Overhead Console Lamp → Repair procedures” chapter in the applicable Workshop Manual.

- Use a non-marring trim removal tool (such as Snap-on® P/N PBN5 or equivalent) to avoid damaging trim pieces.
- Wear disposable gloves to avoid soiling the headliner.

2. Replace the overhead console assembly with a new one and re-install all removed components by reversing the order of removal.
3. Confirm proper operation of overhead console switches, including PSD operation.
