SUNSHADE RETRACT END OF COURSE DAMPER

Prevost vehicles

DESCRIPTION

On the vehicles affected by this bulletin, add dampers to the driver's sunshades guides to ease the end course on sunshade retract.

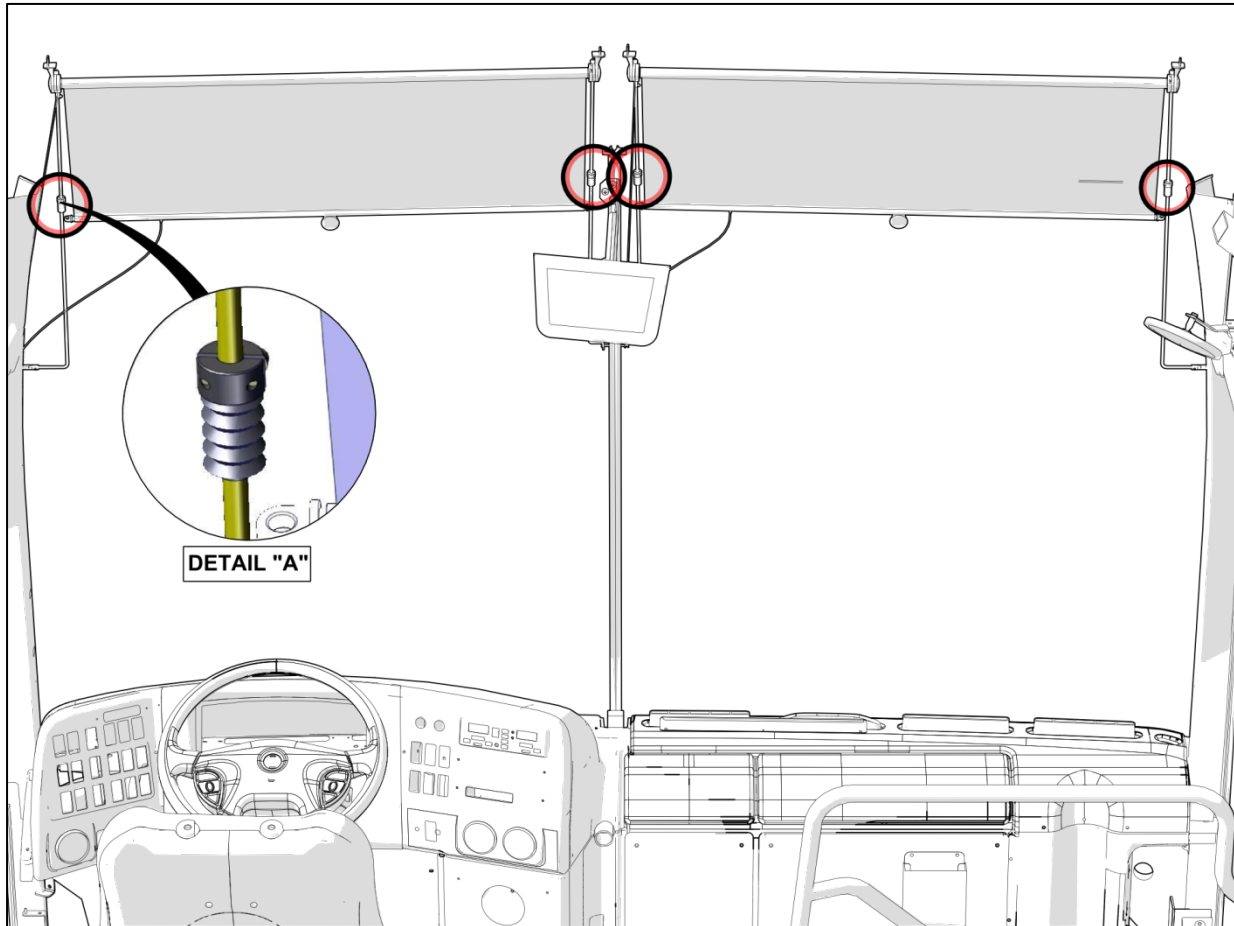
Figure 1

Four rubber dampers need to be added to the guide rods on the front sunshades of the vehicle.

They are fixed to the guide rod by a split collar.

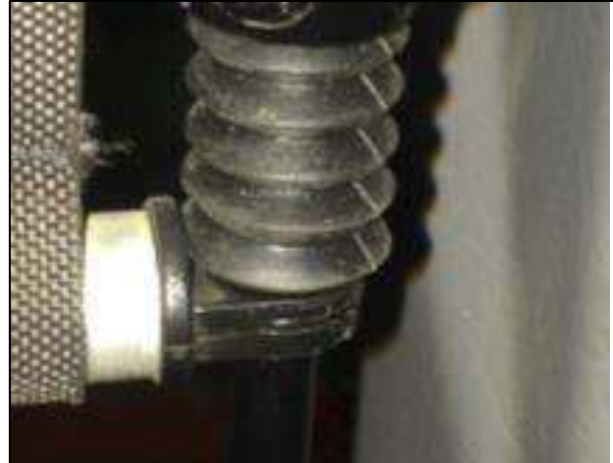
Figure 3

- Slide-on bellows **#504033** above the sunshade guide bushing. (Fig. 3)
- Reinstall the sunshades and rods making sure they are well inserted.

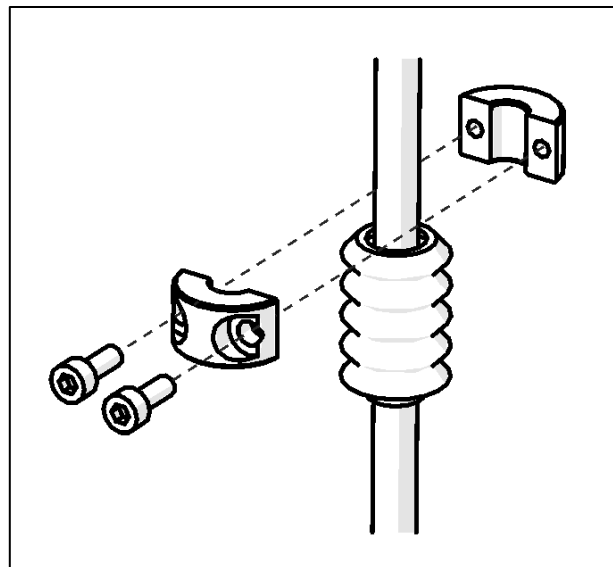
Figure 5

- Collar **#504030** is split in two parts with two screws to secure the assembly. (Fig.5)
Use it to position bellows **#504033** on the guide rod.

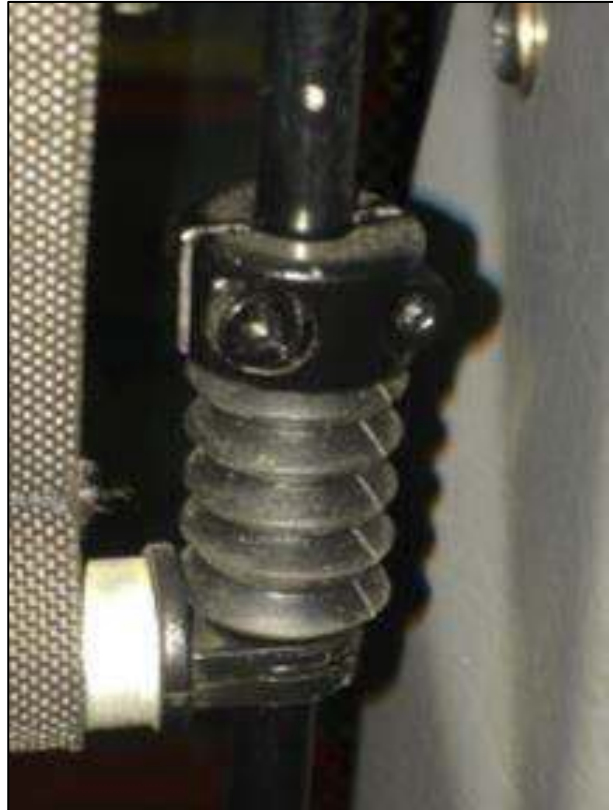
Figure 6

- Place the collar so that the bottom of the sunshade is at the same height as the destination sign. Tighten temporarily. (Fig. 6)
- Repeat on each of the 4 rods.
