# TECHNICAL SERVICE BULLETIN

Technical Service Bulletin: 3-07252016-0232

**Symptom:** Condensation infiltrating into living space from return air duct.

**Remedy:** Add a supply vent in the ceiling return air duct and drain covers in the air conditioner.

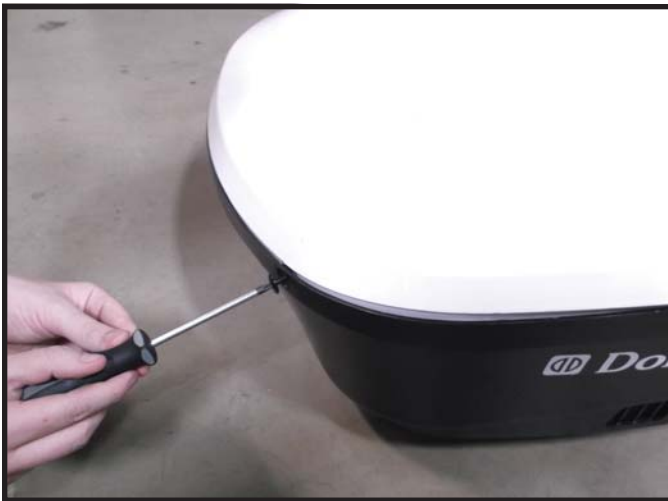
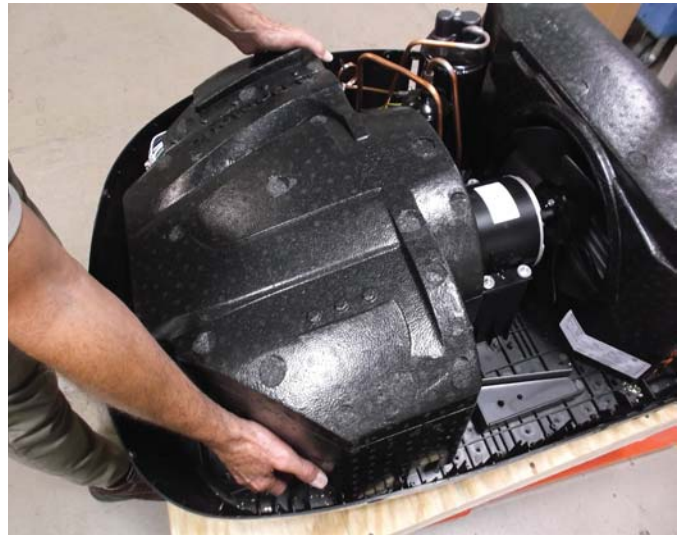
1. **⚠ WARNING** ELECTRICAL SHOCK HAZARD. Disconnect 120 Vac power from product. Failure to obey this warning could result in death or serious injury.
2. **NOTICE** Disconnect the positive (+) 12 Vdc terminal from supply battery. Otherwise, damage to unit could occur.
3. Remove outer plastic shroud.
4. Remove inner EPP foam cover. Carefully remove putty from around electrical wiring and freon tubes. Save for re-installation.

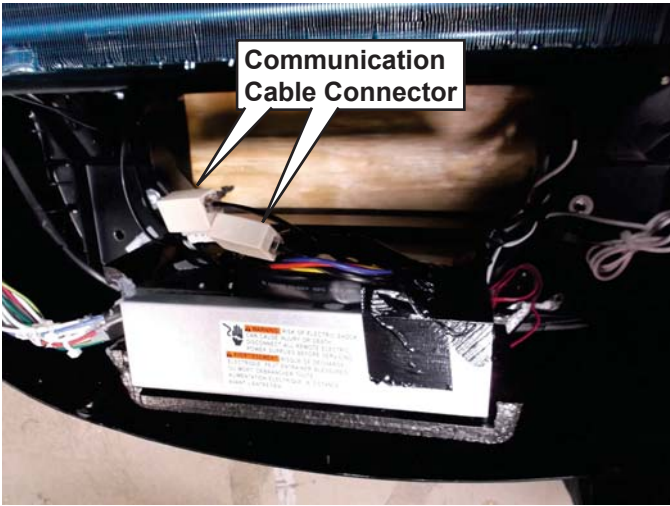
5. Replace the communication cable connectors.

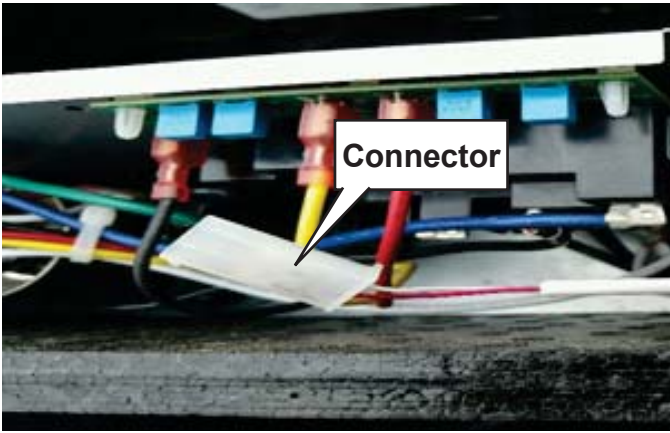
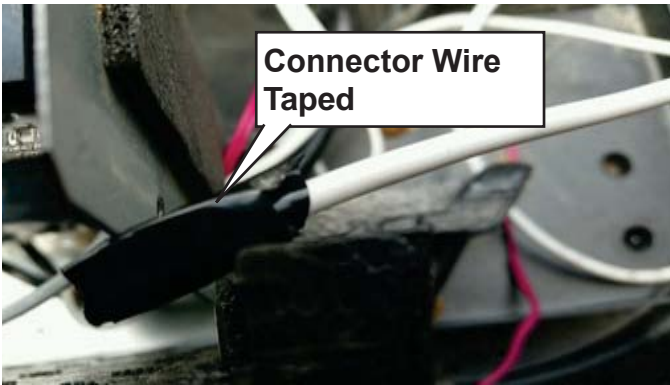
6. Cut off the remote temperature sensor connector and tape end.

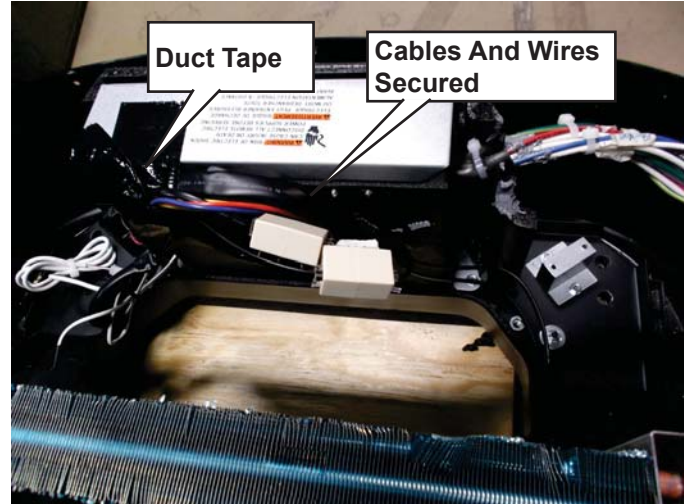
7. Secure loose cables and wires to electrical box using duct tape. This is to keep them from lying in bottom of pan.

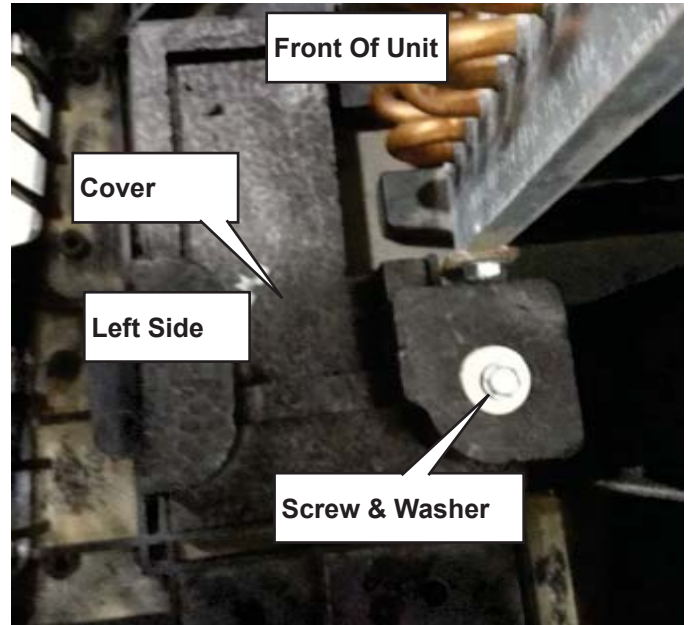
8. Position drain pan covers over outlet, align with predrilled hole and secure with screws.

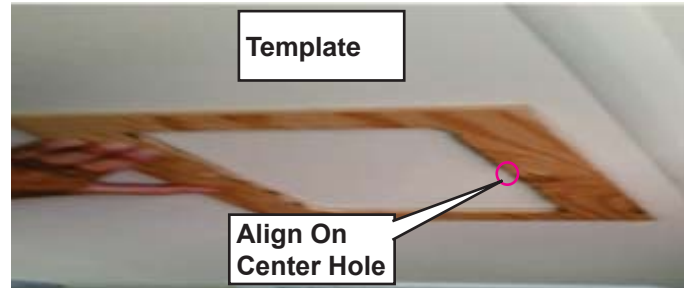
11. Align and center template on center hole and trace opening.

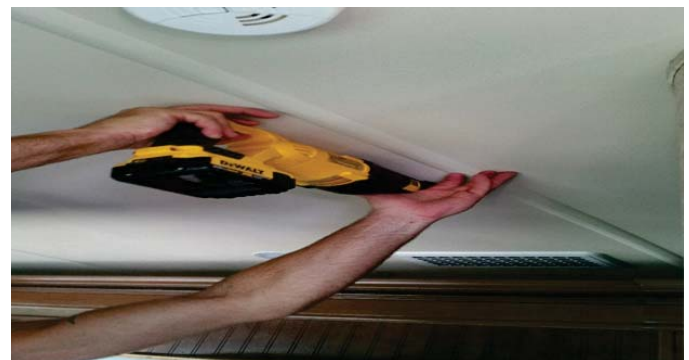
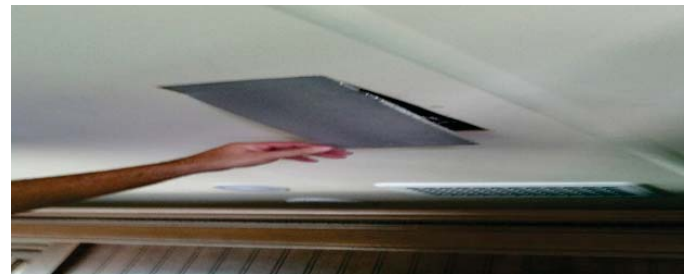
12. Carefully cut the traced area with a knife or saw. Cut through the ceiling panel and through the bottom side of duct only.

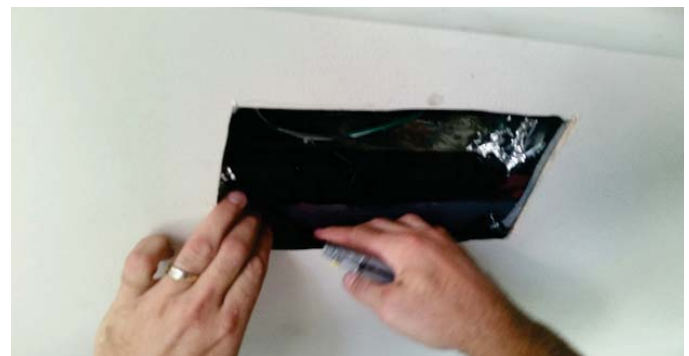
13. Secure edge of ceiling panel and duct in place with aluminum tape.

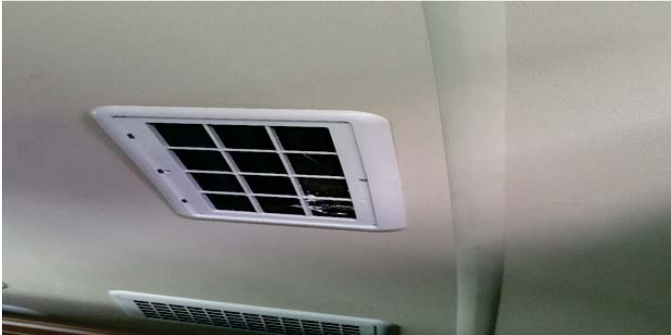
14. Using a #6 x 1" flat head phillips wood screw, secure the base of the vent in place. Hand tighten to prevent stripping.

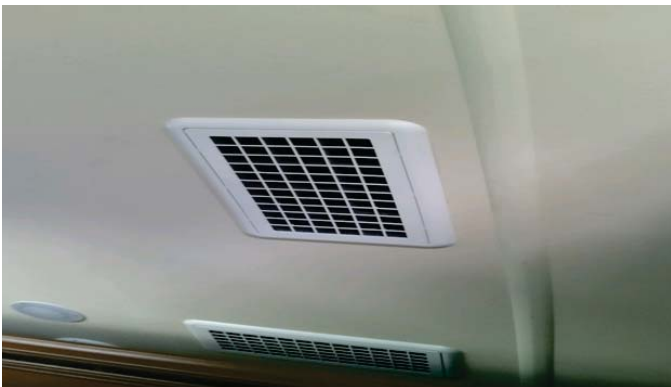
15. Install the finishing cover on the vent.

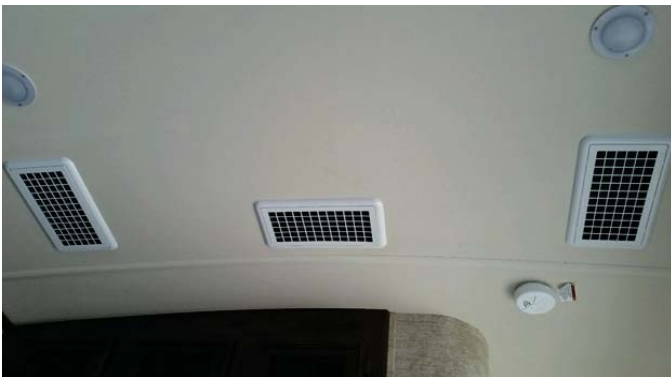
16. This is the finished result.

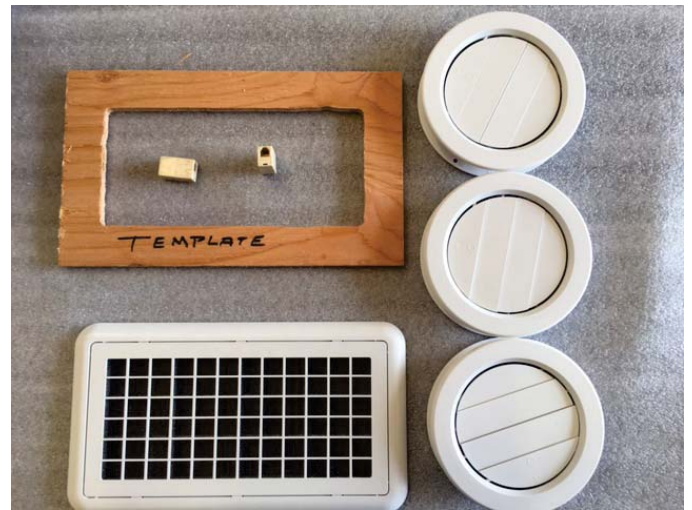
The pictures below show what will be sent.

Includes: 1- Supply air vent, 2 - communication modules, 2 drain pan outlet covers, and 1 - template.
