Trapped Moisture Under Wrap Guard Can Make Paint Look Bad

2015 and later Fit and 2016 and later HR-V

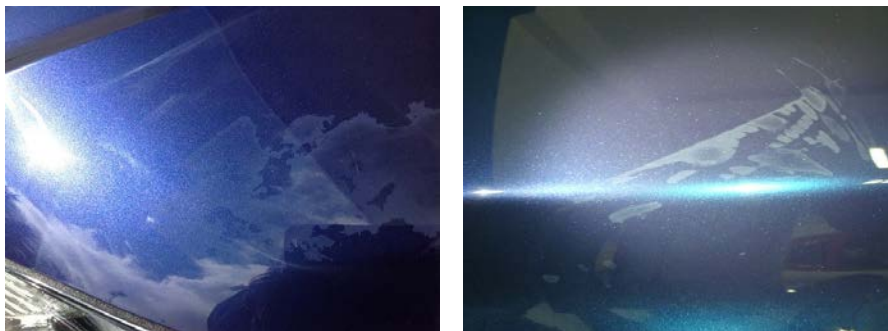
Trapped moisture under the Wrap Guard can penetrate the clear coat, making even the best factory paint job look stained, fogged, or discolored.

Here's what it looks like on bodywork with the Wrap Guard removed:

Fortunately, there's an easy fix for this problem and all you need is a heat gun. Just carefully warm the paint with the Wrap Guard removed and that trapped moisture evaporates. To avoid damaging the paint or any nearby plastic or rubber parts, apply the heat in a circular motion over the affected area and make sure the surface temperature stays under **180°F**.

You may need to do this heat treatment more than once to get rid of that moisture . . . so just be patient and take your time.
