Multistrada 1200 Rider Seat Inspection
Models: Model Year 2015-2016 Multistrada 1200 (all model versions)
Technical Service Bulletin SRV-TSB-16-002

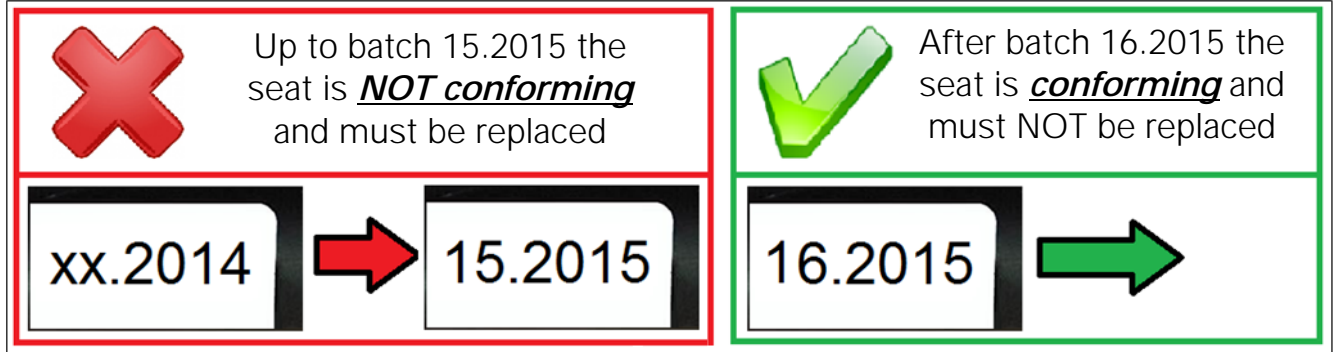
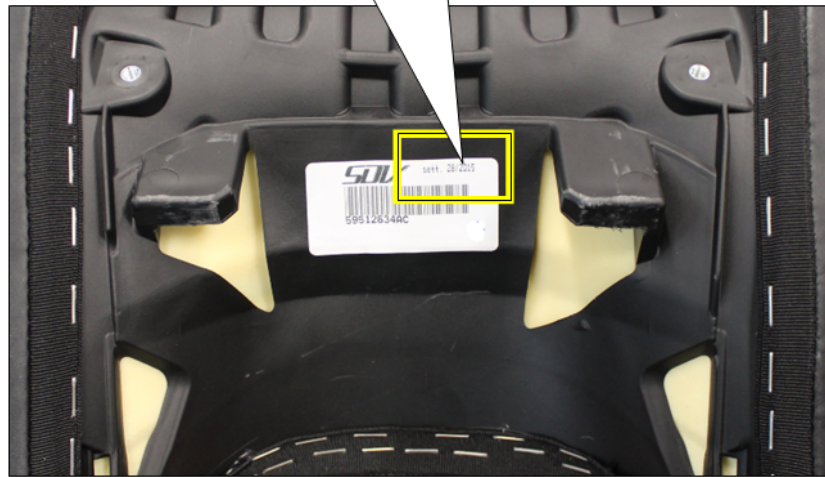
Inspect the seat production batch, indicated in the sticker on the seat bottom.

If the seat batch code is higher than 16.2015 (batch 16.2015 included), the seat must **NOT** be replaced; if the seat batch code is lower than 16.2015, the seat **must be replaced** (the first number indicates the week, while the second number indicates the year).
