TITLE: Air outlets loose on leather dashboard

REF NO:	ISSUING DEPARTMENT:		ARKET:
TJ 31557.2.0	Technical Service		s and Canada
3 US 7	PARTNER:	ISSUE DATE:	STATUS DATE:
	/510 Volvo Car USA	2016-09-23	2016-09-30
FUNC GROUP: 8811	FUNC DESC: Instrument panel	Page	1 of 10

VOLVO	/olvo Car Customer Service	TJ 3 [,]	1557
Title	Dashboard	Page	1(7)
Action	Product fix	Operation number:	98640-2

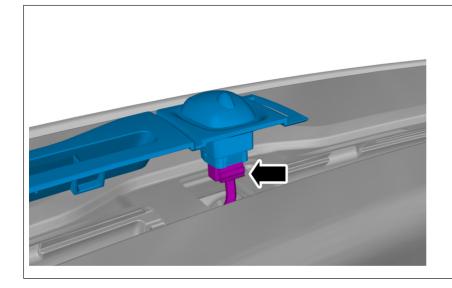
- 1 . Disconnect the connector.
- ² Caution! Secure the wire above the opening using adhesive tape or similar.

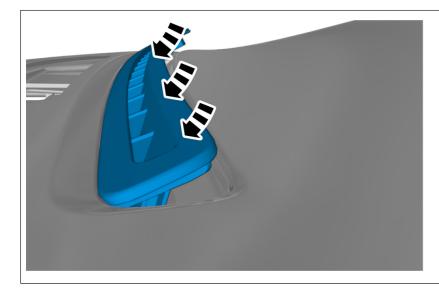
Note! Avoid spillage on visible surfaces. Install the marked component.

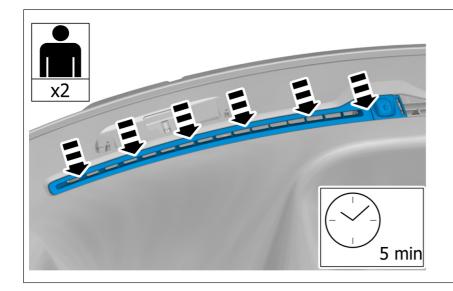
Caution! Make sure that the component is positioned correctly.

Note! This step requires the aid of another technician.

Apply pressure to the joint for the time stated in the graphic.

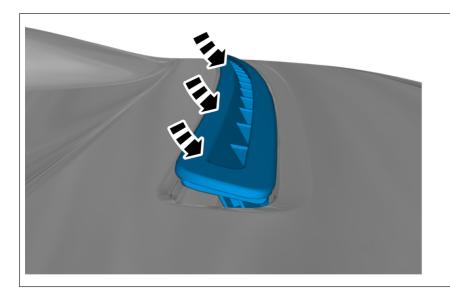
x2

Note! Avoid spillage on visible surfaces.

Install the marked component.
