Service Bulletin

Subject: Front Seat Lateral Movement, Clunk, Squeak, Click Noise or Shift While Cornering

Models: 2012-2016 Buick Regal
2012-2016 Buick Verano
2011-2015 Chevrolet Cruze
2016 Chevrolet Cruze (VIN P)
2013-2015 Chevrolet Malibu
2016 Chevrolet Malibu Limited (VIN 1)
2014-2016 Chevrolet Impala (VIN 1)
2014-2016 Chevrolet SS

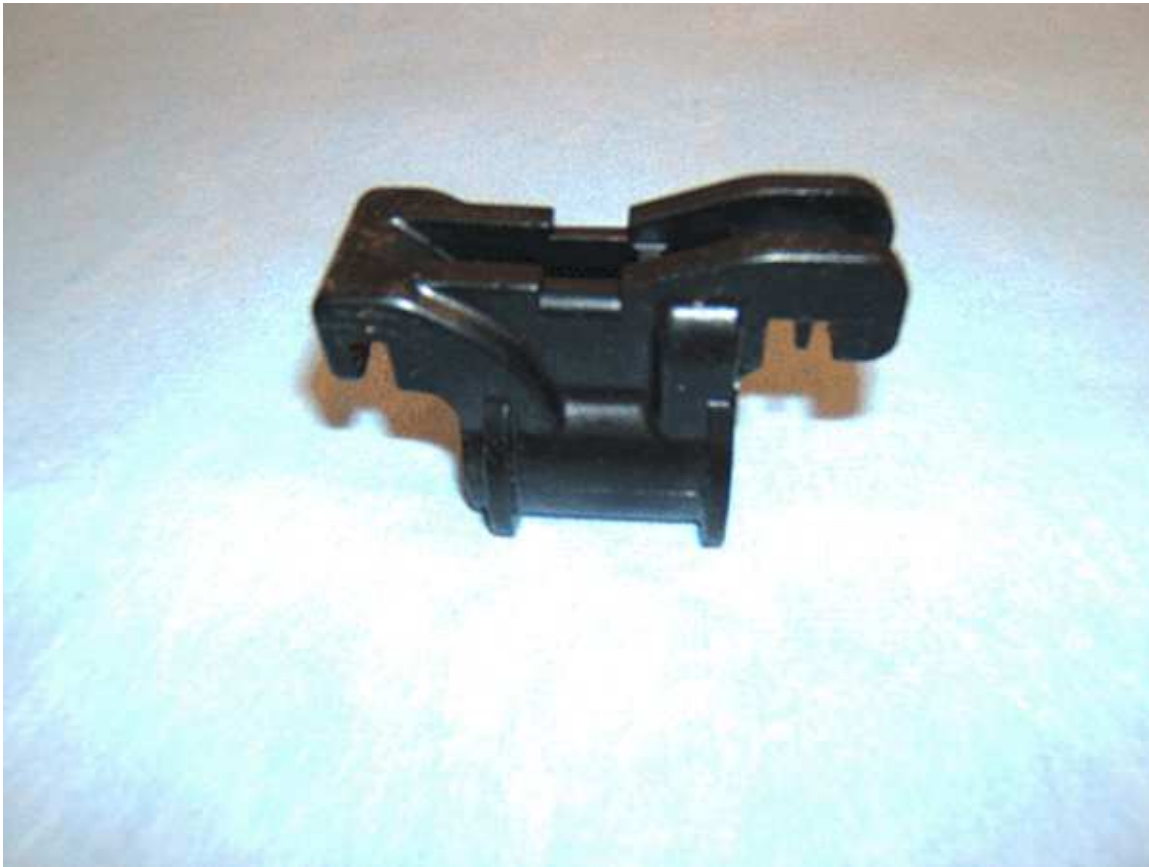
A clip has been made available to eliminate the lateral seat movement. Use the following steps to install the clip to the driver side seat. If the vehicle is equipped with a 6-way adjustable passenger seat, repeat the procedure on the passenger seat.

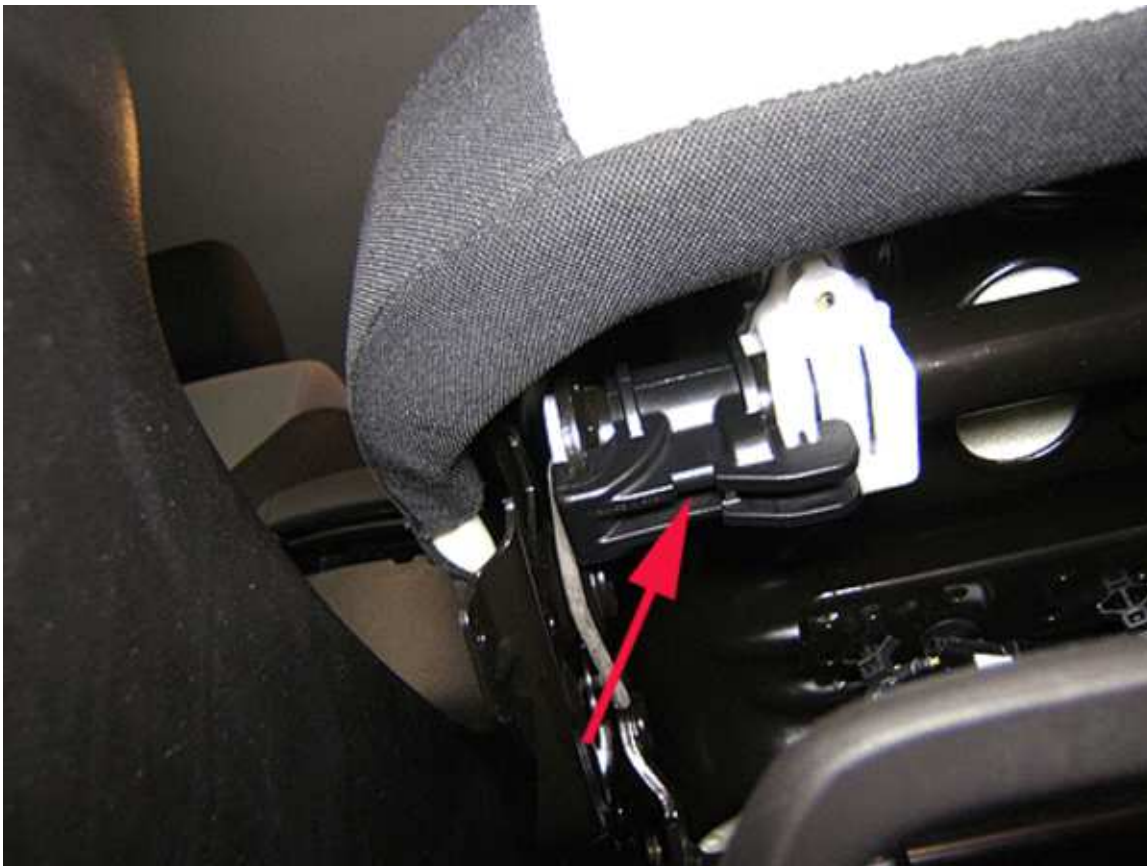
3. Install the clip as shown. Ensure the clip is fully seated around the crossbar and on the guide block.

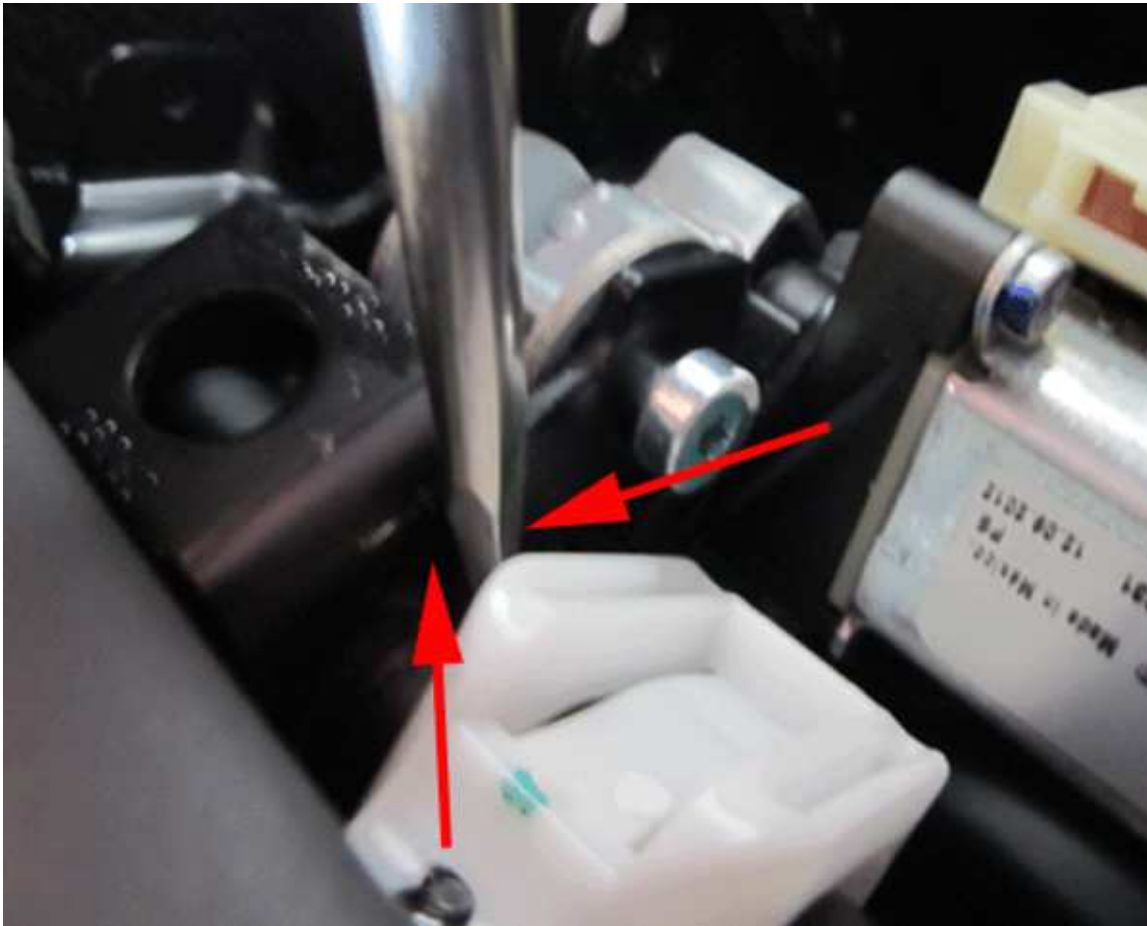
Note: You may need to move the crossbar using a flat head screwdriver to properly align the clip.

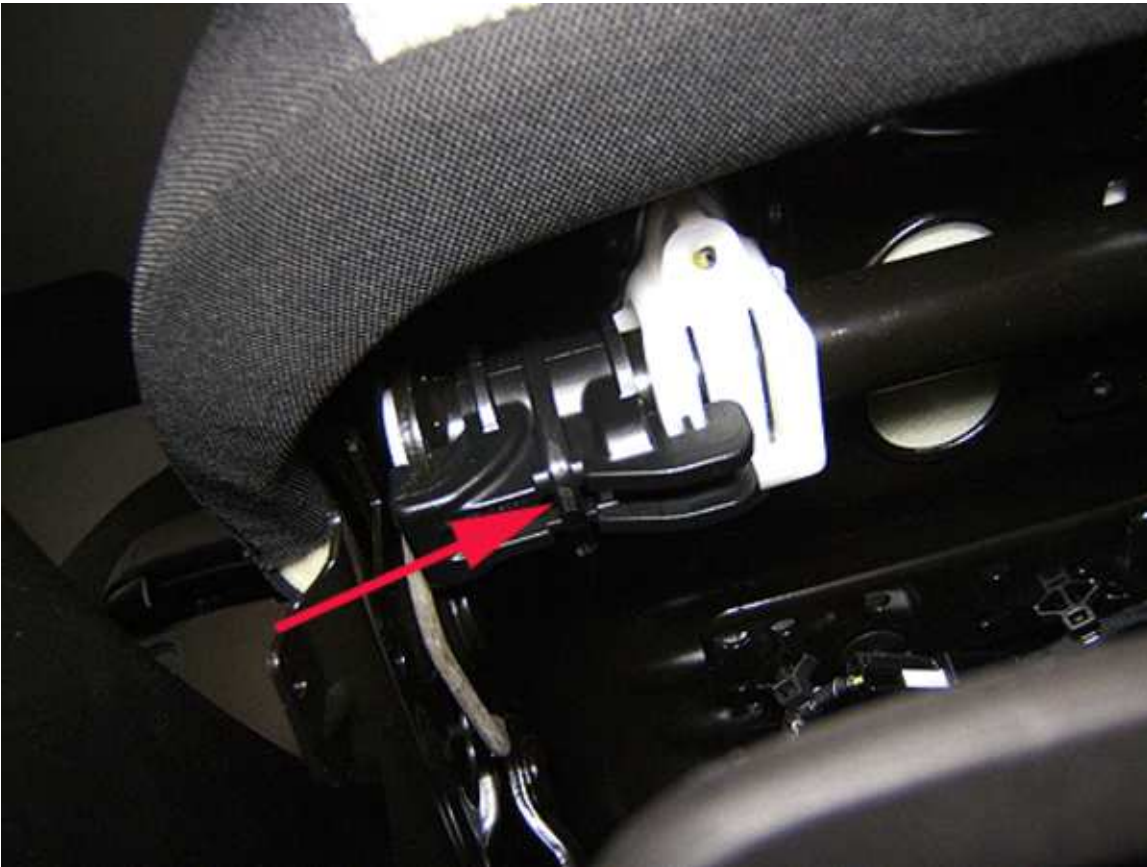
4. Install a nylon wire tie as shown. Trim the excess wire tie material.

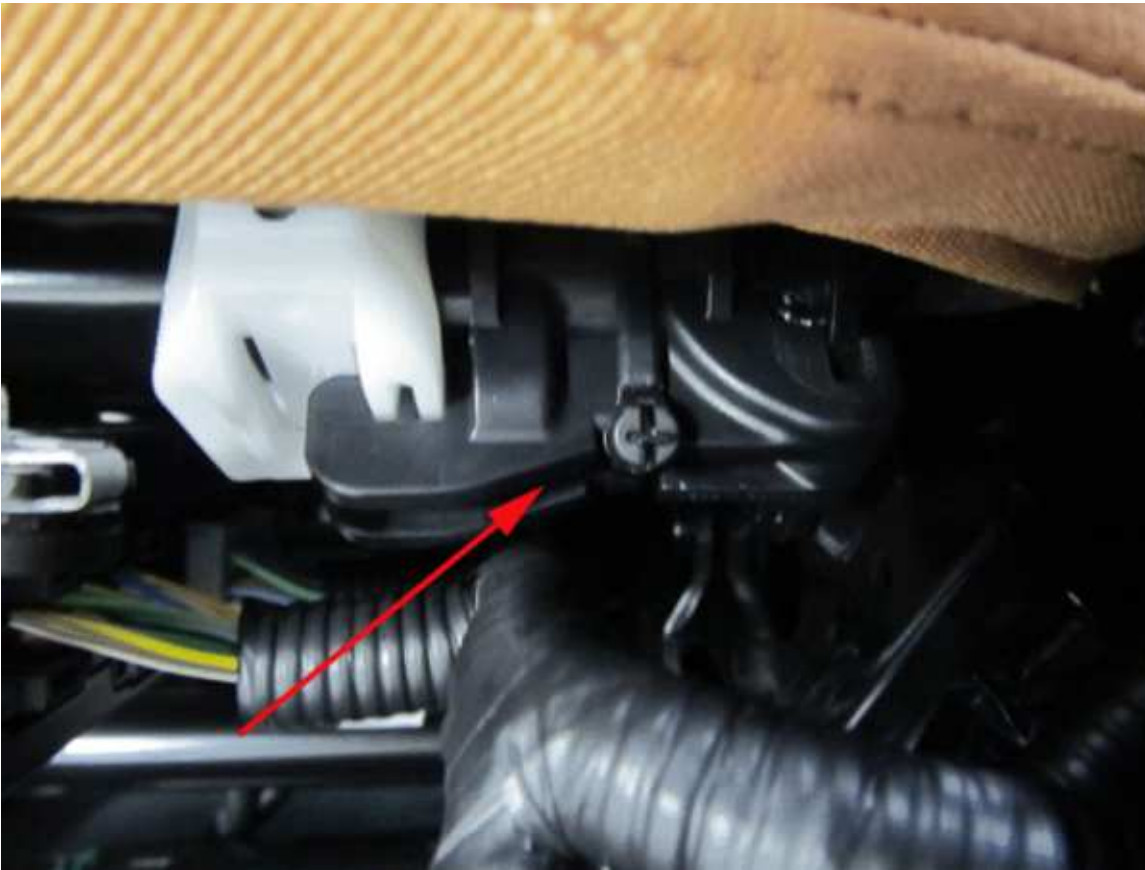
5. On vehicles equipped with power seats, there may be a wire harness attached to the crossbar where the clip is to be installed.
 - If there is a harness clipped to the seat crossbar, remove the harness and clip from the crossbar.
 - Cut the clip off of the harness.
 - Use a second wire tie to re-secure the harness to the new seat clip. Ensure the harness does not come into contact with the connector area of the first wire tie.
 - Ensure that the wire harness is still properly routed after this operation to avoid pinched/cut wires by the power seat mechanism.
