Service Update

49870 Splash Guard Damage

Reference Number: N162049870
GWM Number: 2049870

Condition	Certain 2016 model year Cadillac CT6 vehicles may have a condition where ground contact of the splash guards may result in breakage, severe wear of the splash guards, and potentially buckle the fender's inner flange.
Correction	Dealers will un-install the front and rear splash guards, and plug the drilled holes with push pins.

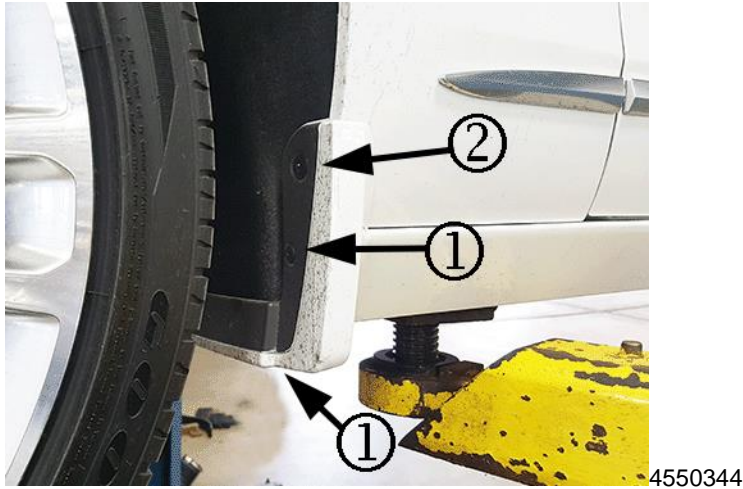
2. Remove the front splash shield screws (1) and drill out rivet (2).

Note: If the finish is damaged from drilling out the rivet, use touch up paint to prevent any corrosion issues.

3. Discard the screws removed from the front splash shield.

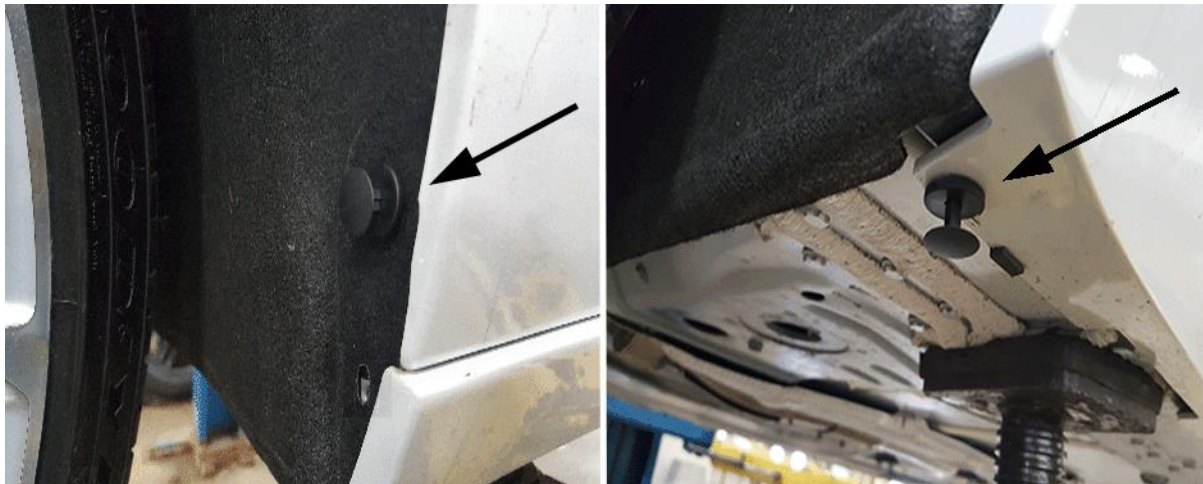
4. Install 2 push pin retainers in the location shown above (1).

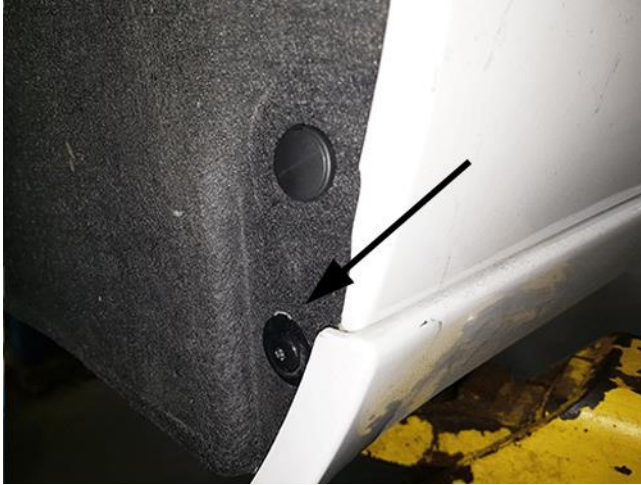
4550350

5. Install a new screw with washer in the location shown above.
6. Repeat the above steps for the opposite side.
7. Remove the rear splash shield screws (4) and save 2 for re-installation to the inner wheel well.

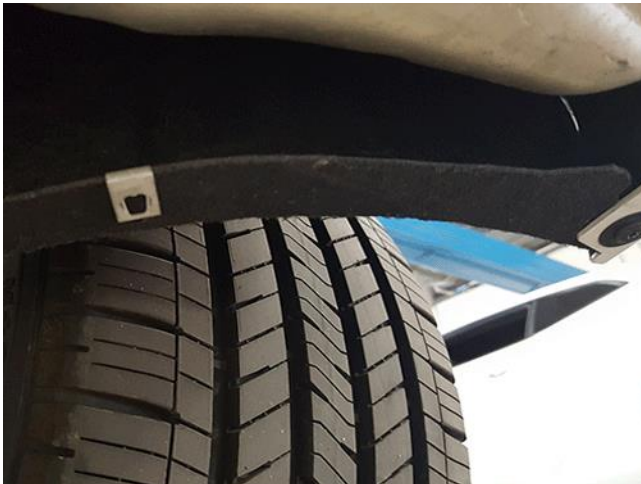
4550353

8. Remove the retaining screw clip and discard.

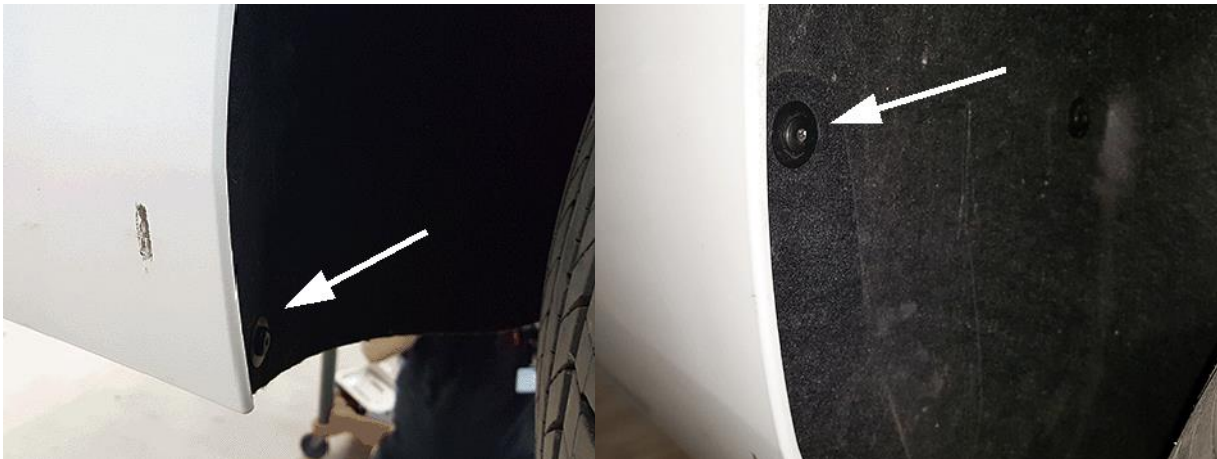
4550354

9. Install the 2 retaining screws removed from step 7 and install to inner wheel well screw holes.

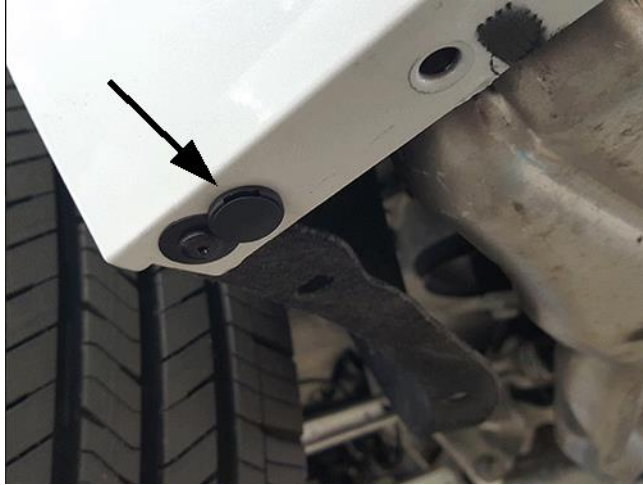
4550358

10. Install a push pin retainer at the location shown.
11. Repeat steps 6-10 for the other side.
12. Clean any adhesive residue left from the splash shields with general purpose adhesive cleaner.
13. Lower vehicle.
