GROUP <b>Climate Control</b>	MODEL <b>Various Models</b>
	NUMBER <b>PS266 (Rev 1, 9/30/2016)</b>	DATE <b>March 2013</b>

SUBJECT: <b>HVAC RECEIVER/DRYER - DESICCANT REPLACEMENT</b>

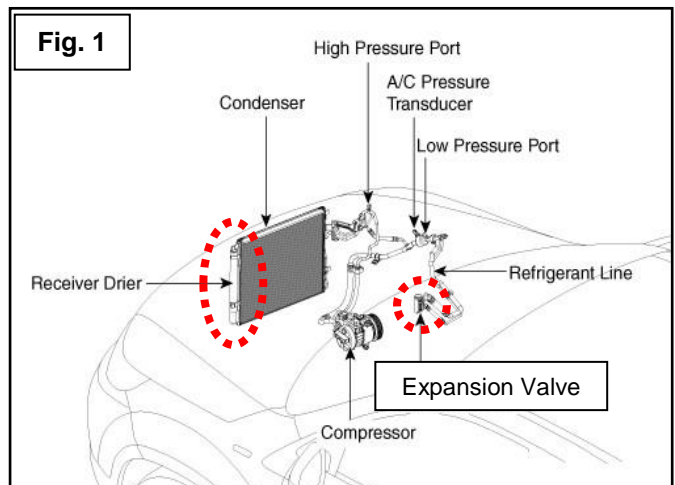
If you suspect a plugged Expansion Valve, the inlet screens can be cleaned. If the valve is not equipped with an inlet screen and is restricted, the Expansion Valve may also need to be replaced (Fig. 1).

In the event of a HVAC system concern in which metal particles or shards have contaminated the system, the Desiccant or the entire A/C Receiver/Dryer Assembly may need to be replaced. This is due to the fact that it may be impossible to remove all metal contaminants from the Receiver/Dryer during the A/C flushing procedure. Refer to the included table for detailed information on component replacement by model.
