Dual Exhaust Tips Look Uneven?

AFFECTED VEHICLES

2017 Accord V6 and 2017 Accord Sport

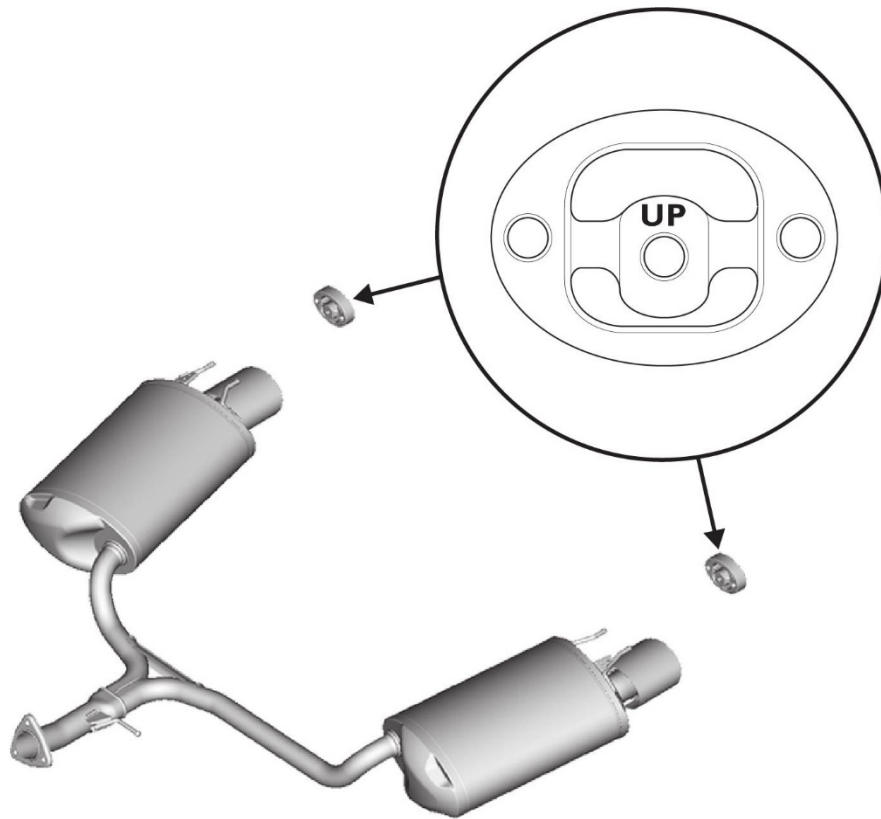
Do those dual exhaust tips look a bit uneven? Chances are one of the rubber exhaust hangers isn't properly installed.

The rubber exhaust hanger is directional and must be installed with the word **UP** in its center, facing up. If it's not, the muffler won't hang like it should and the attached exhaust tip will look uneven with the other one.

To address this issue, make sure both rubber exhaust hangers are properly installed.
