TECHNICAL BULLETIN

LTB00932NAS1

Sun Visor Vanity Mirror - Lower-Level Service Repair

Range Rover Evoque (LV)

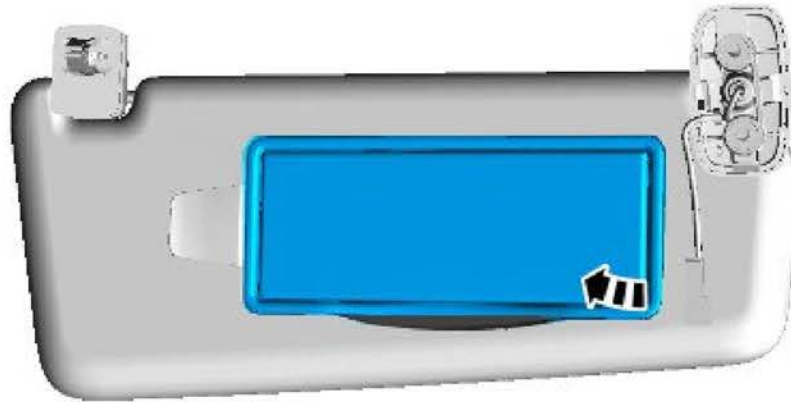
E190303

- NOTE: right-hand sun visor shown; left-hand sun visor similar.**

Using a suitable trim tool, remove the sun visor vanity pack.

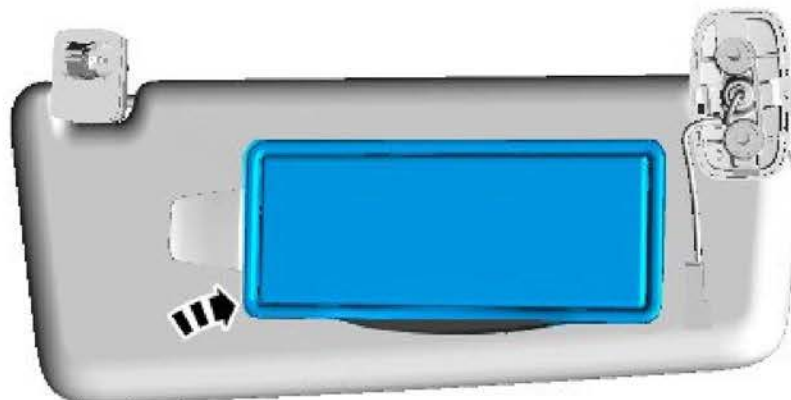
E190326

**NOTE: right-hand sun visor shown; left-hand sun visor similar.**
Install the new sun visor vanity pack until a 'click' is heard.
