Technical Bulletin

87 16 11 July 11, 2016 2044165

Air Conditioning Does Not Cool and or Compressor is Noisy

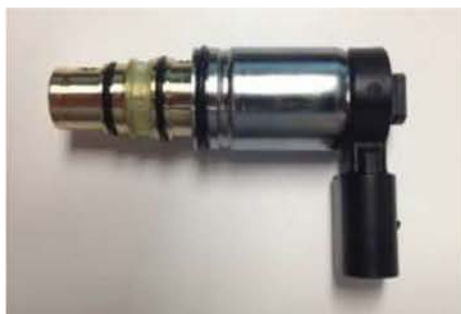
Figure 1 N280 Refrigerant Regulating Valve
1K0260839

The condition may be caused by a faulty A/C compressor regulator valve N280 (Sanden). The internal components of the valve can be obstructed and incapable of full function. This loss of refrigerant regulation from N280 can cause noise from the air conditioning compressor and/or affect the HVAC cooling.

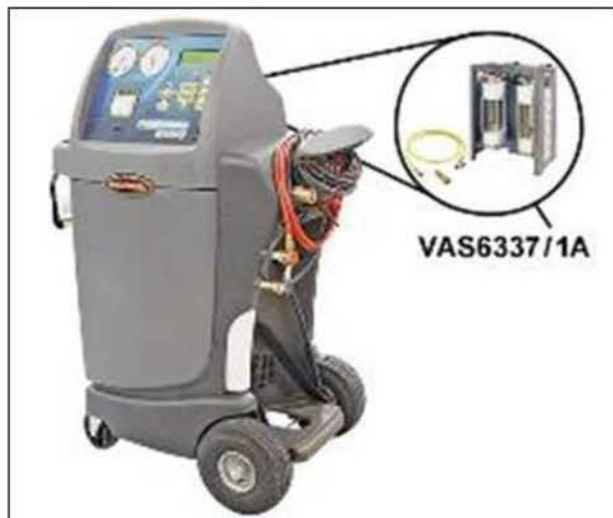
Figure 4. Robinair A/C Service Unit.

Connect both the refrigerant service station (Figure 4) and the diagnostic tester to the vehicle.

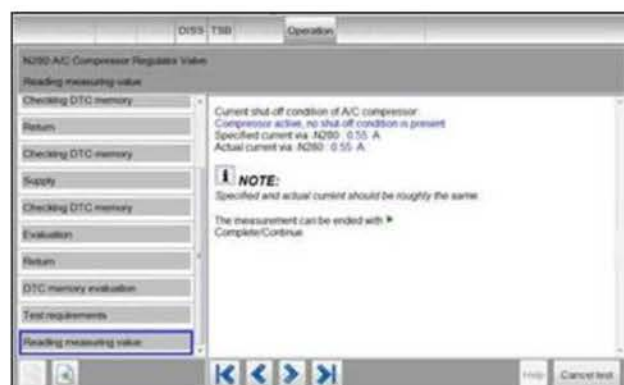
Figure 5. Checking N280 signal value Measuring Value Block.

Monitor the measuring value for the air conditioner compressor regulating valve N280 signal (Figure 5).

The actual and specified values will be plausible and will show a normal regulating range of current for cooling request (0.400 A – 0.820 A).

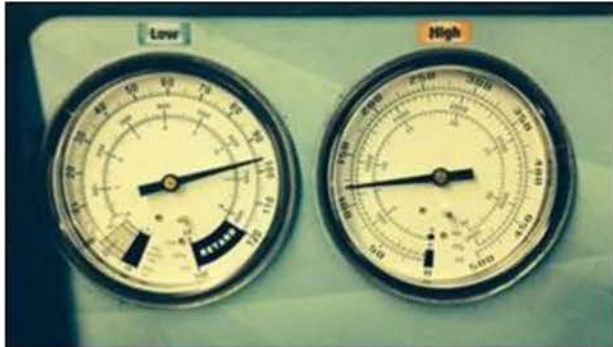
Figure 6. Equalized pressure condition. No pressure generated from compressor.

After verifying the compressor should be on and operating check the gauge readings on the Robinair® service station. If the gauges show no pressure generation from the compressor continue to the next step.

(Example of no pressure generation is when the pressure readings on the high and low sides are equalized in Figure 6).

⚠ Note: If the gauge readings are showing normal compressor operation per the Elsa Repair Manual, this bulletin does not apply and further diagnosis is required.

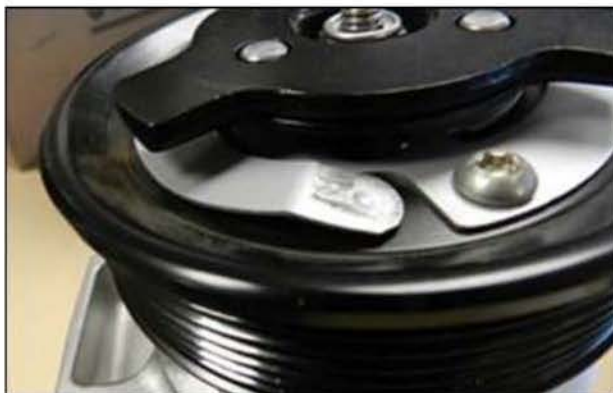
Figure 7a. Example of torque limiter over load protection activated.

⚠ Note: If the torque limiter has been released the N280 regulating valve is not at fault. The compressor needs to be replaced.

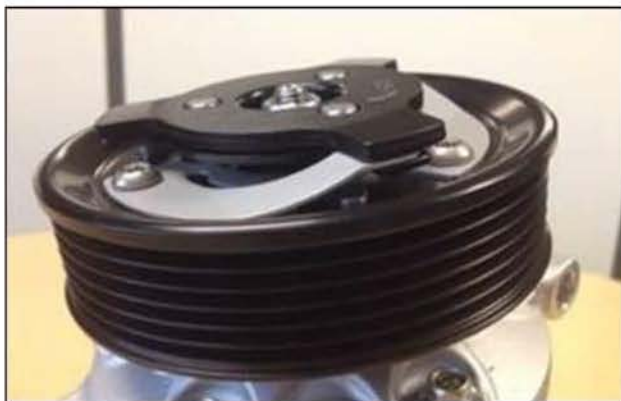
Check that the compressor torque limiter has not been activated (Figure 7b).

Figure 7b. Example of torque limiter over load protection still intact.

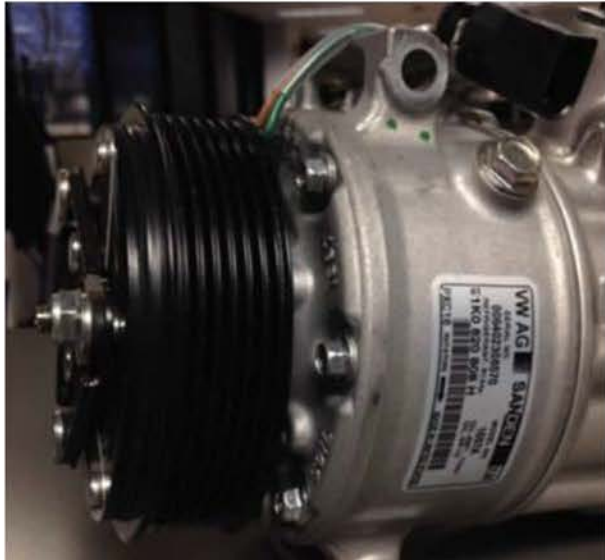
Figure 8. MY2016 AC compressor with clutch (Sanden)

For MY2016 vehicles with Sanden AC compressor 1K0820808H make sure the compressor clutch is engaged when the AC is switched on.

If clutch is not engaging perform diagnosis of the compressor clutch J44 test.

Check that adaptation channel 9 and is set at 1 for clutch enabled. (See TT 87-16-01).

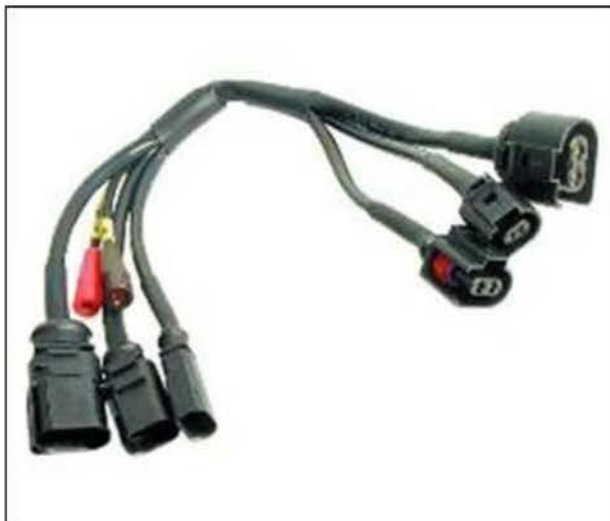
Figure 9. VAS 5256 breakout harness.

Shut off the engine. Connect the breakout harness VAS 5256 (Figure 9) between the N280 valve and its connector.

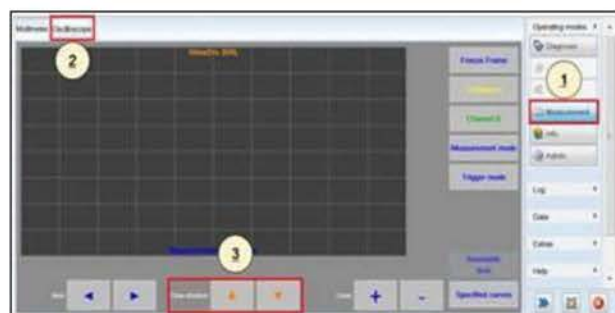
Figure 10. Select Measurements from operating mode menu".

Go to Operating Mode "Measurements" to check the N280 signal from the control module.

Change time division to 2ms/Div (Figure 10).

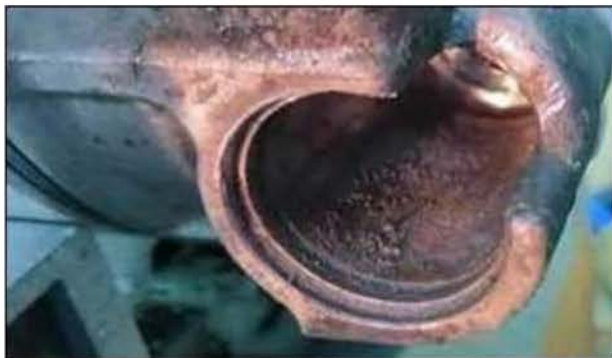
Figure 14. Corrosion in the N280 valve bore.

Assess the condition of the N280 valve bore and the valve filter screen (Figure 14). If severe contamination is found in valve bore there is a risk of damaging the replacement valve on installation. In these cases the A/C compressor must be replaced.

A slight amount of debris or corrosion does not present a risk and does not justify replacement of the AC compressor.

- If little or no corrosion or contamination is found perform Repair Procedure A: Replacing the N280 regulating valve.
- If corrosion and contamination is found, perform Repair Procedure B: A/C compressor replacement.
- Document the all workshop findings of this procedure on the repair order.

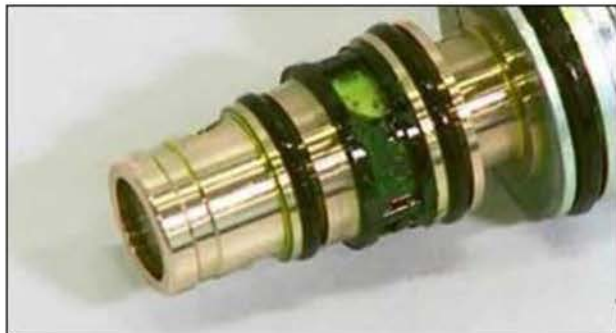
Figure 15: Severe contamination at the N280 valve filter screen.

Small random particles on the filter screen does not constitute “severe” contamination and does not justify replacement of the A/C compressor.

Should severe contamination be found at the valve filter screen (Figure 15) and A/C compressor replacement becomes necessary, ensure that the refrigerant circuit is flushed in the course of repair.

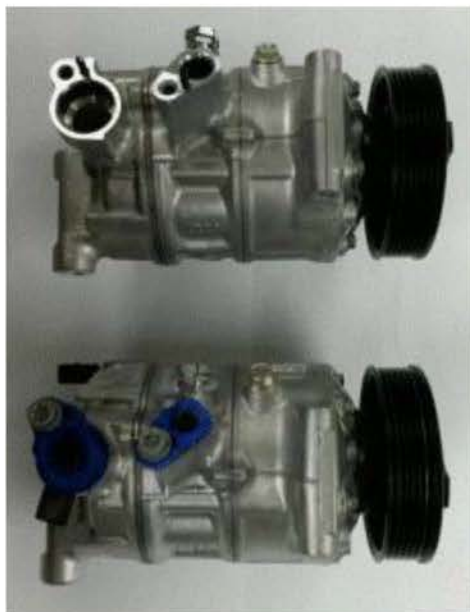
Figure 18

When installing a new compressor transfer the compressor shipping caps to the original compressor as shown in Fig 18.

All replaced compressors must have the shipping caps re-installed before being returned to the WPRC.

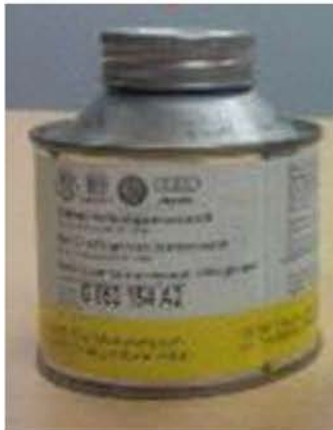
Figure 19: Sanden compressor manufacturer PAG oil G 052 154 A2.

The replacement Sanden compressor will come with the specified type of PAG oil G 052 154 A2 (Figure 19).

The compressor comes with a full charge of oil for the entire refrigerant circuit. However the amount of PAG oil supplied with the replacement compressor may not be the exact amount to replenish the refrigerant circuit. Drain and measure the PAG oil in the replacement compressor to determine the required amount. If the amount needs to be adjusted, do so using the correct type of PAG oil specified in ETKA. Refer to Elsa for the correct oil capacity for the compressor being installed.
