Technical Bulletin

87 16 16 August 29, 2016 2044165 Supersedes Technical Bulletin V871613 dated July 26, 2016 to update causal part line in warranty table and model year applicability.

Air Conditioning Does Not Cool and or Compressor is Noisy

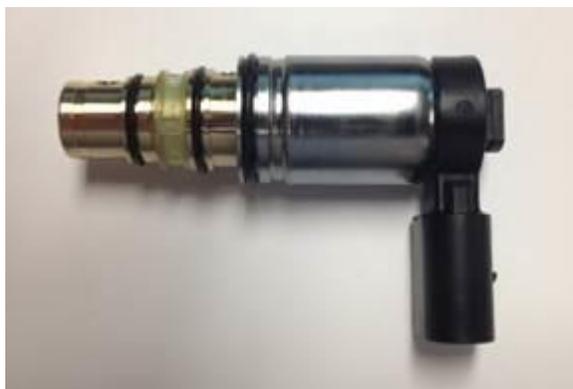
The condition may be caused by a faulty A/C compressor regulator valve N280 (Sanden). The internal components of the valve can be obstructed and incapable of full function. This loss of refrigerant regulation from N280 can cause noise from the air conditioning compressor and/or affect the HVAC cooling.

Figure 1 N280 Refrigerant Regulating Valve
1K0260839

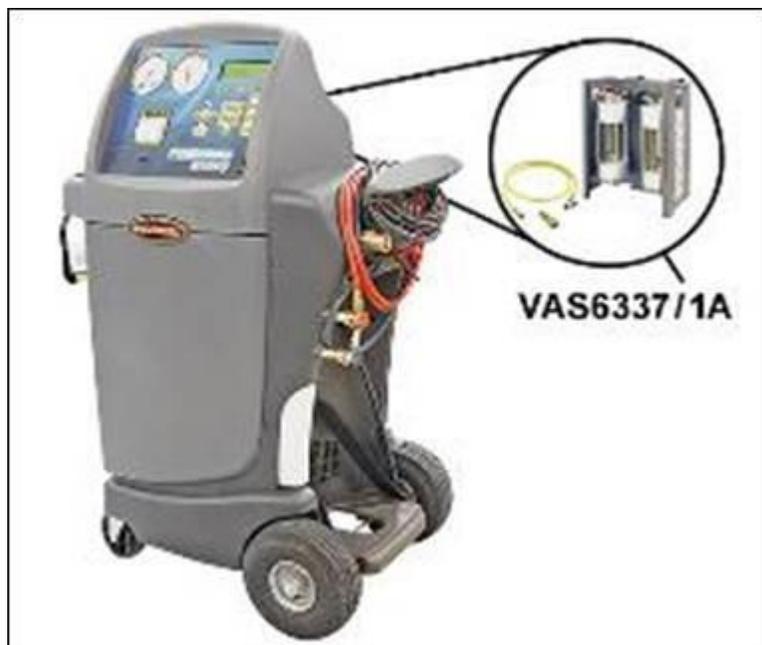
Connect both the refrigerant service station (Figure 4) and the diagnostic tester to the vehicle.

Figure 4. Robinair A/C Service Unit.

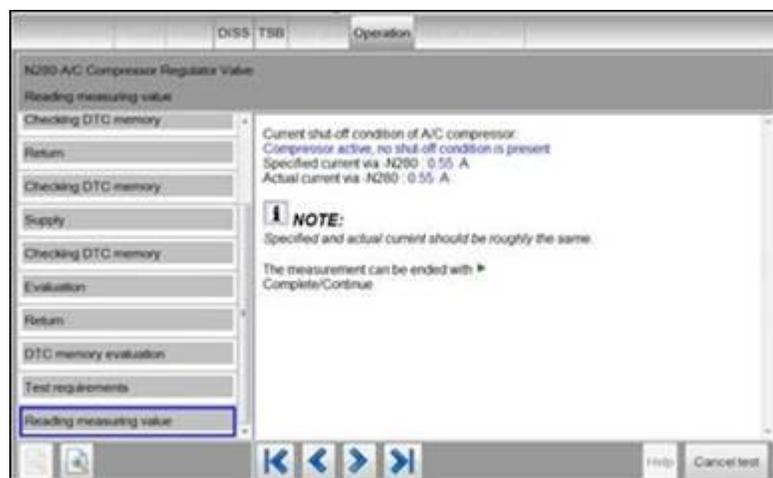
Monitor the measuring value for the air conditioner compressor regulating valve N280 signal (Figure 5).

The actual and specified values will be plausible and will show a normal regulating range of current for cooling request (0.400 A – 0.820 A).

Figure 5. Checking N280 signal value Measuring Value Block.

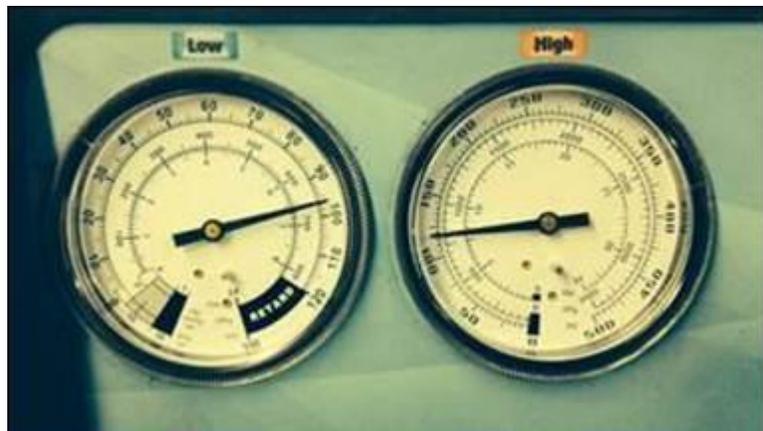
Figure 6. Equalized pressure condition. No pressure generated from compressor.

After verifying the compressor should be on and operating check the gauge readings on the Robinair® service station. If the gauges show no pressure generation from the compressor continue to the next step.

(Example of no pressure generation is when the pressure readings on the high and low sides are equalized in Figure 6).

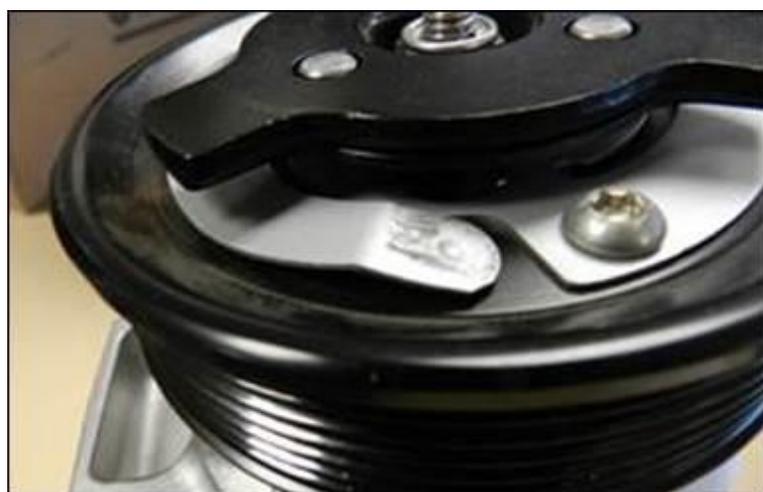
Figure 7a. Example of torque limiter over load protection activated.

⚠ Note: If the torque limiter has been released the N280 regulating valve is not at fault. The compressor needs to be replaced.

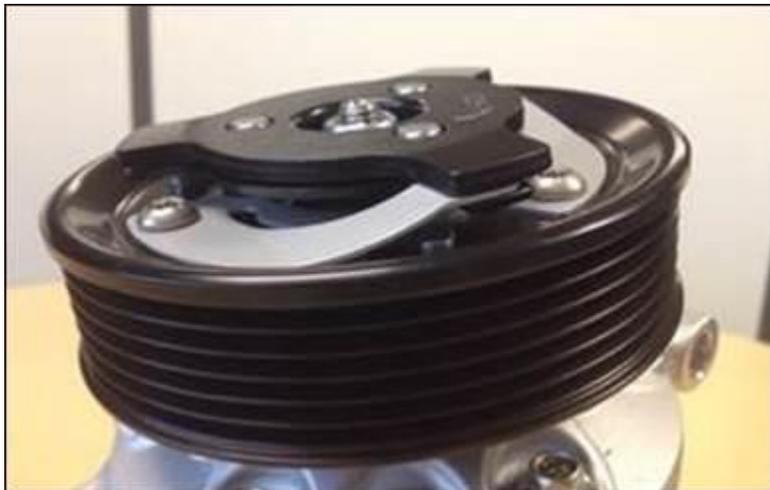
Check that the compressor torque limiter has not been activated (Figure 7b).

Figure 7b. Example of torque limiter over load protection still intact.

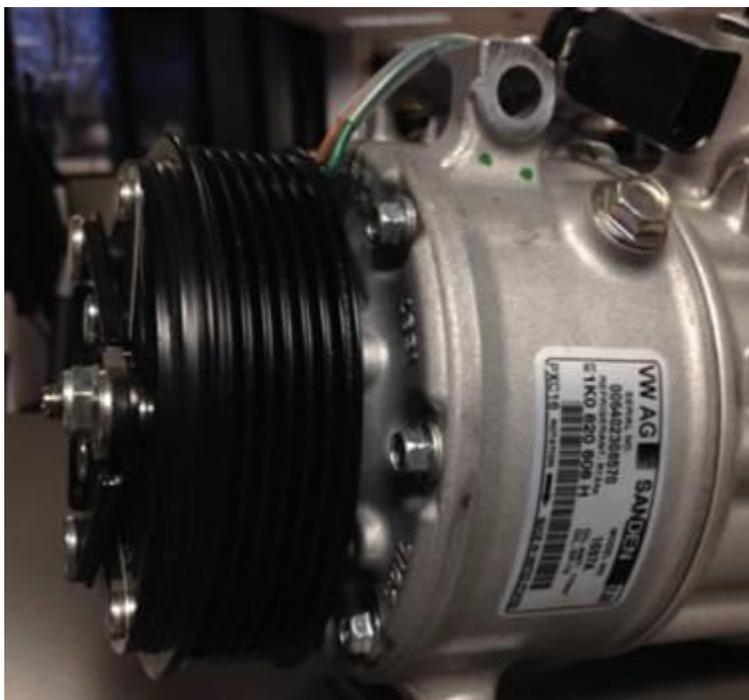
Figure 8. MY2016 AC compressor with clutch (Sanden)

For MY2016 vehicles with Sanden AC compressor 1K0820808H make sure the compressor clutch is engaged when the AC is switched on.

If clutch is not engaging perform diagnosis of the compressor clutch J44 test.

Check that adaptation channel 9 and is set at 1 for clutch enabled. (See TT 87-16-01).

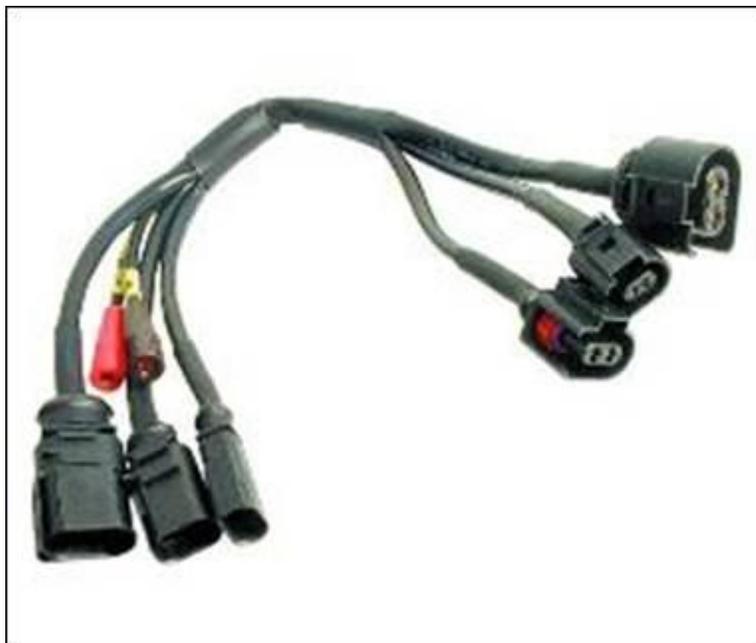
Shut off the engine. Connect the breakout harness VAS 5256 (Figure 9) between the N280 valve and its connector.

Figure 9. VAS 5256 breakout harness.

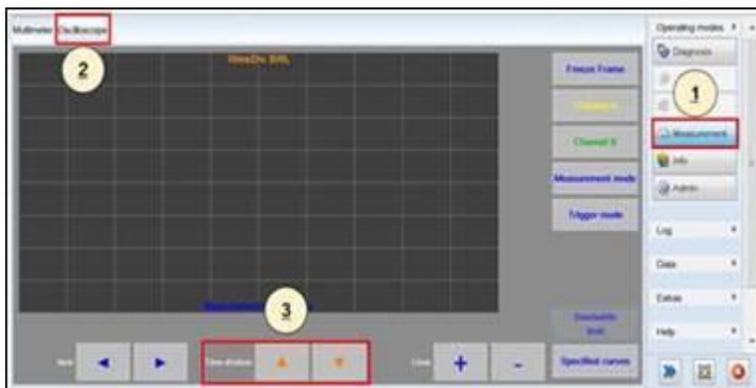
Go to Operating Mode "Measurements" to check the N280 signal from the control module.

Select Measurements.

Select oscilloscope.

Change time division to 2ms/Div (Figure 10).

Figure 10. Select Measurements from operating mode menu".

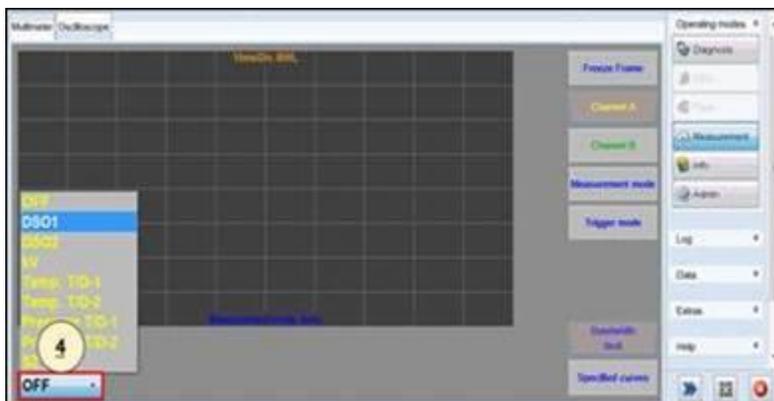
Select the correct DSO channel according to the test leads hooked to the vehicle (Figure 10).

Figure 11. Setting up DSO channel”.

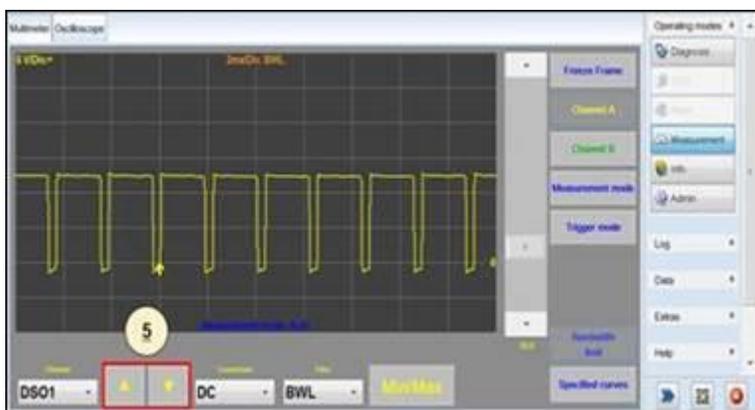
Change the voltage to 5VDiv.

Check the signal wave form (Figure 11). The square wave signal should be between 75% and 100%.

If the wave form signal is good, the mechanical integrity of the N280 valve needs to be inspected.

Figure 12. Checking the N280 signal wave form.

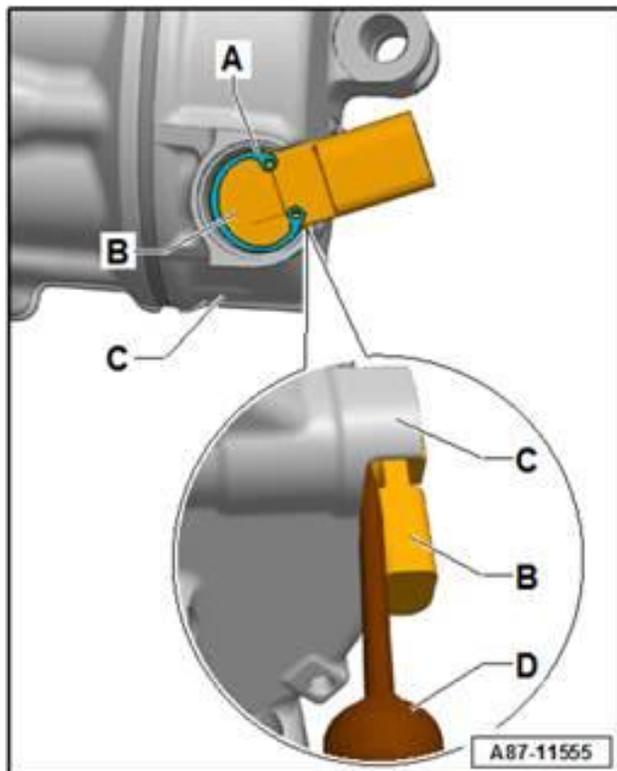
Figure 13. Circlip / N280 removal

1. Remove circlip-A- carefully.

2. Carefully remove the A/C Compressor Regulator Valve -N280- -B- from the A/C compressor mount -C-, using a suitable screwdriver -D-, for example (Figure 13).

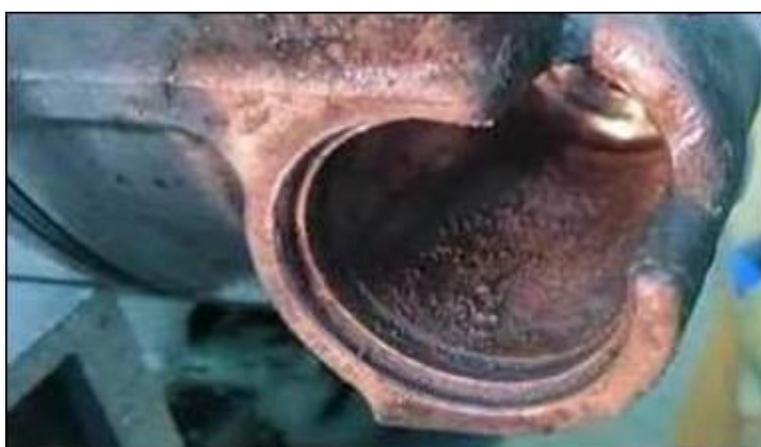
Figure 14. Corrosion in the N280 valve bore.

Assess the condition of the N280 valve bore and the valve filter screen (Figure 14). If severe contamination is found in valve bore there is a risk of damaging the replacement valve on installation. In these cases the A/C compressor must be replaced.

A slight amount of debris or corrosion does not present a risk and does not justify replacement of the AC compressor.

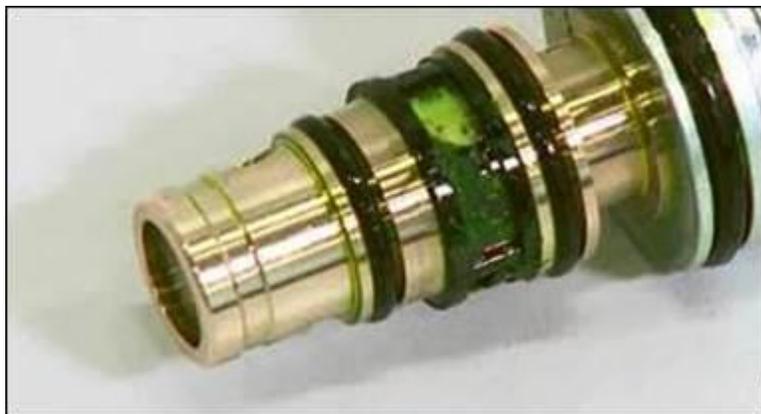
Should severe contamination be found at the valve filter screen (Figure 15) and A/C compressor replacement becomes necessary, ensure that the refrigerant circuit is flushed in the course of repair.

Note:
Small random particles on the filter screen does not constitute “severe” contamination and does not justify replacement of the A/C compressor.

Figure 15: Severe contamination at the N280 valve filter screen.

- If little or no corrosion or contamination is found perform Repair Procedure A: Replacing the N280 regulating valve.
- If corrosion and contamination is found, perform Repair Procedure B: A/C compressor replacement.
- Document the all workshop findings of this procedure on the repair order.

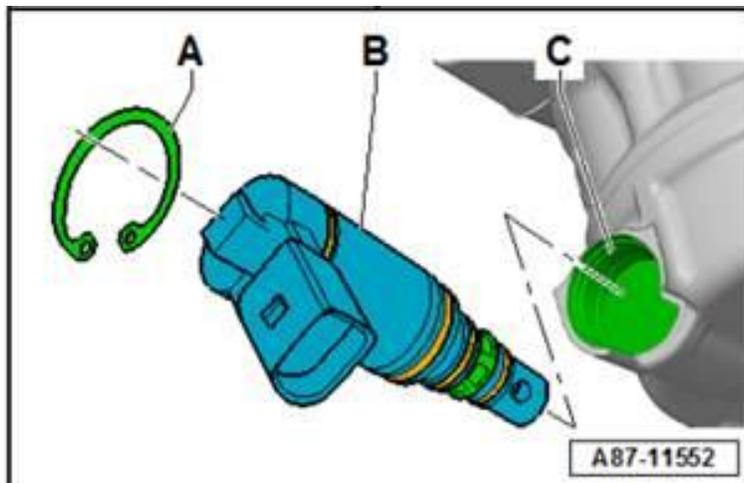
Figure 16: Prepare mount for N280 installation.

Risk of damaging another N280 Valve or compressor may result due to dirt contamination or damage to the sealing surfaces in the mount.

- If necessary, carefully clean the A/C compressor mount -C- using only a clean, lint-free cloth. DO NOT use compressed air.
- Make sure while cleaning the mount -C- that no dirt gets into the area underneath the O-ring sealing surface -F- or the existing channels and none of the mount sealing surfaces become damaged.

1. Check the A/C compressor mount -C- and the circlip groove for dirt, and if necessary, clean them carefully and thoroughly with a clean, lint-free cloth (Figure 16).

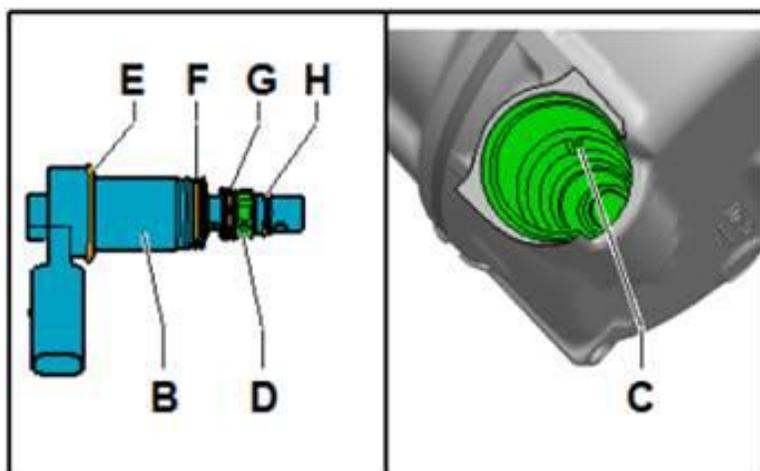
Figure 17. Check and prepare N280 o-rings

1. Check the O-rings -F-, -G-, -H- and -E- (if applicable) of the A/C Compressor Regulator Valve - N280- -B- for damage.
2. Coat the O-rings -F-, -G-, -H- and -E- (if applicable) of the A/C Compressor Regulator Valve - N280- -B- lightly with refrigerant oil and check for proper seating (Figure 17).

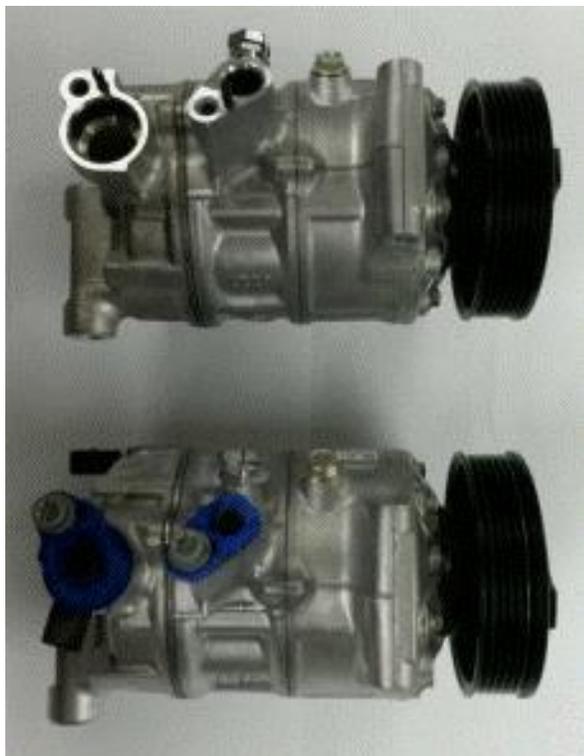
Figure 18

When installing a new compressor transfer the compressor shipping caps to the original compressor as shown in Fig 18.

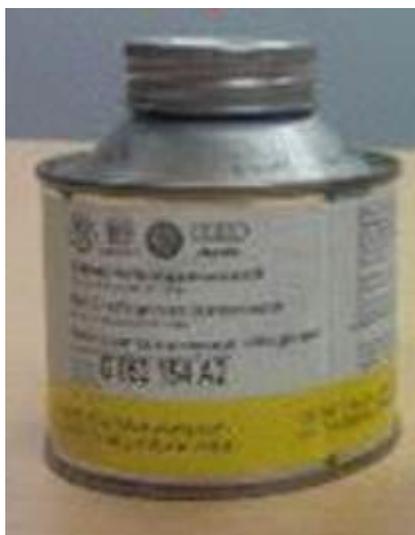
The replacement Sanden compressor will come with the specified type of PAG oil G 052 154 A2 (Figure 19).

Figure 19: Sanden compressor manufacturer PAG oil G 052 154 A2.

The compressor comes with a full charge of oil for the entire refrigerant circuit. However the amount of PAG oil supplied with the replacement compressor may not be the exact amount to replenish the refrigerant circuit. Drain and measure the PAG oil in the replacement compressor to determine the required amount. If the amount needs to be adjusted, do so using the correct type of PAG oil specified in ETKA. Refer to Elsa for the correct oil capacity for the compressor being installed.
