Audi

Service Action

Code: 61B8

Subject	Drain Valves
Release Date	April 6, 2016
Affected Vehicles	U.S.A. & CANADA: 2016 TT Roadster <i>Check Campaigns/Actions screen in Elsa on the day of repair to verify that a VIN qualifies for repair under this action. Elsa is the <u>only</u> valid campaign inquiry & verification source.</i> <ul style="list-style-type: none">✓ Campaign status must show "open."✓ If Elsa shows other open action(s), inform your customer so that the work can also be completed at the same time the vehicle is in the workshop for this campaign.
Problem Description	The drain valves for the soft top storage box may become obstructed by dirt or debris.
Corrective Action	Remove the drain valve from each drain hose.
Parts Information	Part removal only. No parts required.
Code Visibility	On or about April 6, 2016, affected vehicles will be listed on the Inventory Vehicle Open Campaign Action report under My Dealership Reports (found on www.accessaudi.com & OMD Web). A list will not be posted for dealers who do not have any affected vehicles. On or about April 6, 2016, this campaign code will show open on affected vehicles in Elsa. On or about April 6, 2016, affected vehicl

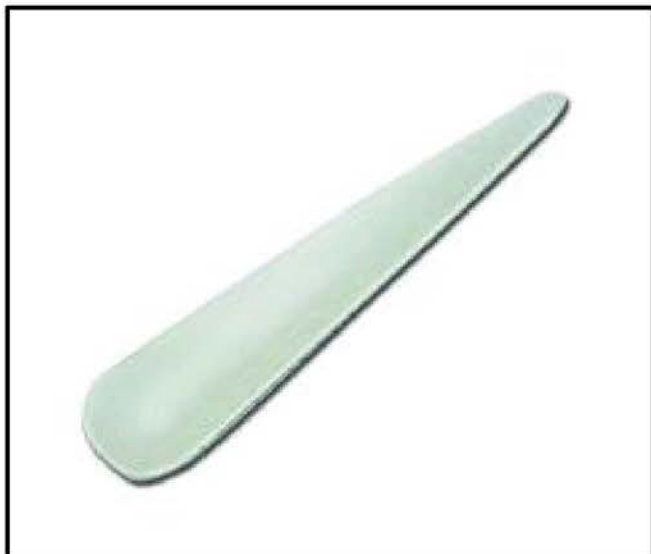
- Trim Removal Wedge or equivalent

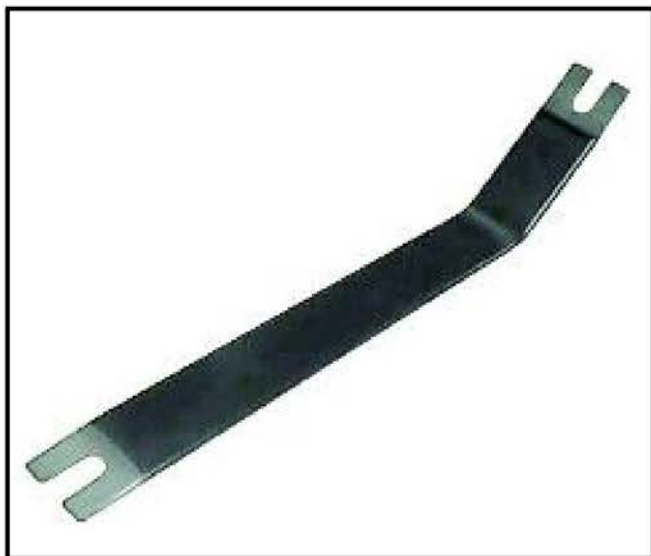
- Pry Lever <80-200> or equivalent

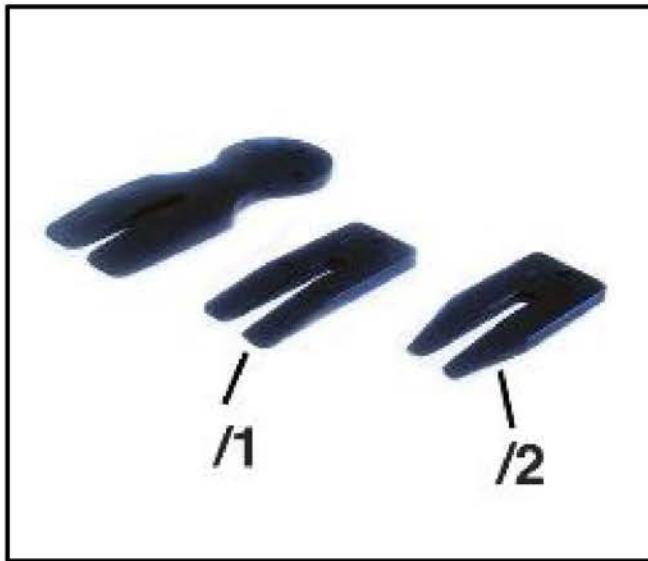
- Wedge Set T10383 or equivalent

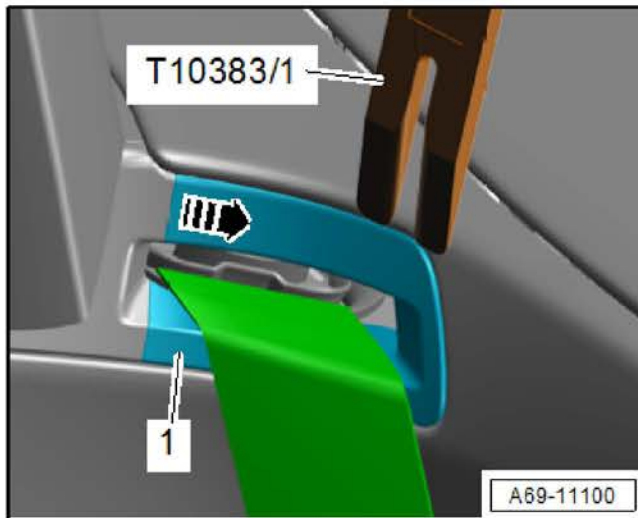
- Unclip the front driver side seat belt guides <1> from the rear panel cover using Wedge Set <T10383/1>.
- Remove the seat belt guide outward in the direction of the <arrow> out of the rollover protection trim panel.
- Repeat on the passenger side.

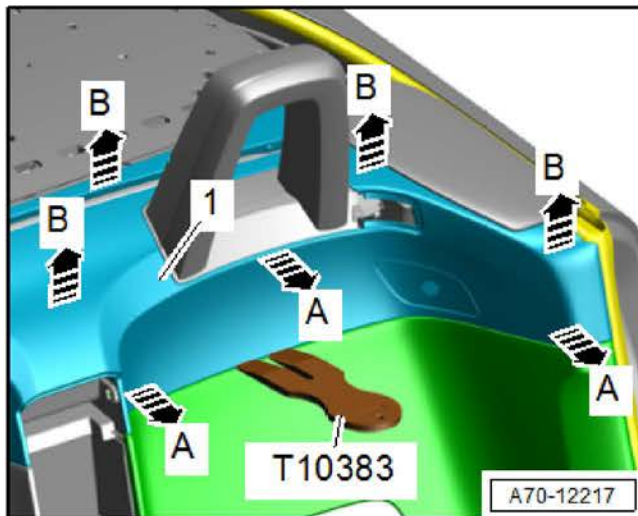
- Open the storage compartment.
- Unclip the rear panel cover <1> in the front area toward the front in direction of <arrows A> carefully along the seam using the Wedge Set <T10383>.
- Then unclip the rear panel cover upward from the body and from the wind deflector carrier in direction of <arrows B>.
- Perform same process on the passenger side.
- Remove the rear panel cover upward over both rollover supports.

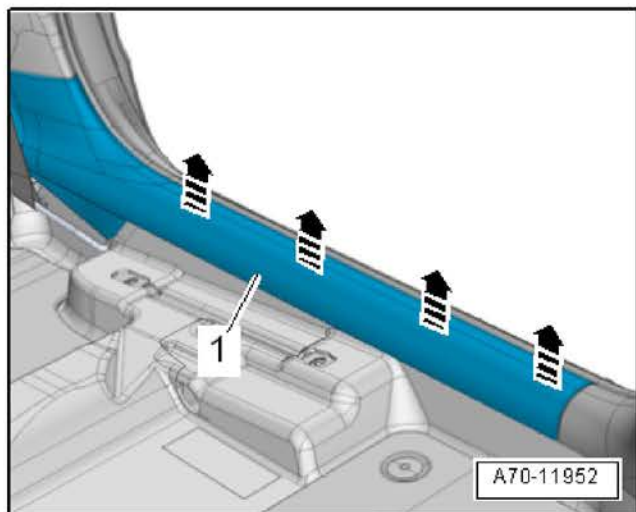
- Free up the sill panel in the area of the door seal.
- Unclip the front of the sill panel strip <1> using the Wedge Set <T10383> beginning from the side sill in direction of <arrows>.

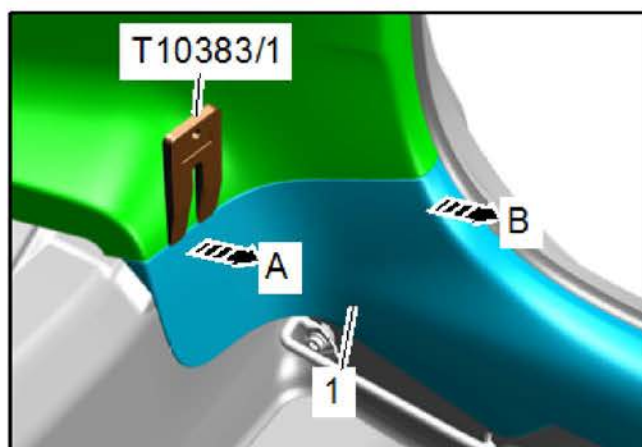
- Release the tabs <2> and the sill panel clip <3> with the Wedge Set <T10383/1> in direction of <arrow A>.
- Remove the sill panel <1> forward from the side trim panel in direction of <arrow B>.
- Remove the sill panel.
- Repeat on passenger side.

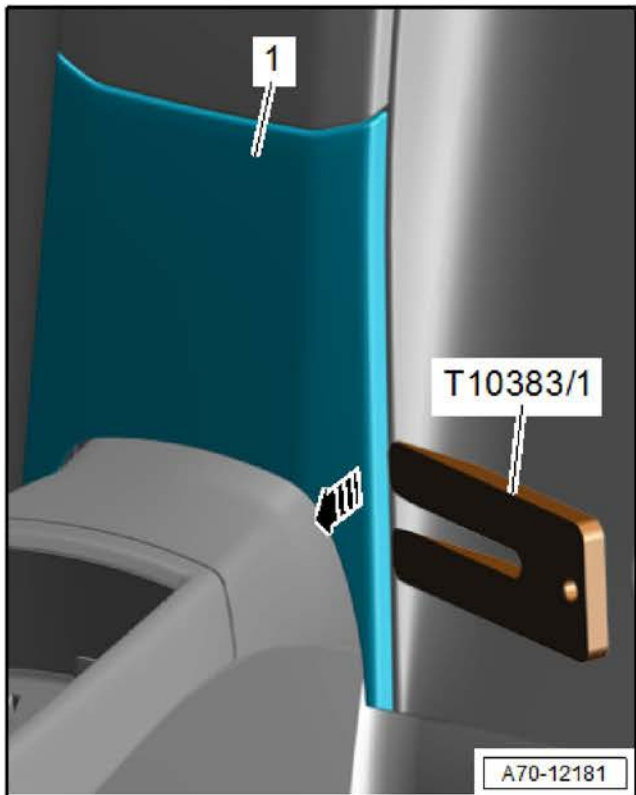
- Unclip the center rear panel trim panel <1> with the Wedge Set <T10383/1> in direction of <arrow> and remove.

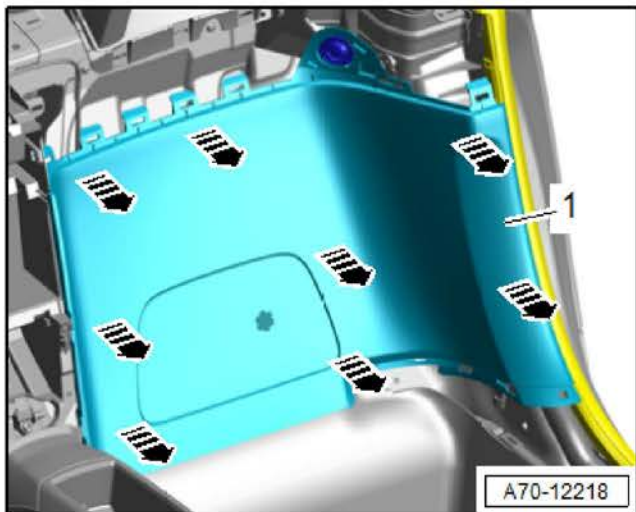
- Open the storage compartment.
- Unclip the rear panel trim panel <1> from the rear panel in direction of <arrows> with the Pry Lever <80-200> beginning from the outer bottom.
- Pull the rear panel trim panel slightly toward the inside and disconnect the connector for the speaker.
- Repeat on passenger side.

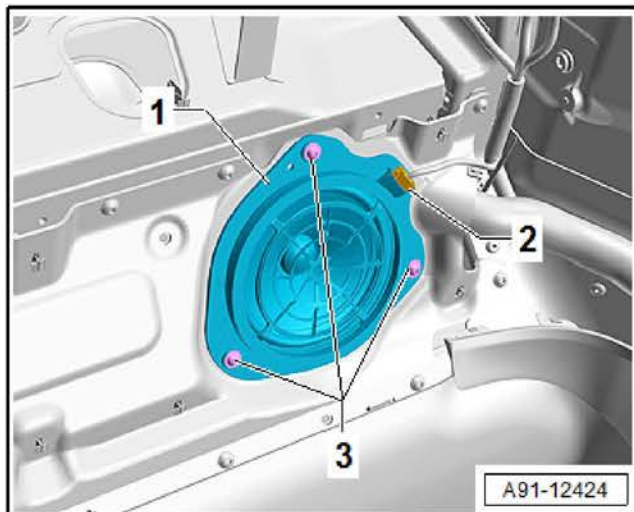
- Remove the screws <3> and then remove the speaker from the rear panel.
- Repeat on passenger side.

- Reinstall the water drain hose in the floor panel on both driver and passenger side.
- Ensure water drain hose is securely reinstalled.
- Install speakers tightening screws to 3 Nm.

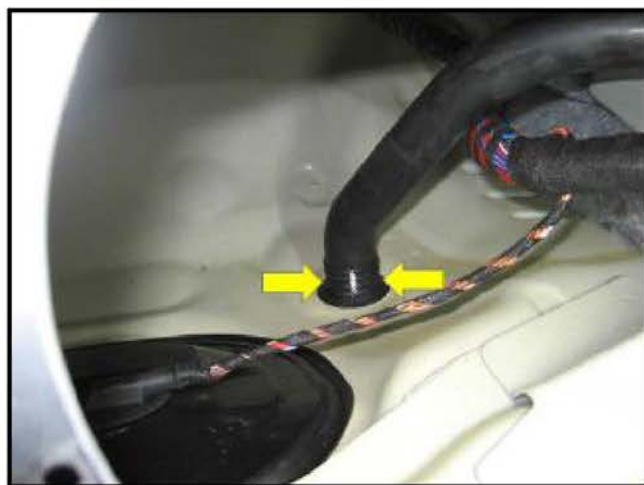
- Detach the water drain hose at the floor panel.
- Gently compress the water drain hose <arrows> and pull it out upward.
- Repeat on passenger side.

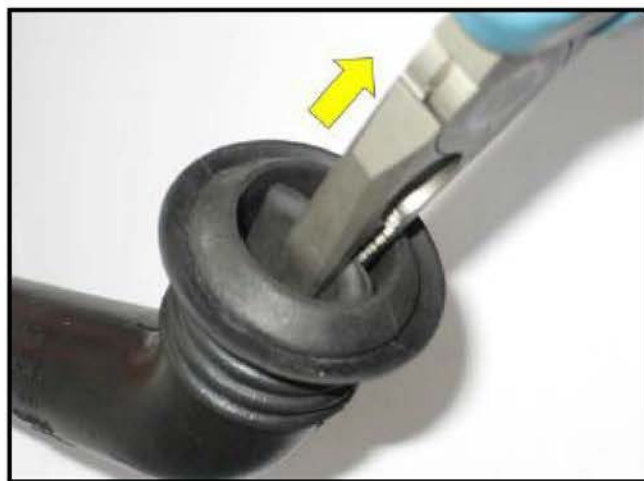
What is the issue? On Audi TT Roadster vehicles manufactured within a specific period, the drain valves for the soft top storage box may become obstructed by dirt or debris.

- Pull valve insert out using pliers <arrow>.
- Repeat on passenger side.
