**87 16 16** August 29, 2016 **2044165** Supersedes Technical Bulletin V871613 dated July 26, 2016 to update causal part line in warranty table and model year applicability.

### Air Conditioning Does Not Cool and or Compressor is Noisy

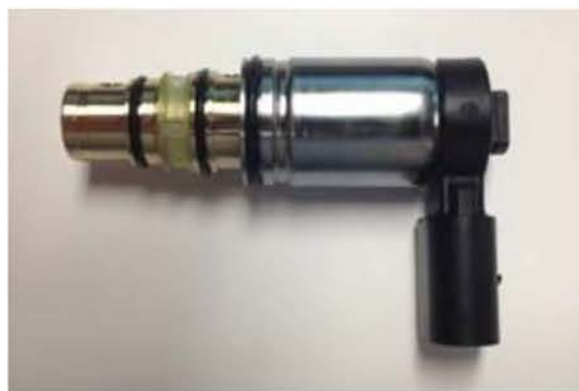
The condition may be caused by a faulty A/C compressor regulator valve N280 (Sanden). The internal components of the valve can be obstructed and incapable of full function. This loss of refrigerant regulation from N280 can cause noise from the air conditioning compressor and/or affect the HVAC cooling.

**Figure 1** N280 Refrigerant Regulating Valve  
1K0260839

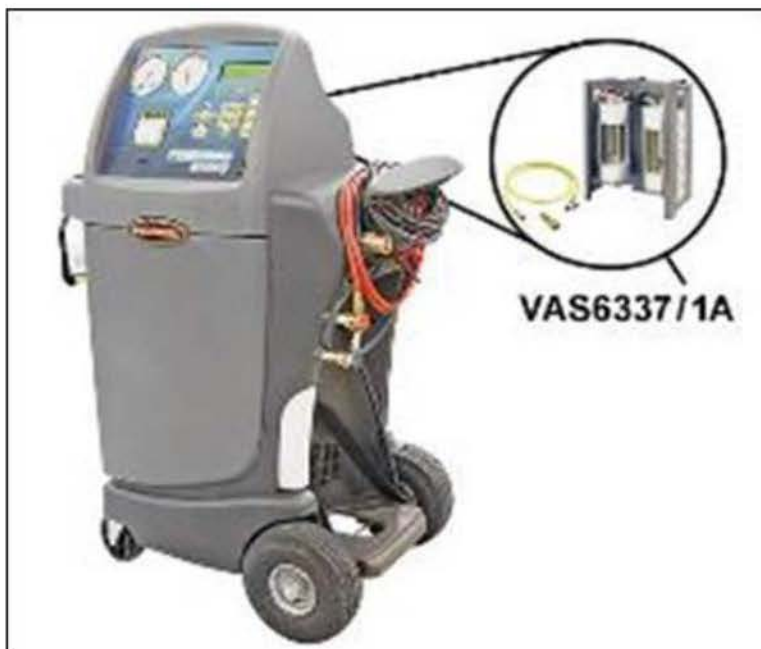
Connect both the refrigerant service station (Figure 4) and the diagnostic tester to the vehicle.

**Figure 4.** Robinair A/C Service Unit.

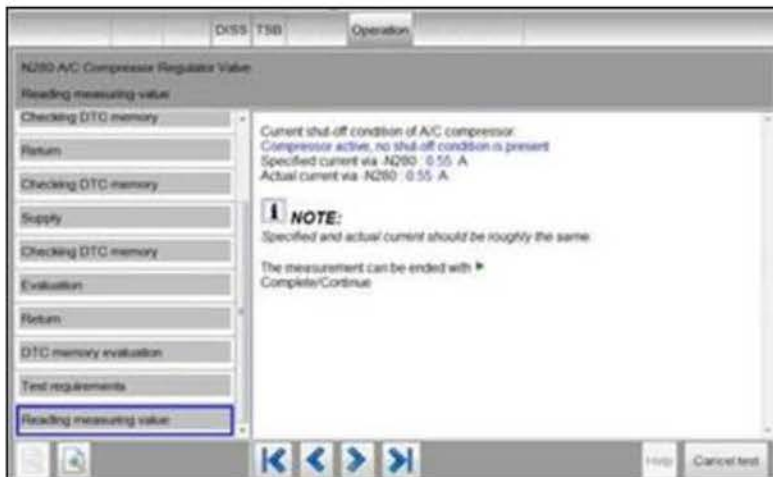
Monitor the measuring value for the air conditioner compressor regulating valve N280 signal (Figure 5).

The actual and specified values will be plausible and will show a normal regulating range of current for cooling request (0.400 A – 0.820 A).

Figure 5. Checking N280 signal value Measuring Value Block.

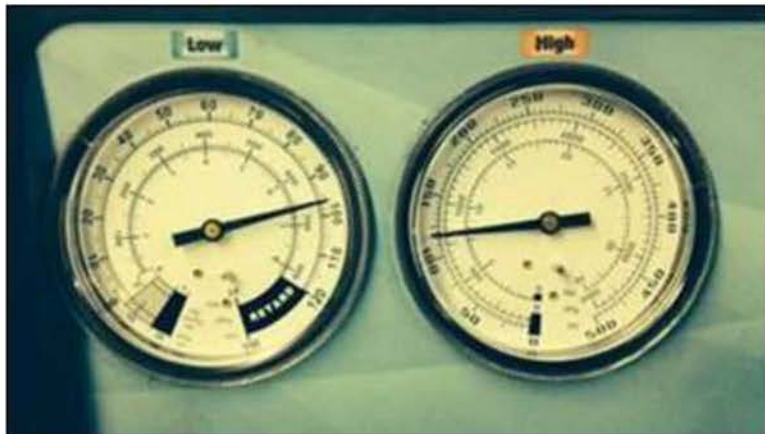
**Figure 6.** Equalized pressure condition. No pressure generated from compressor.

After verifying the compressor should be on and operating check the gauge readings on the Robinair® service station. If the gauges show no pressure generation from the compressor continue to the next step.

**(Example of no pressure generation is when the pressure readings on the high and low sides are equalized in Figure 6).**

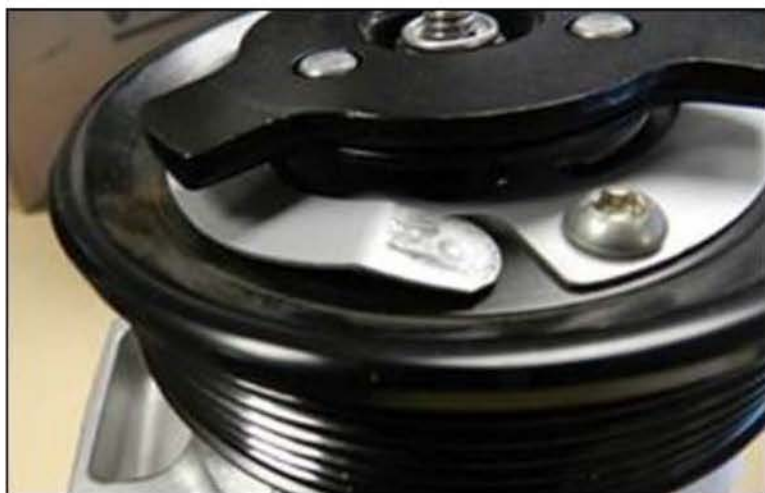
**Figure 7a.** Example of torque limiter over load protection activated.

**⚠ Note: If the torque limiter has been released the N280 regulating valve is not at fault. The compressor needs to be replaced.**

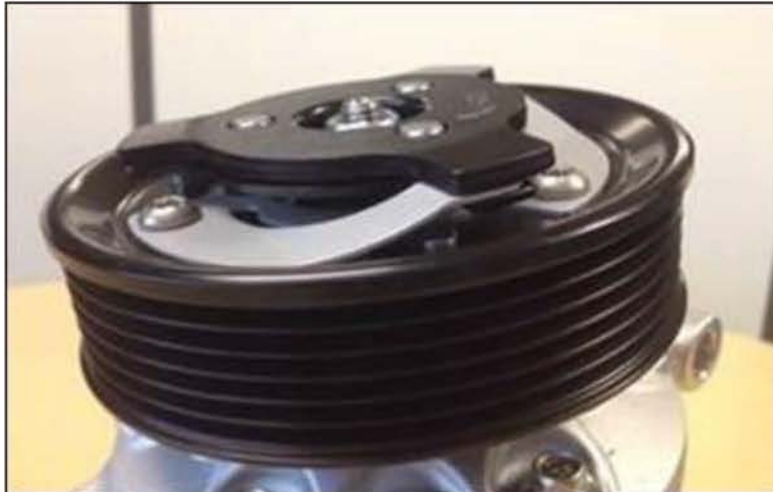
Check that the compressor torque limiter has not been activated (Figure 7b).

**Figure 7b.** Example of torque limiter over load protection still intact.

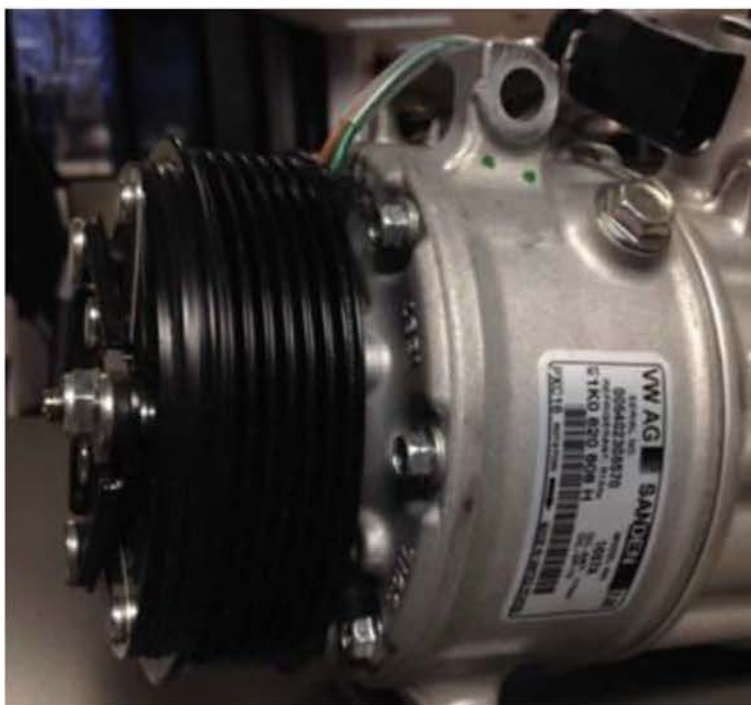
**Figure 8.** MY2016 AC compressor with clutch (Sanden)

For MY2016 vehicles with Sanden AC compressor 1K0820808H make sure the compressor clutch is engaged when the AC is switched on.

If clutch is not engaging perform diagnosis of the compressor clutch J44 test.

**Check that adaptation channel 9 and is set at 1 for clutch enabled. (See TT 87-16-01).**

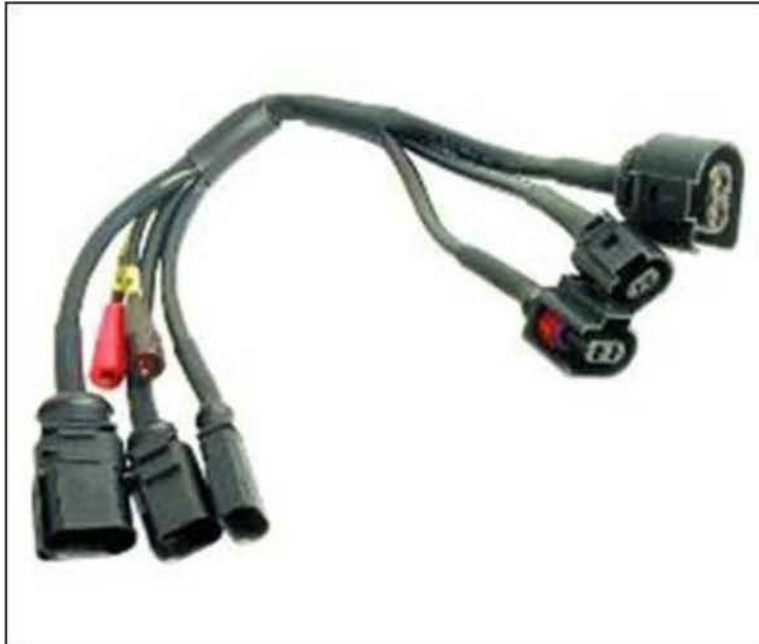
Shut off the engine. Connect the breakout harness VAS 5256 (Figure 9) between the N280 valve and its connector.

Figure 9. VAS 5256 breakout harness.

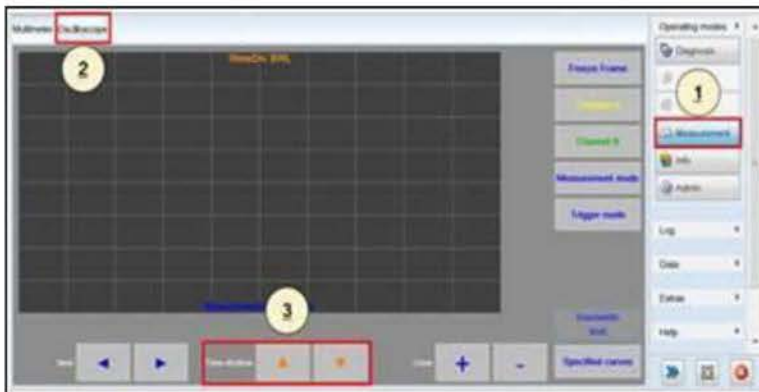
Go to Operating Mode "Measurements" to check the N280 signal from the control module.

Select Measurements.

Select oscilloscope.

Change time division to 2ms/Div (Figure 10).

Figure 10. Select Measurements from operating mode menu".

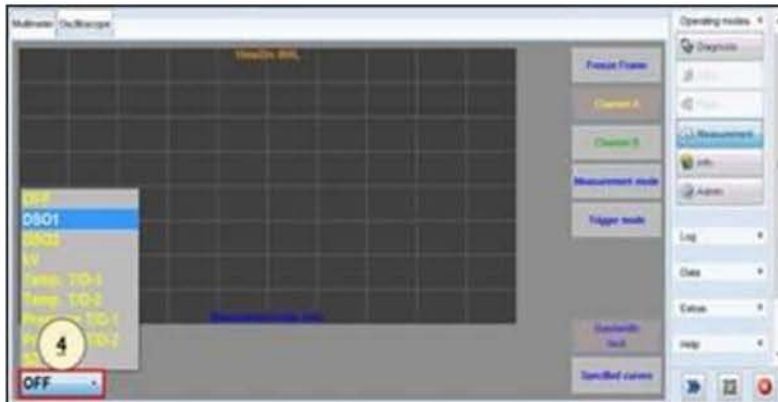
Select the correct DSO channel according to the test leads hooked to the vehicle (Figure 10).

Figure 11. Setting up DSO channel”.

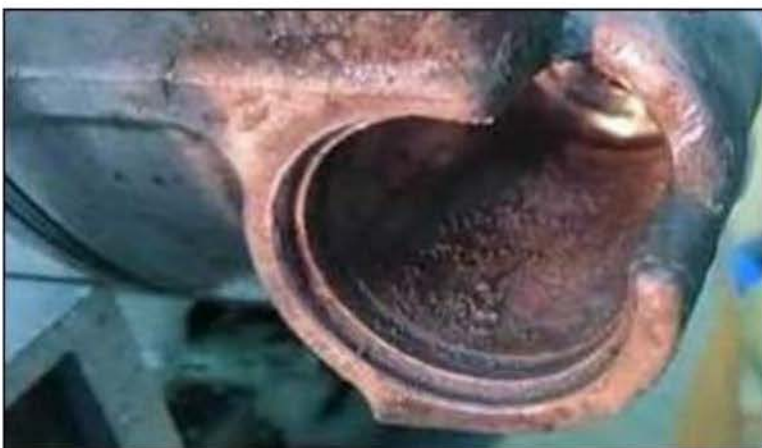
Figure 14. Corrosion in the N280 valve bore.

Assess the condition of the N280 valve bore and the valve filter screen (Figure 14). If severe contamination is found in valve bore there is a risk of damaging the replacement valve on installation. In these cases the A/C compressor must be replaced.

**A slight amount of debris or corrosion does not present a risk and does not justify replacement of the AC compressor.**

- If little or no corrosion or contamination is found perform Repair Procedure A: Replacing the N280 regulating valve.
- If corrosion and contamination is found, perform Repair Procedure B: A/C compressor replacement.
- Document the all workshop findings of this procedure on the repair order.

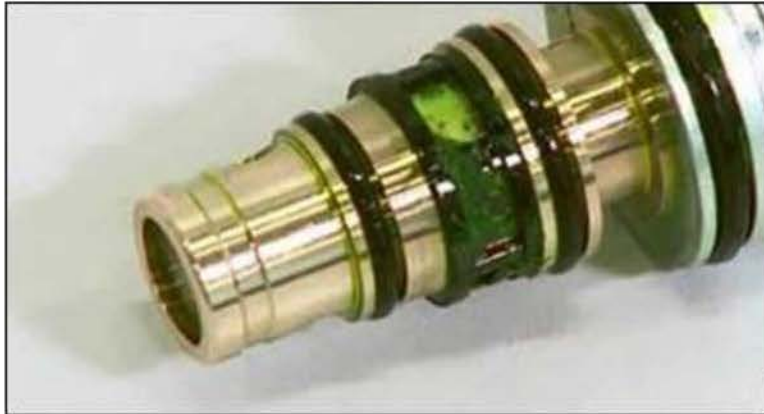
Should severe contamination be found at the valve filter screen (Figure 15) and A/C compressor replacement becomes necessary, ensure that the refrigerant circuit is flushed in the course of repair.

**Small random particles on the filter screen does not constitute “severe” contamination and does not justify replacement of the A/C compressor.**

**Figure 15:** Severe contamination at the N280 valve filter screen.

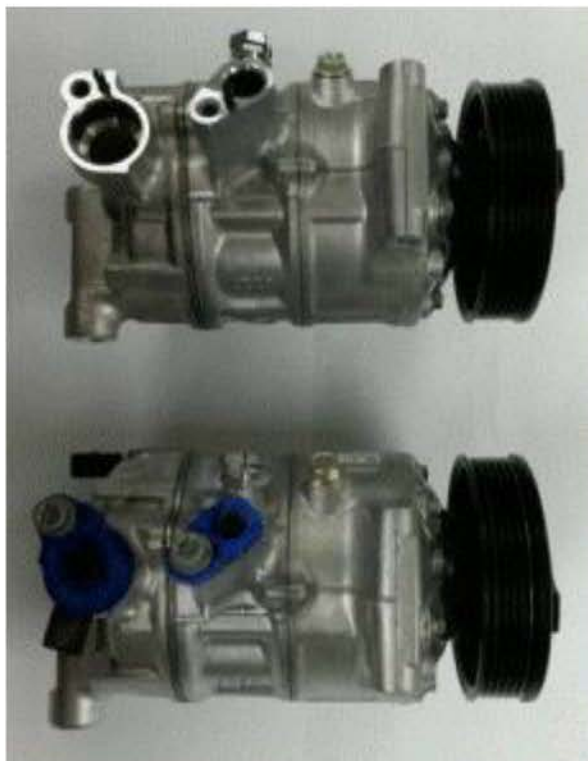
Figure 18

When installing a new compressor transfer the compressor shipping caps to the original compressor as shown in Fig 18.

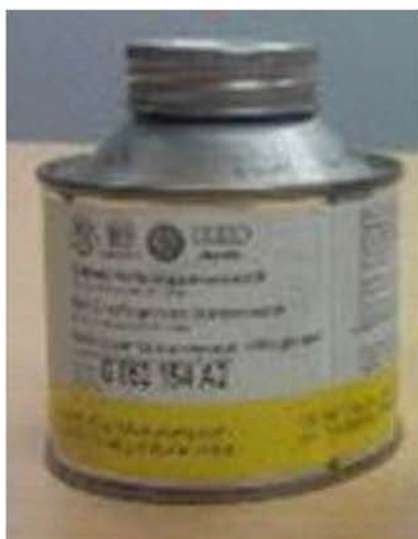
Figure 19: Sanden compressor manufacturer PAG oil G 052 154 A2.

The replacement Sanden compressor will come with the specified type of PAG oil G 052 154 A2 (Figure 19).

**The compressor comes with a full charge of oil for the entire refrigerant circuit. However the amount of PAG oil supplied with the replacement compressor may not be the exact amount to replenish the refrigerant circuit. Drain and measure the PAG oil in the replacement compressor to determine the required amount. If the amount needs to be adjusted, do so using the correct type of PAG oil specified in ETKA. Refer to Elsa for the correct oil capacity for the compressor being installed.**
