**Technical Service Webinar**  
September, 2016

# Technical Service Webinar

# **TSB 2036668/3 MIL on, rough running, no start (DTCs P0087, P0088, and/or P0191) (TDI only) Gen III 2.0 and Gen II 3.0**

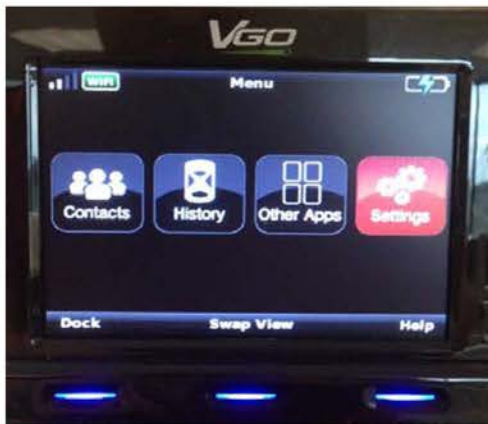
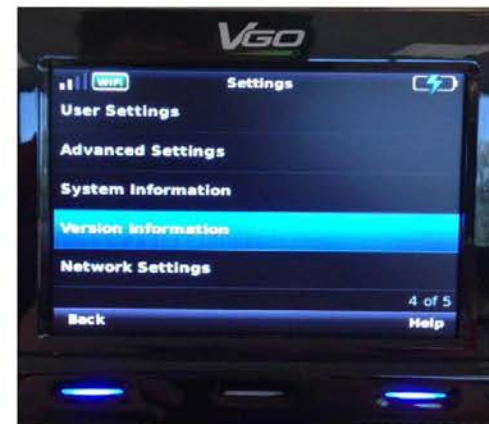
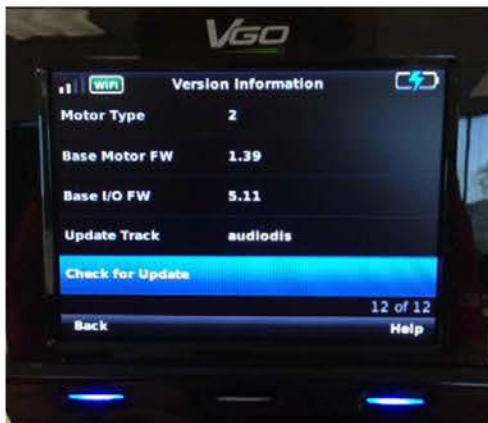
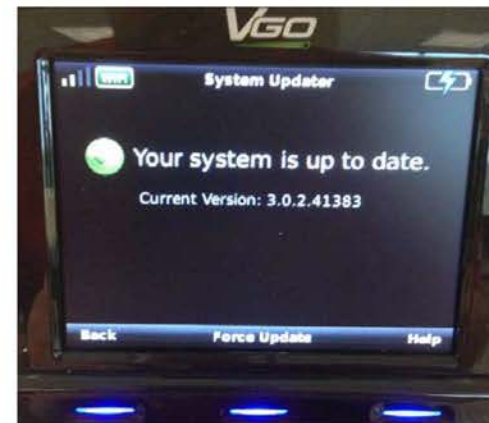
# Enabling pass through function

Settings>Advanced Settings>enter password 345>scroll down to USB virtualization and set to ON. Now re-start the unit and pass through function will be available.

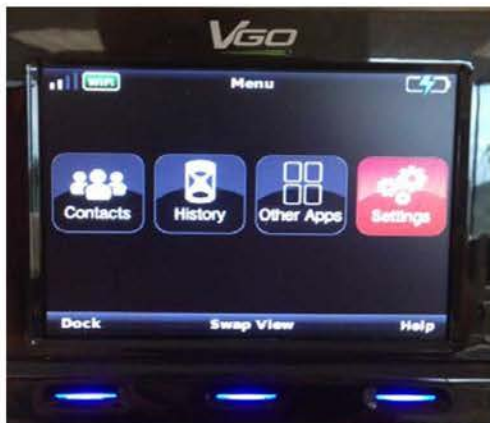
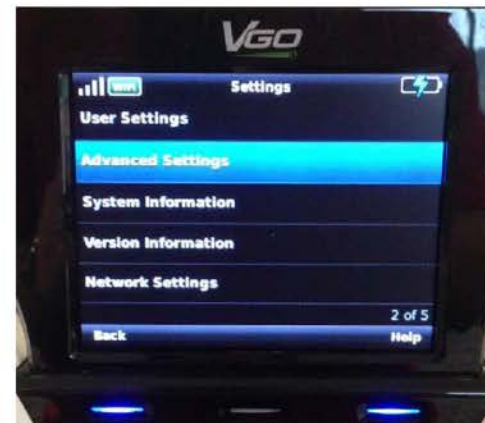
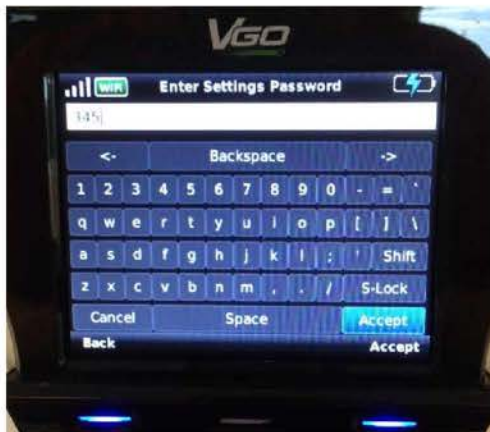
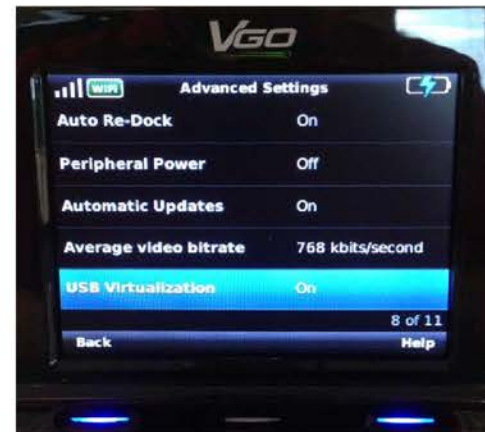
## Connection Tips

- Diagnostic head must be connected via USB2 cable to the base
- USB connections on the back of screen will not allow the pass through to connect
- 10' USB2 cable that comes with the bore scope may be used for the diagnostic head

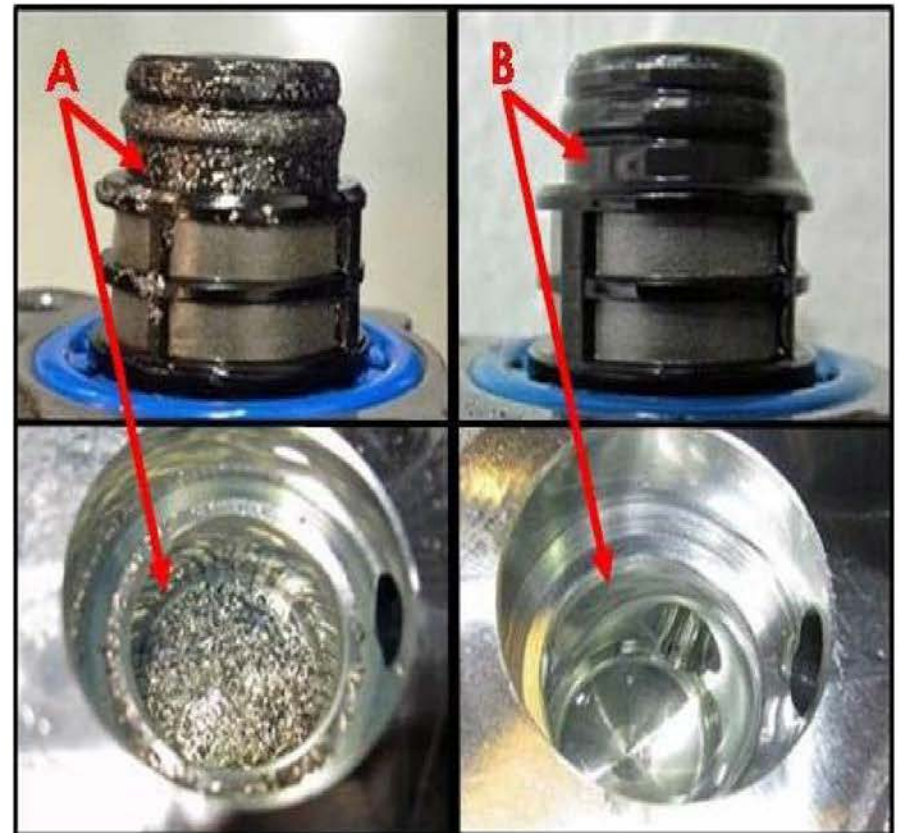
Remove the N290 fuel metering valve and inspect the valve and valve bore for the presence of metallic particles (Figure 2). Proceed with the appropriate section below.

Fuel metering valve and valve bore with metallic particles (A), and without metallic particles (B).

If metallic particles *are* found on the N290 fuel metering valve or in the valve bore, open a TAC ticket before continuing with the repair.

If metallic particles *are not* found on the N290 fuel metering valve or in the valve bore do NOT replace the high pressure fuel pump.

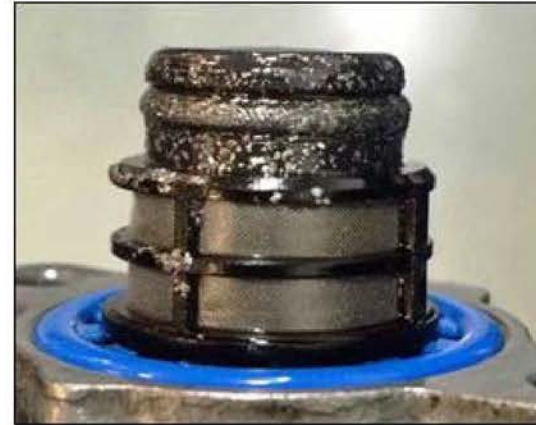
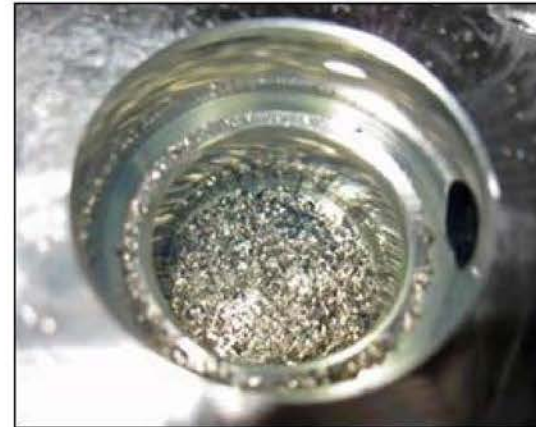
## TSB 2036668/3 continued

- GFF diagnostic log
- Clear pictures showing the metallic particles in the N290 fuel metering valve and bore.
- All related diagnostic steps performed including test plans

Ensure that neither O-ring is damaged. If either O-ring is damaged, replace the high pressure fuel pump.

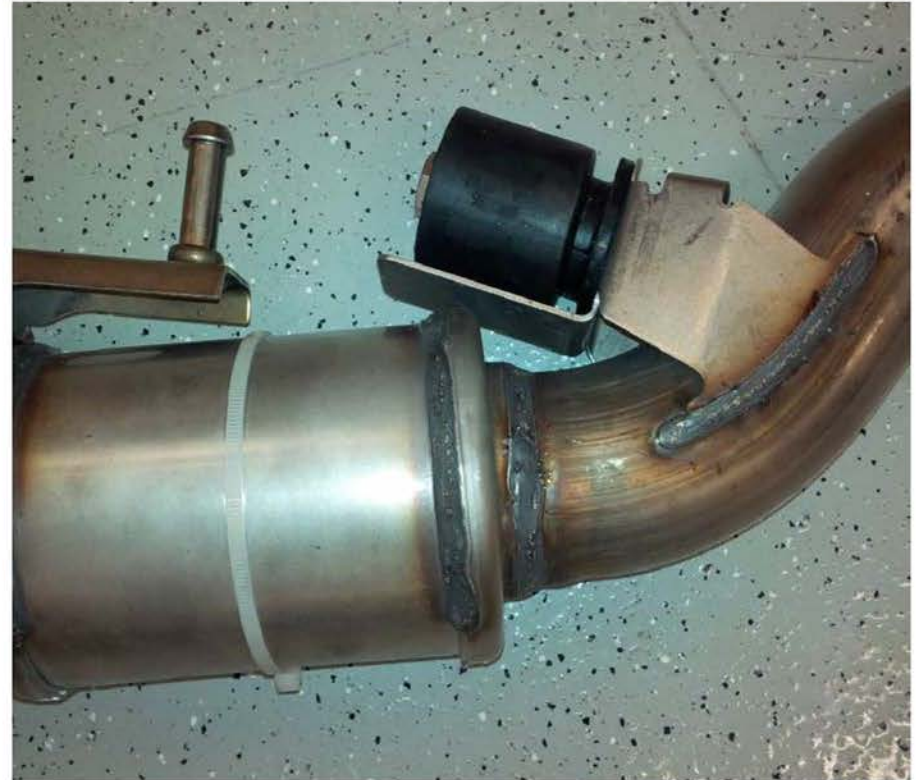
# Updated Pipe

Updated down pipes are available. The new pipes will have a 500 gram weight on the pipe that acts as a vibration damper, there will be a superseded part number as well. The old pipes do not have a vibration damper.

- Superseded part number.
- Vibration damper installed.
- Old pipes have been purged from parts stock as of March 2016, any pipe ordered by VIN will be the updated version.
- The collars must be transferred to the old pipes and sent back for warranty.

If pipes are replaced make sure the new pipes have the retainers securely installed around the flex joint. This retainer must remain on the pipe through the install process and be the last part removed. The retainers must be transferred to the old pipes to be returned for warranty. It is crucial for the retainer to be on the pipes when they arrive and through the install process because if the pipe flexes more than 10\* the flex joint may be damaged.

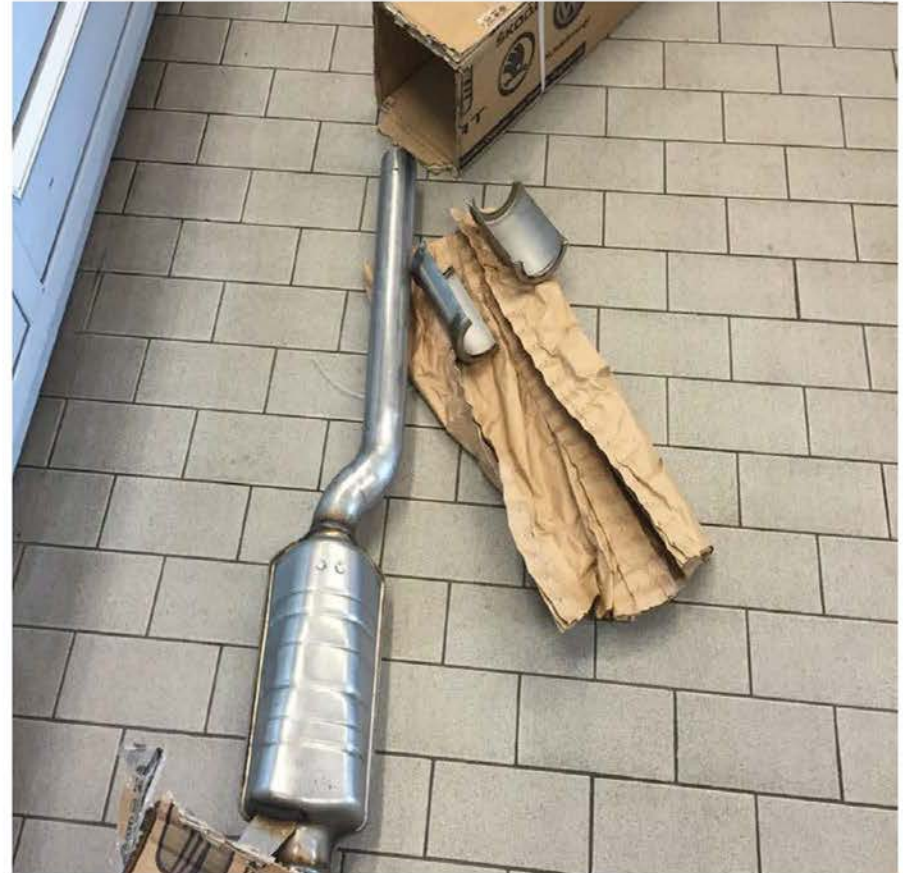
# Damaged Pipe

Example of an improperly packaged pipe received at the dealership

The clamps are not installed which can cause over extension of the flex joint.

Create a TAC case with the following info:

1. Sales doc number
2. Part number
3. How the part arrived at the dealer, in a box, bubble wrap, no protection. (picture)
4. If in a box and the sleeve came off, how many tie wraps were found in the box?
5. Part warranty the pipe as damaged part.
