SERVICE CAMPAIGN BULLETIN

NTB16-120

VOLUNTARY SERVICE CAMPAIGN 2013 – 2014 PATHFINDER; CVT

APPLIED VEHICLES: 2013 – 2014 Pathfinder (R52)

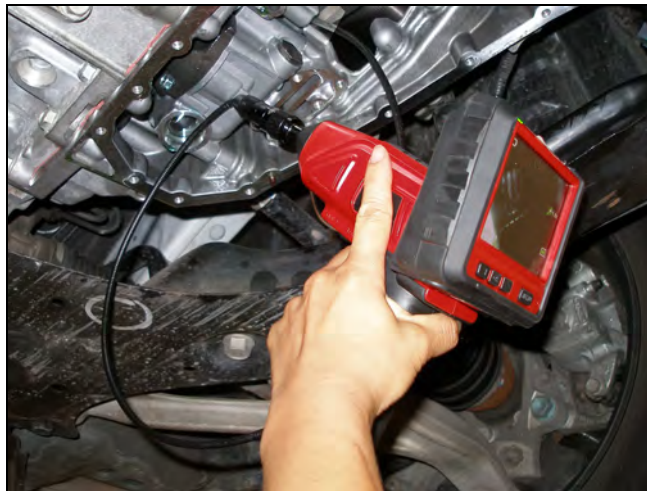
Figure 2C

- Holding the borescope with one hand allows for turning the tire with the other hand (see Figure 2C).

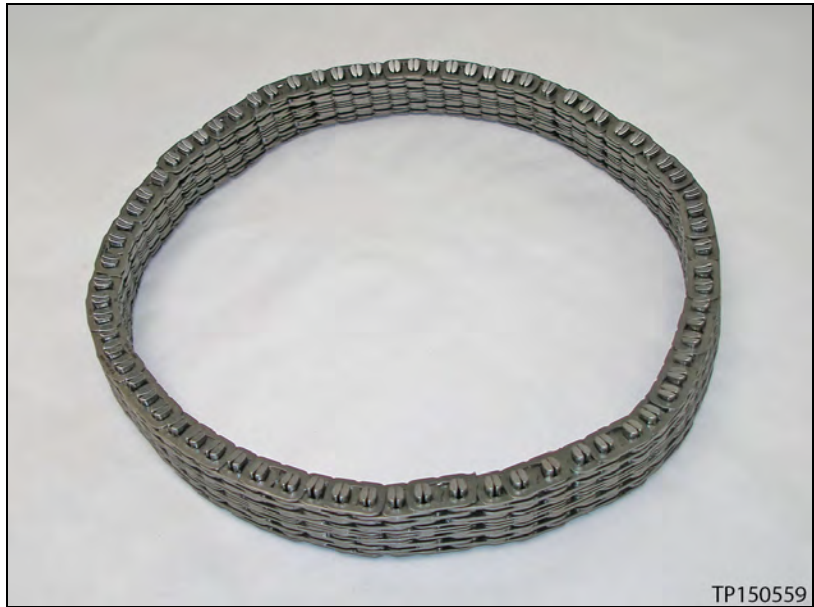
Figure 9C: CVT chain

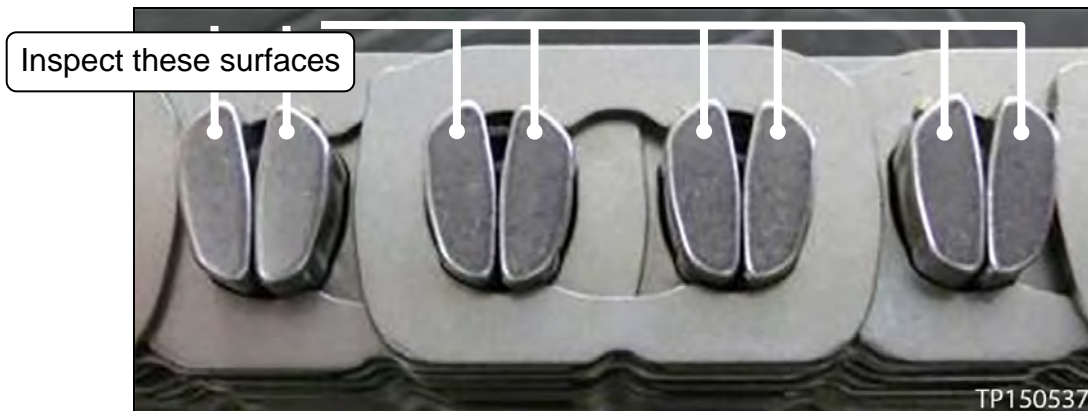
Figure 11C: Close-up of area to be inspected

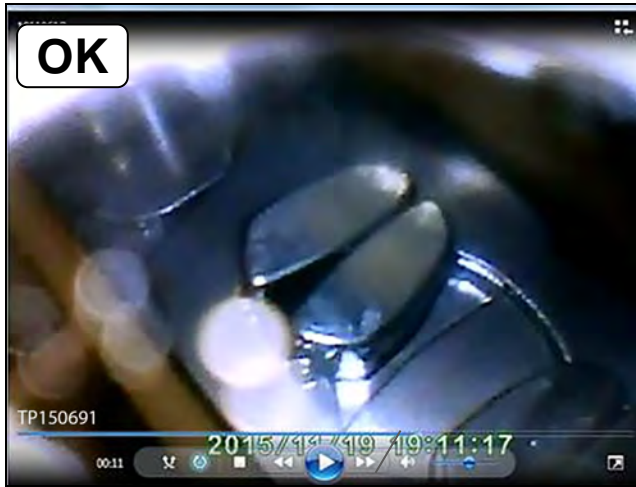
Photos in Figure 12C and 13C were taken with borescope J-51951.

NOTE: Reference the photos on pages 22 – 24 for examples of chain slippage and for comparison to the vehicle you are working on.

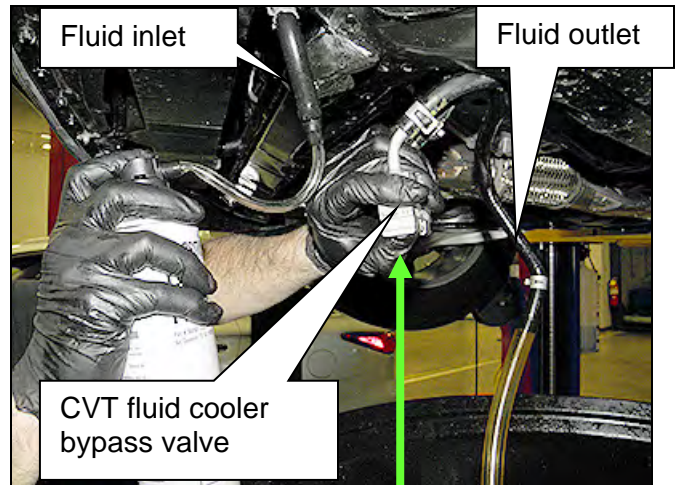
Figure 3E

14. Now reverse the direction that the hoses are being flushed (Figure 3E) and repeat steps 8 through 12 twice (total of 3 times).
