SERVICE BULLETIN

Classification: FA15-003b	Reference: NTB15-062b	Date: October 26, 2016
------------------------------	--------------------------	---------------------------

2014-2016 ROGUE; POPPING NOISE FROM FRONT SUSPENSION WHEN TURNING

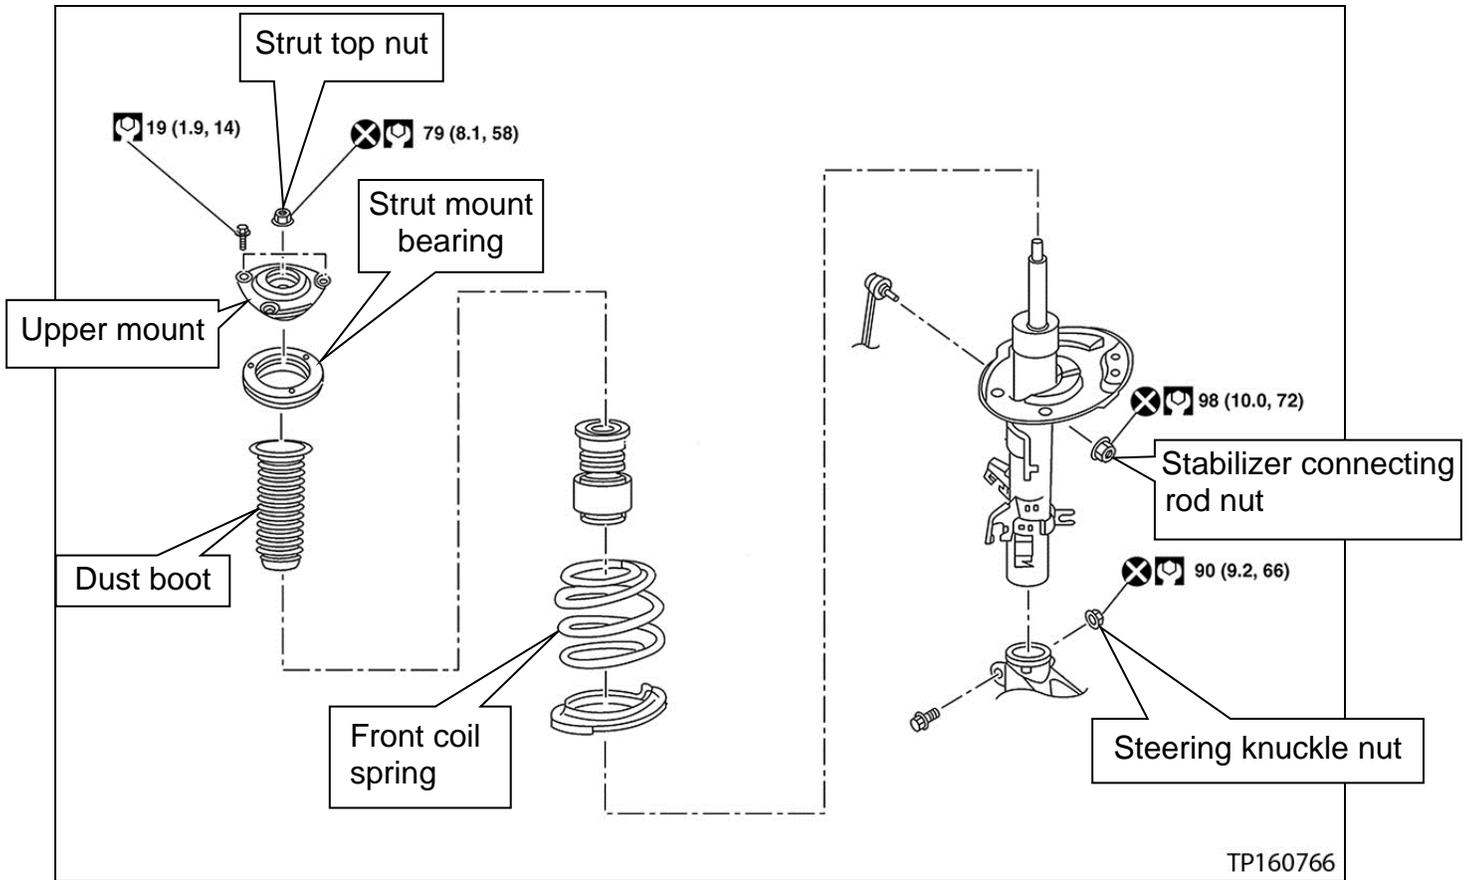
Parts to be replaced on both front strut assemblies are called out in Figure 1 below.

Replace both front coil springs, strut mount bearings, and all other parts listed under **PARTS INFORMATION**.

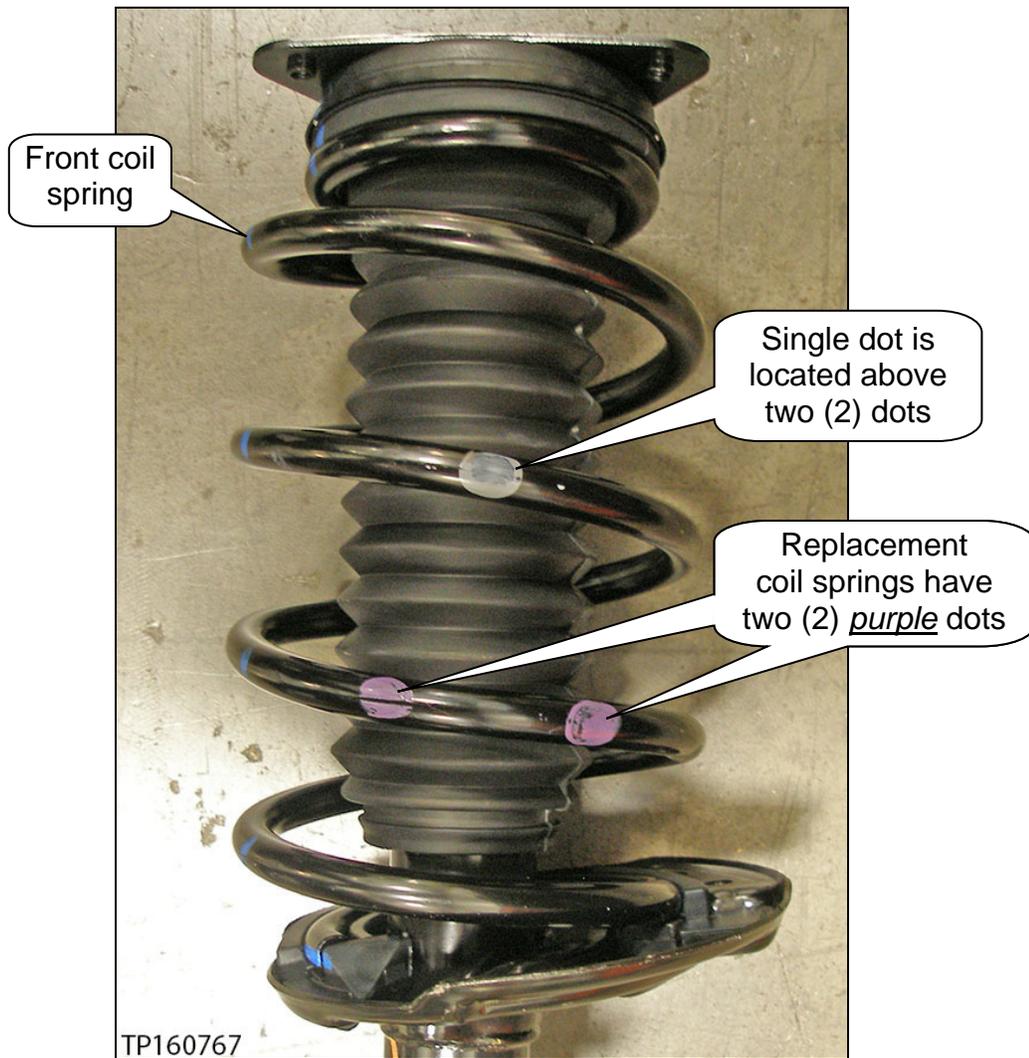
Figure 4

- With the coil spring installed, the single dot must be ABOVE the two dots (see Figure 4).

IMPORTANT: The **Coil Spring Installation Guidelines** section in this bulletin **MUST** be followed in order for a correct repair to be performed.

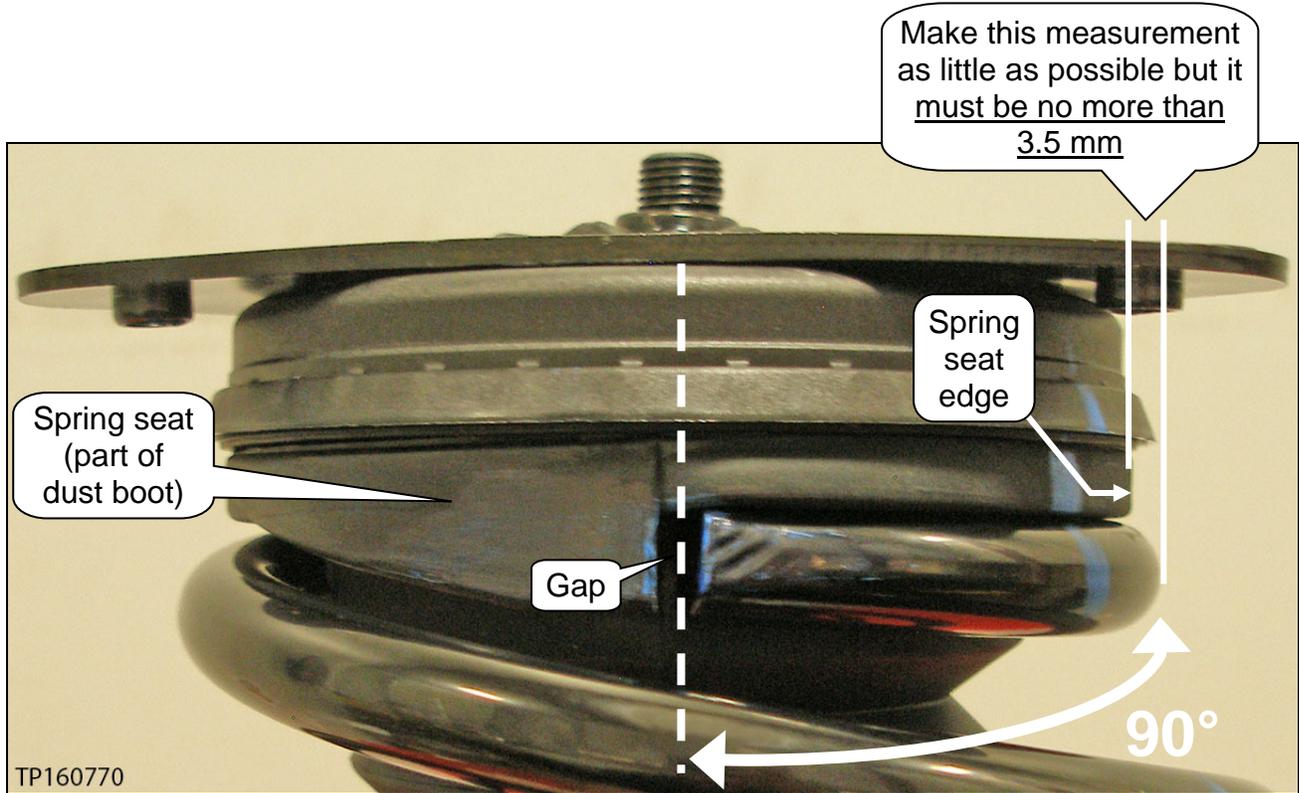
Figure 7

- The side edge of the upper coil spring, located 90° counter clockwise from the gap, needs to be as little as possible but it must be no more than 3.5 mm from the edge of the spring seat (see Figure 7).
- If the measurement is greater than 3.5 mm, rotate the coil spring into the spring seat (close the gap).
