GROUP	MODEL
Service Campaign	2011~2015MY Optima (TF) 2011~2015MY Optima Hybrid (TF HEV) 2009~2010MY Rondo (UN) 2009~2014MY Sedona (VQ)
NUMBER	DATE
SC135 (Rev 1, 10/13/2016)	September 2016

VOLUNTARY EMISSIONS SERVICE CAMPAIGN

EVAPORATIVE CANISTER INSPECTION AND/OR REPLACEMENT (SC135)

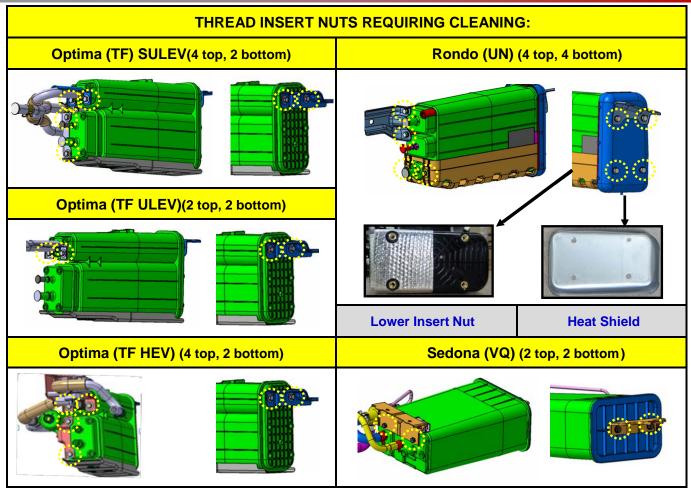
3. Clean all insert nuts using a metal brush and shop air. See diagram on page 3 for specific thread insert locations requiring cleaning. Inspect all insert areas of the charcoal canister (B) carefully for cracks (C), as shown in "Insert Area Crack Examples" table on the next page.

Note: In case of Rondo (UN) clean the lower Insert nuts after removing bracket and heat shield.

If <u>no</u> cracks are present, proceed to "Replace Bracket Kit" and discard all bolts and previously removed bracket which will not be reused.

If cracks <u>are</u> present, proceed to the "Canister Replacement" procedure and retain removed brackets for later reuse and only discard removed bolts.

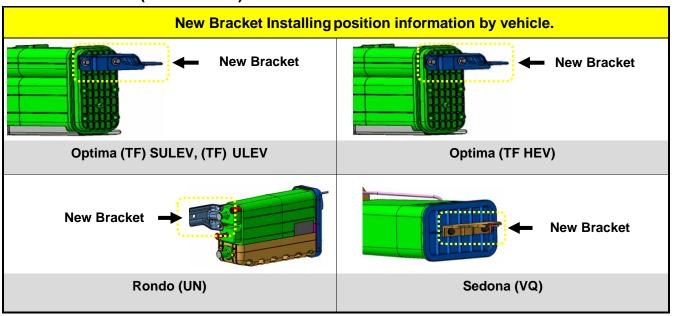
Refer to table on page 5 and install vehicle appropriate new bracket kit to the canister. Install in order of bolt → bracket → rubber washer → canister.

Tightening torque:

3.7 ~ 4.3 lb-ft (5.0 ~ 5.9 Nm)

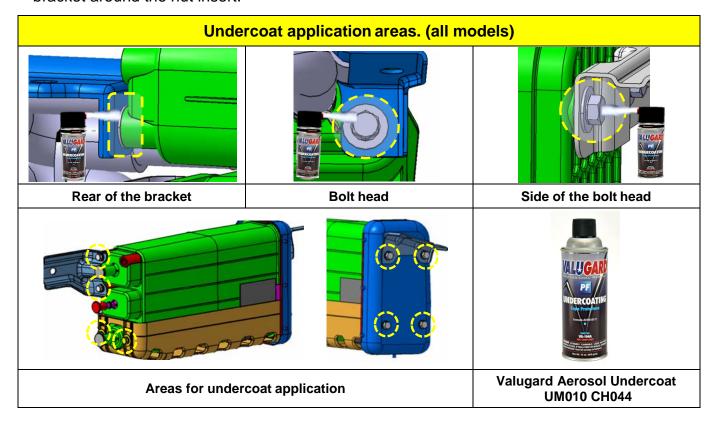
2. Apply Valugard Aerosol Undercoat (UM010 CH044) around the bolt, washer and area behind bracket around the nut insert.

Bolt tightening location	Insert Nut	Rubber Washer	Heat Shield	Bracket		
		0	N/A			
Optima (TF) SULEV		- Rubber Washer - Rubber Washer	+Bracket(Previou +Bracket(New)	s)		
Optima (11) GOLEV	6	0	N/A			
① Optima (TF) ULEV		Rubber WasherRubber Washer	+Bracket(Previou +Bracket(New)	s)		
		0	N/A			
Optima (TF HEV)		 Insert Nut + Rubber Washer + Bracket(Previous) Insert Nut + Rubber Washer + Bracket(New) 				
Optima (II Tilev)		0				
Rondo (UN) SULEV, Rondo (UN) ULEV	②. Insert Nut +	- Rubber Washer Rubber Washer + · New Bolt(No Rub	Heat Shield + Brac	ket (Previous).		
		0	N/A	P		
① ② Sedona (VQ)		Rubber Washer - Rubber Washer	- Bracket(Previous +Bracket(New)	8)

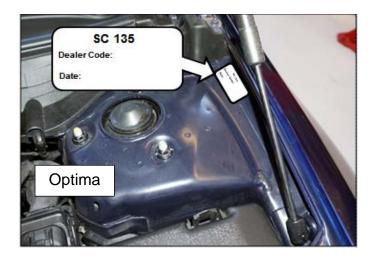
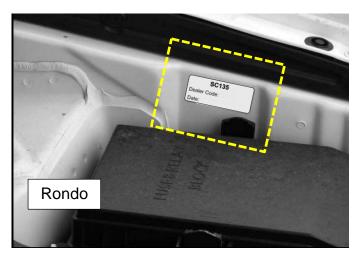
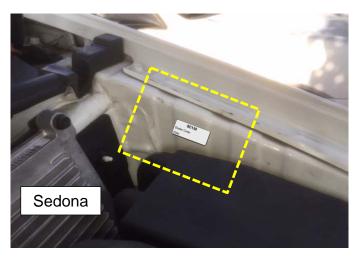
Apply SC 135 Campaign Completion Label onto the body in the area next to the shock tower, as shown. **NOTE: Be sure to clean the mounting surface to ensure proper label adhesion.**

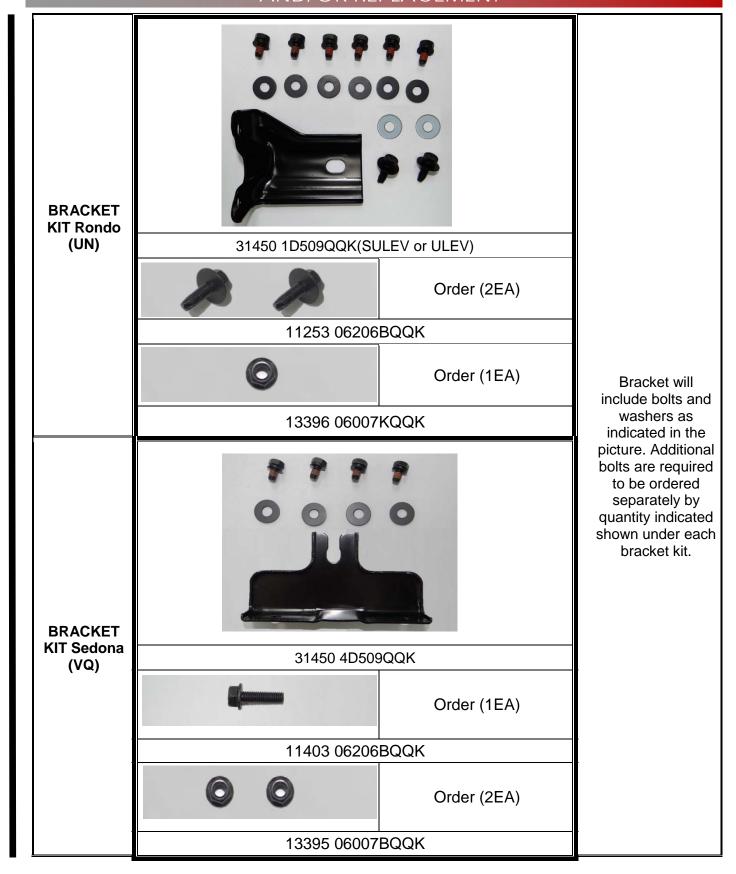
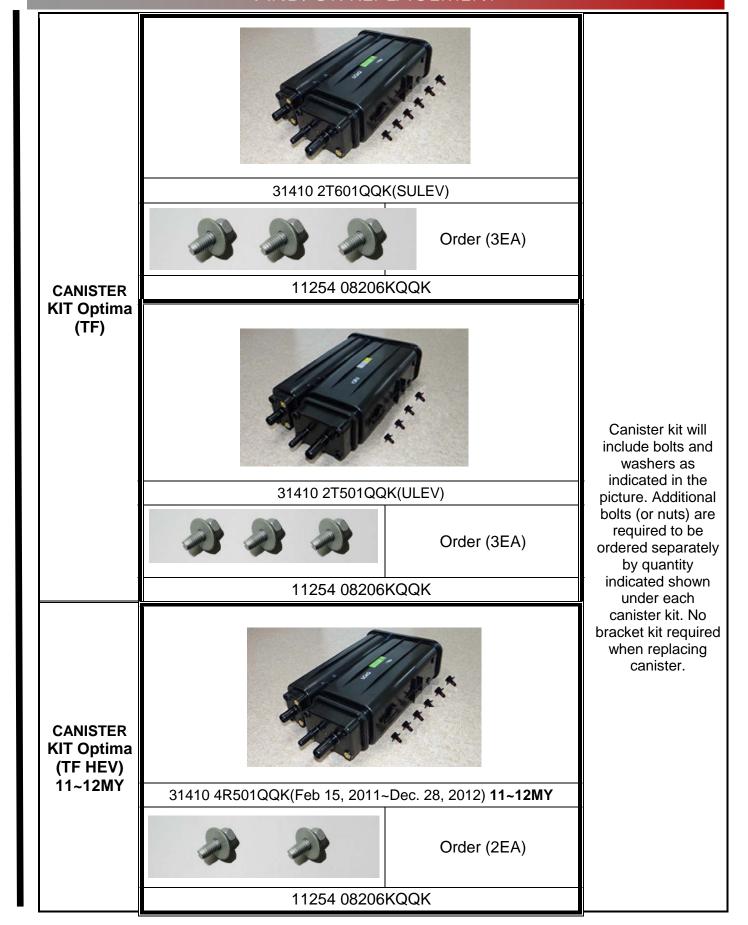
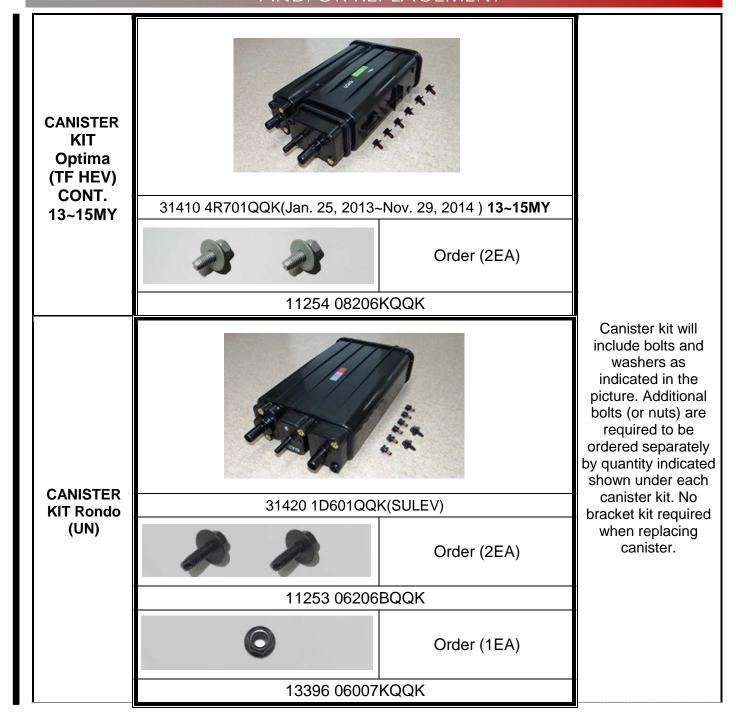
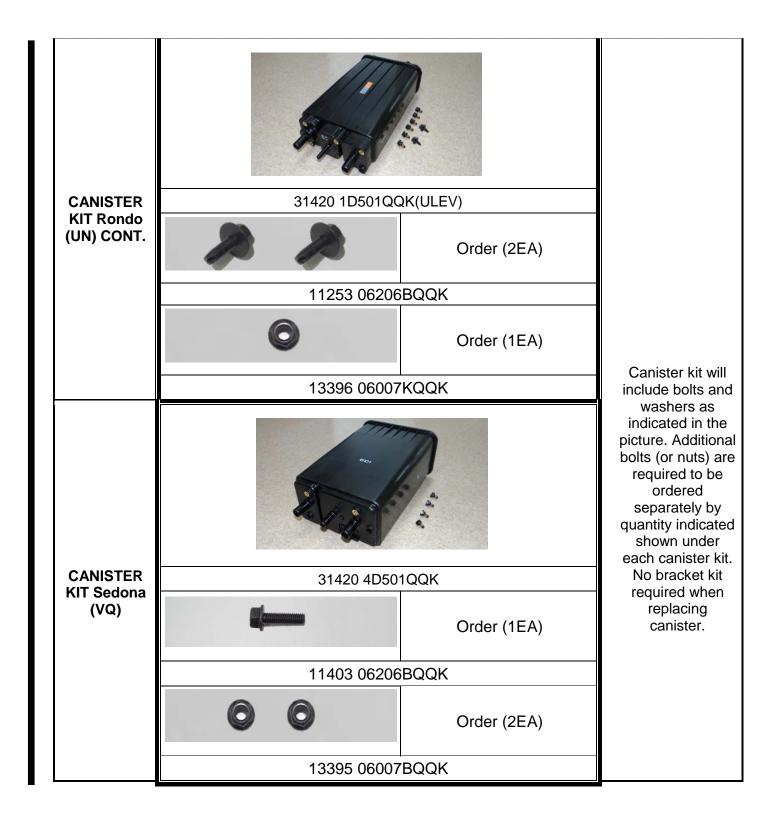
31450 2T609QQK(SULEV)	
	Order (3EA)	
BRACKET KIT Optima	11254 08206KQQK	
(TF)	* * * * *	Bracket will include bolts and washers as indicated in the picture. Additional bolts are required to be ordered separately by quantity indicated shown under each bracket kit.
	31450 2T509QQK(ULEV)	
	Order (3EA)	
	11254 08206KQQK	
BRACKET KIT Optima (TF HEV)	4444 000000	
(11 1124)	31450 4R509QQK(HEV)	
	Order (3EA)	
	11254 08206KQQK
