MODEL
2016MY
Optima (JFa)

148 (Rev 11/15/2016)

TECHNICAL SERVICE BULLETIN

SUNROOF BUZZING NOISE

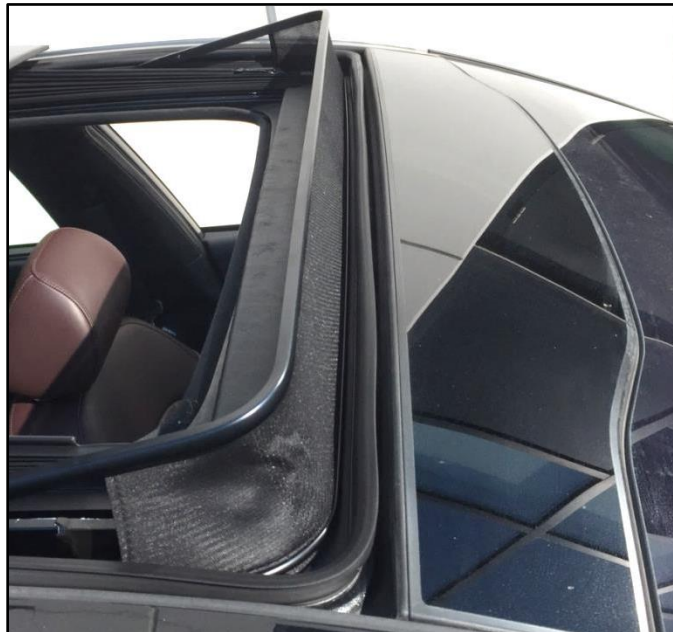
This bulletin provides information on some 2016MY Optima (JFa) vehicles, produced from September 28, 2015 to June 20, 2016, which may exhibit a buzzing noise that may increase with intensity in conjunction with the HVAC fan speed. This concern is caused by a loose sunroof weather strip vibration due to air leakage past the sunroof seal. To correct this concern, follow the procedure outlined in this bulletin to apply adhesive to the weather strip base.
