Technical Journal

IHU software download problem, cars with CD Player

REF NO: TJ 31360.1.1	ISSUING DEPARTMENT: Technical Service	CAR MARKET: United States and Canada	
PARTNER: 3 US 7510 Volvo Car USA		ISSUE DATE: 2016-06-22	STATUS DATE: 2016-06-28
FUNC GROUP: 3900	FUNC DESC: media, navigation and communication	Page 1 of 4

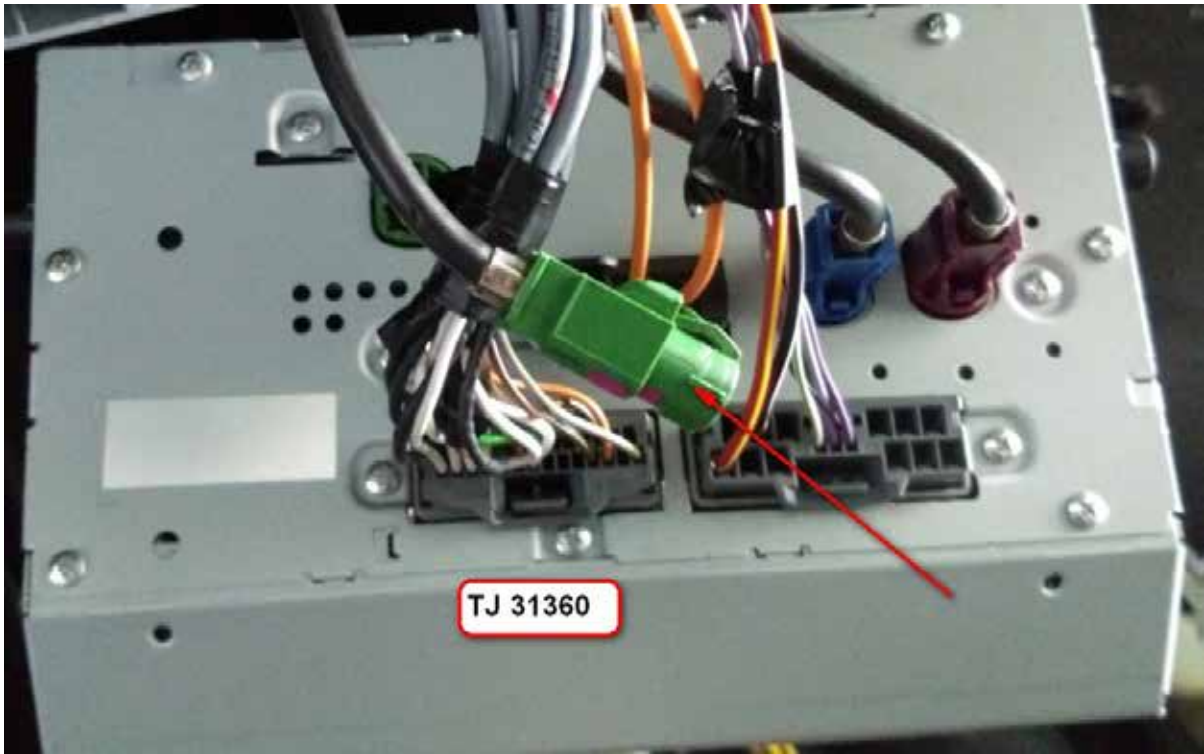
- Check the inline connector to the ODP located on the passenger side of the center console (ODP_pic_1.jpg).
- * - Check the connector at the ODP inside the console (ODP_Pic_3.JPG)
- Check the connector at the IHU (IHU_pic_2.jpg)

Check the terminals in the connectors for damage.
