TITLE:  
**C70 headliner hanging down, repair clip**

<b>REF NO:</b> TJ 29245.2.1	<b>ISSUING DEPARTMENT:</b> Technical Service	<b>CAR MARKET:</b> United States and Canada	
<b>PARTNER:</b> 3 US 7510 Volvo Cars North America		<b>ISSUE DATE:</b> 2015-03-05	<b>STATUS DATE:</b> 2016-07-29
<b>FUNC GROUP:</b> 8389	<b>FUNC DESC:</b> Miscellaneous	Page 1 of 8

TJ 29245

<b>Title</b>	Convertible Top Center Headliner	<b>Page</b>	1 ( 6 )
<b>Action</b>	Product fix	<b>Operation number:</b>	98537-2

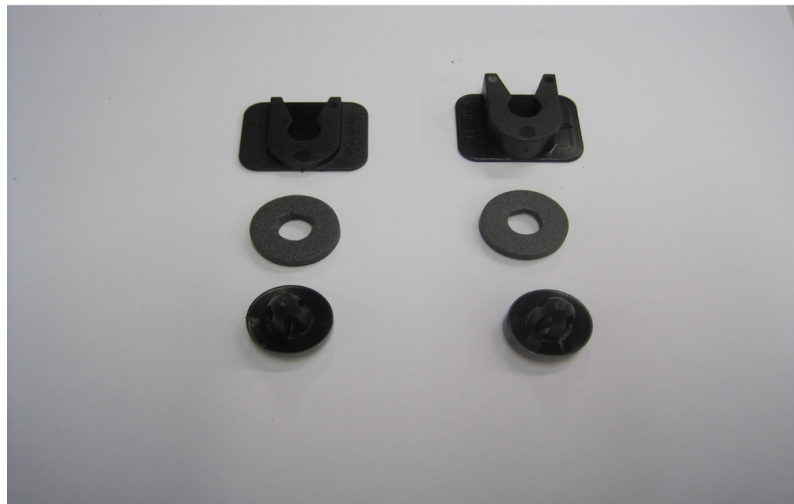
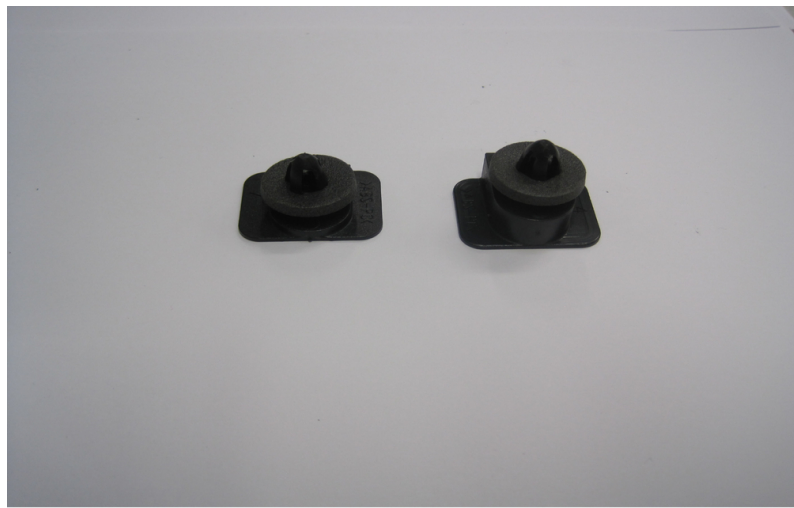
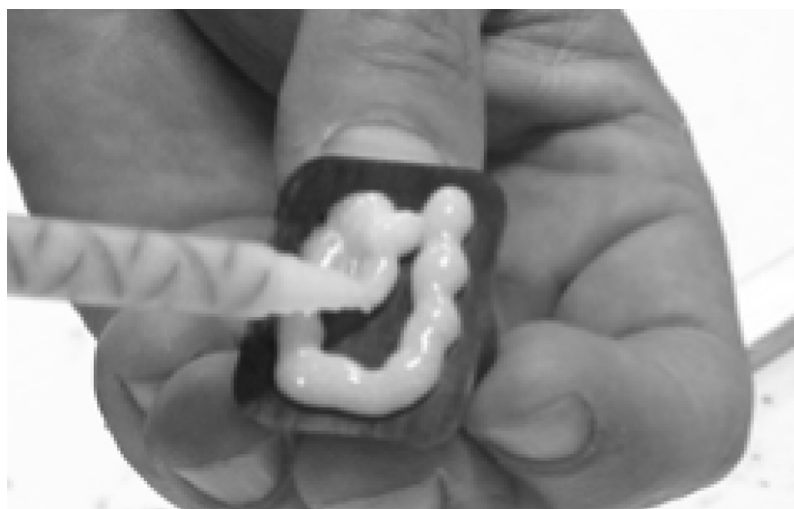
Caution! Apply the adhesive carefully as illustrated.

**Note! The glue should be applied generously**

Special Tool: 1891989348, Glue gun

Use: Glue , 0893301900

Static mixer tip: 08910005
