# Technical Journal

**Extended Warranty P89405, Volvo Emblem on Radiator Grille  
iron mark logo**REF NO:  
**TJ 25957.3.6**ISSUING DEPARTMENT:  
**Technical Journal**CAR MARKET:  
**United States and Canada**PARTNER:  
**3 US 7510 Volvo Cars North America**ISSUE DATE:  
**2016-08-08**STATUS DATE:  
**2016-08-10**FUNC GROUP:  
**8232**FUNC DESC:  
**Radiator grille moulding;  
radiator grille****Page 1 of 8****“Right first time in Time”**

<b>Title</b>	Emblem radiator masking	<b>Page</b>	1 ( 6 )
<b>Action</b>	Replacement	<b>Operation number:</b>	82395-2

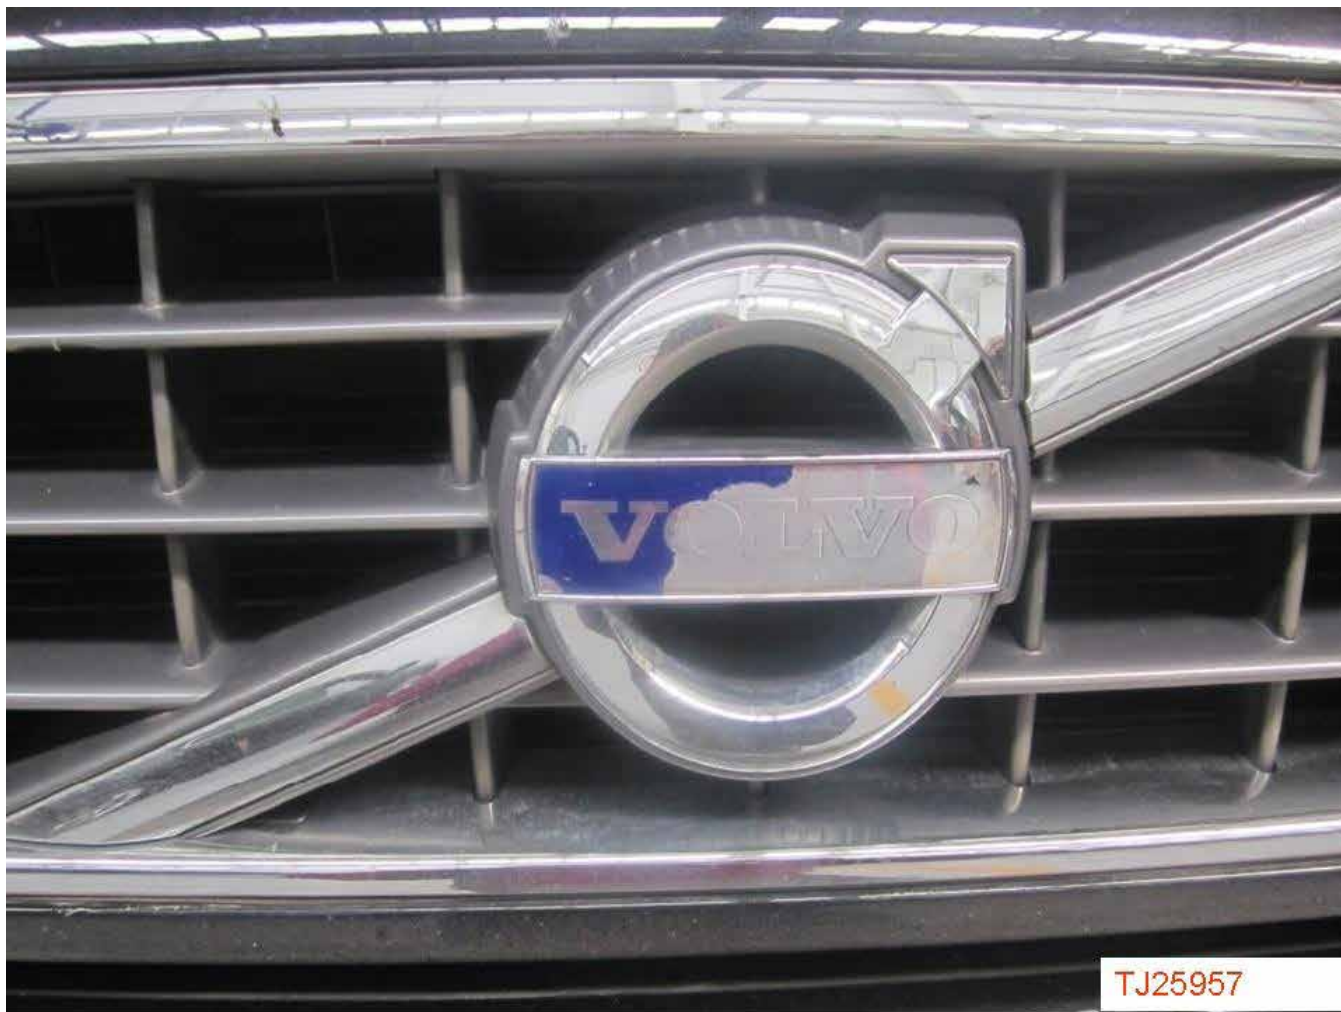
Volvo Cars of North America, LLC and Volvo Cars of Canada Corp. has voluntarily decided to further extend warranty coverage on certain model year 2010 – 2014 S80, S60, V70, XC70, XC60, XC90, S40, V50, C30, C70 models. Volvo has determined that there is the potential for the VOLVO emblem on the radiator grille Iron Mark logo to peel off.

The corrective action is to replace the VOLVO emblem on the radiator grille Iron Mark logo, if the vehicle displays the condition listed in this technical journal.

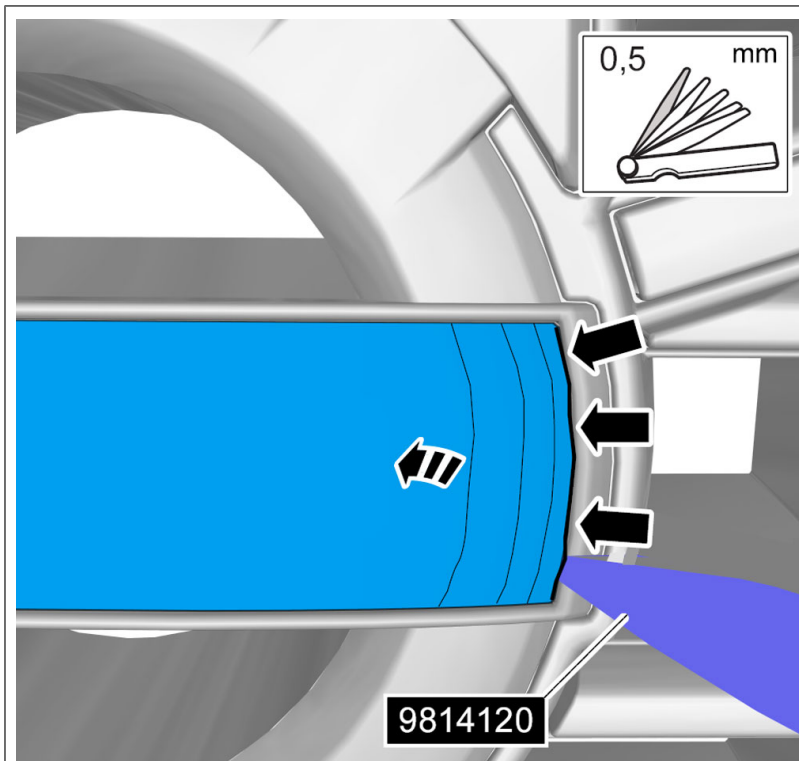
**Caution! Observe caution when carrying out this step.**

Special Tool: T9814120, Feeler gauge

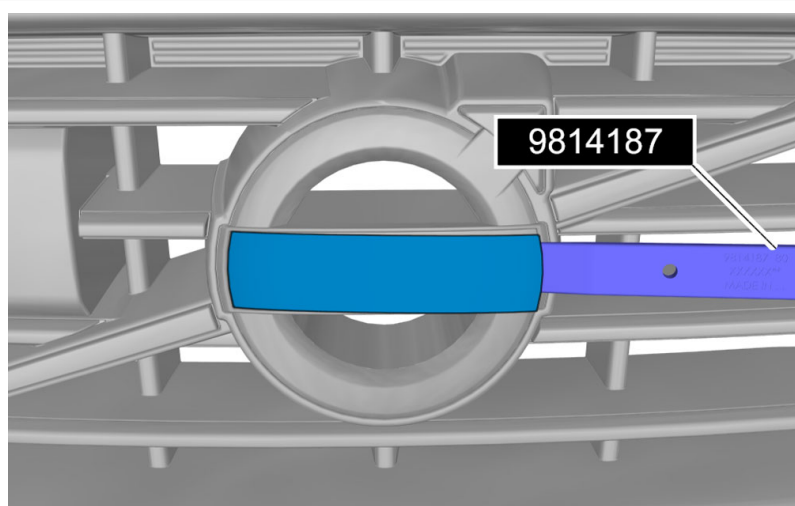
Special Tool: T9814187, Clip tool

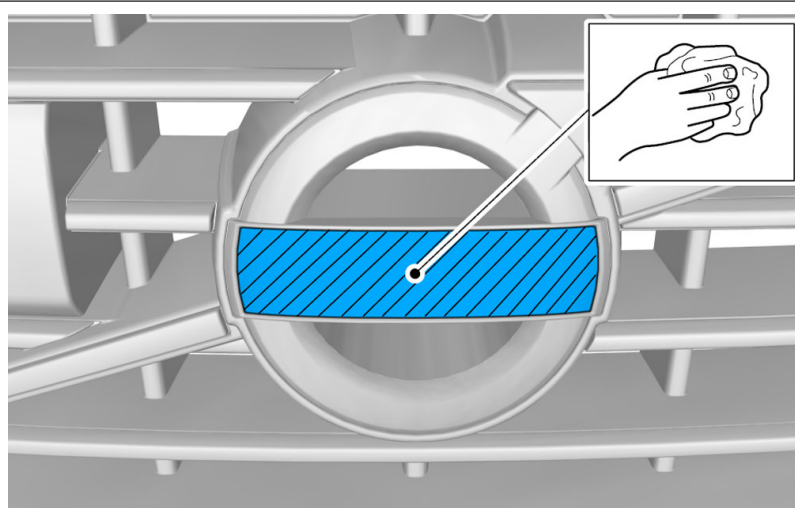
**Use:** H Cleaner , 1161436

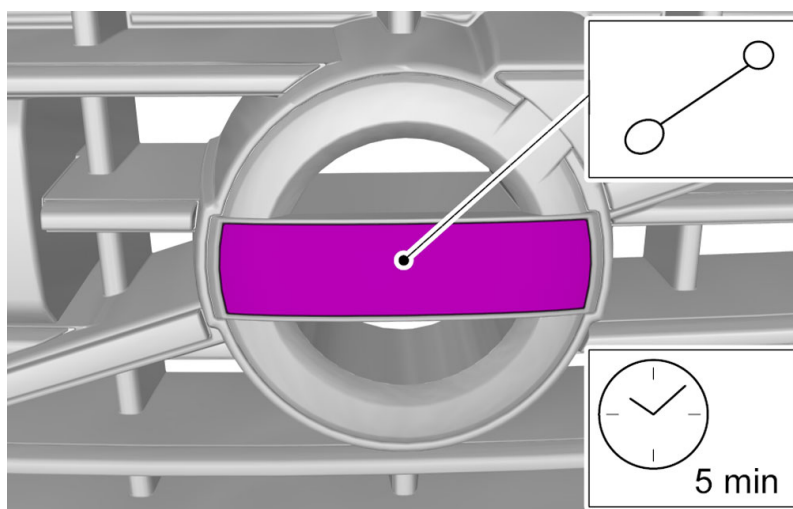
**Warning!** Be prepared to collect escaping fluid.

**Caution!** Make sure to protect adjacent surfaces or components.

**Use:** Wurth primer 089391013

Allow to dry.

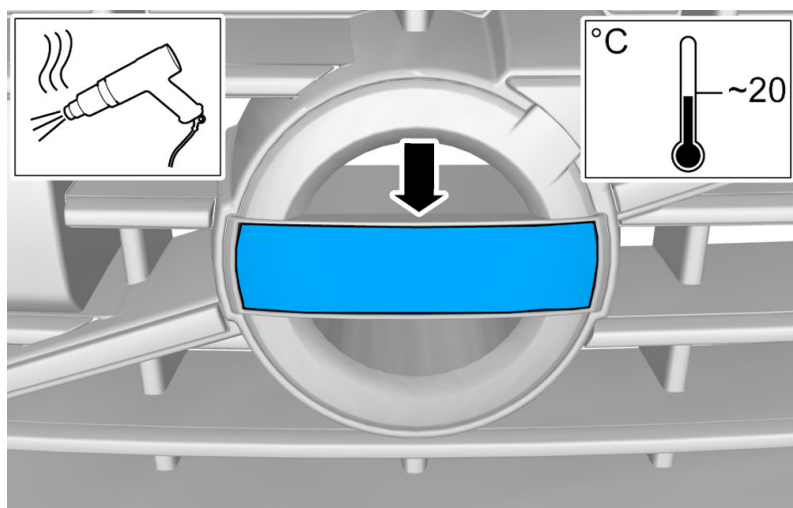
**Caution!** Make sure that the component is not bent.

**Caution!** Make sure that equal pressure is applied to the full length of the component.

**Note!** Make sure that the mating faces are at a minimum temperature of 20°C.
