# SAFETY RECALL

Date	Number	Release	Page
04.2016	<b>RVXX1603</b>	<b>01</b>	1 (4)

## One Piece Steering Shaft, Replacement

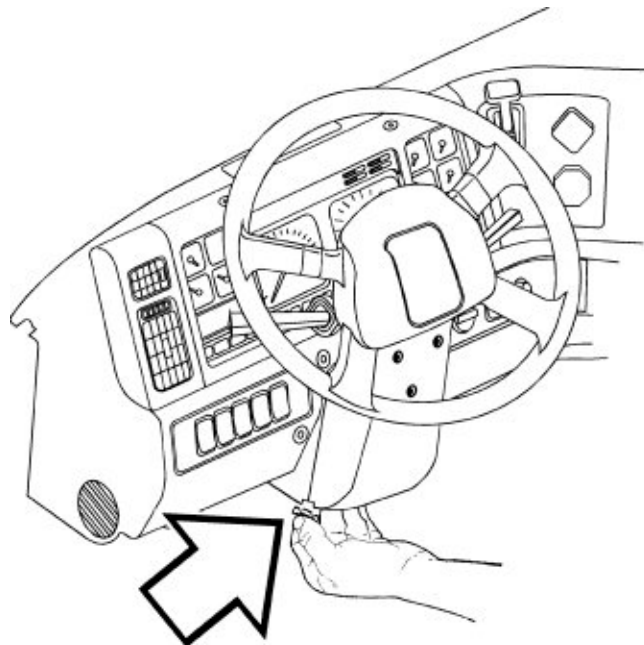
1. Verify service recall eligibility by checking service recall status in VDA.
2. Secure the vehicle for service by parking it on a flat level surface, applying the parking brake, chocking the rear wheels, and placing the transmission in neutral. Open hood.
3. Ensure the vehicle front wheels are pointing straight ahead.
4. Remove the push clips from the bottom of the front and rear upper steering column covers.

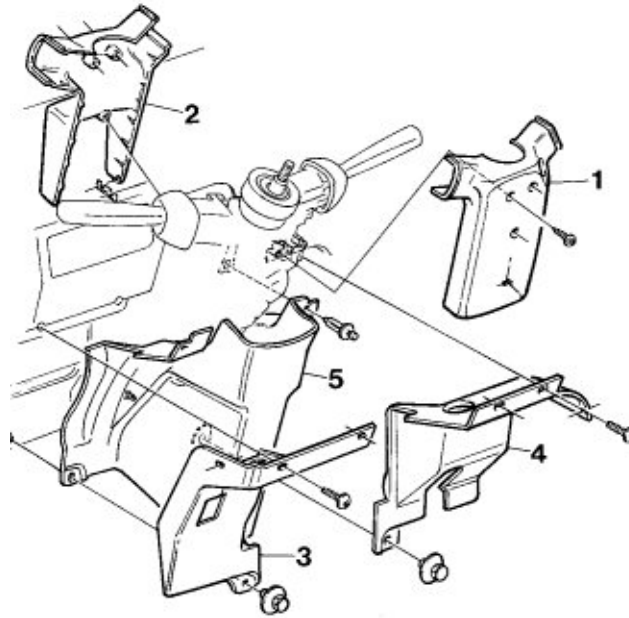
5. Remove the covers from around the steering wheel in the order shown.

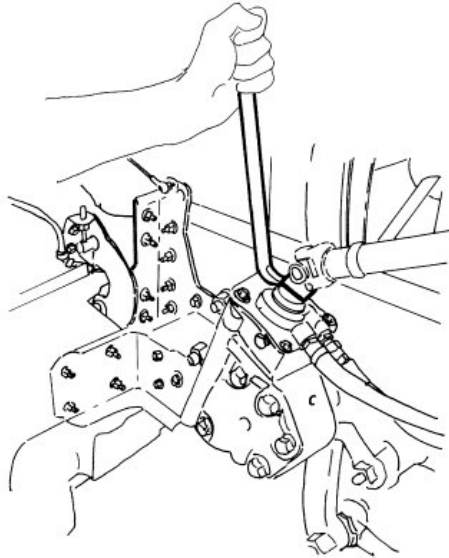
6. Loosen the pinch bolt on the steering shaft upper U-joint. Pry the U-joint off the steering column.
7. Remove the bolts from the shaft boot in the engine compartment. Retain the bolts for reuse.
8. Remove the pinch bolt on the steering shaft lower U-joint. Pry the U-joint off the steering gear.

**CAUTION: Possible equipment damage. Some steering gears have a plastic ring on the input shaft that acts as both a timing ring and a dirt cover. Use care not to damage the ring when prying the U-joint off the steering gear. Failure to use care could damage the plastic ring.**

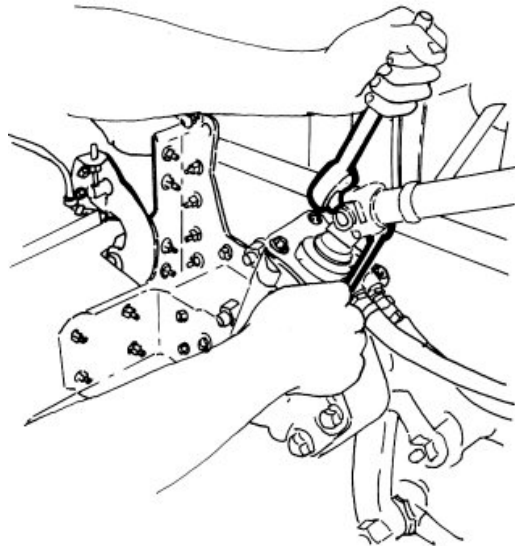
11. Replace the pinch bolts on each end of the steering shaft with a new original equipment bolt.
12. Connect the shaft upper U-joint to the steering column. Tighten the pinch bolt to  $60 \pm 10$  Nm ( $45 \pm 7$  ft-lb). The pinch bolt is perpendicular to the steering column shaft.
13. Ensure the steering wheel is centered.
14. Connect the shaft lower U-joint to the steering gear input shaft. Tighten the pinch bolt to  $60 \pm 10$  Nm ( $45 \pm 7$  ft-lb).
