# Field campaign

| Topic | Bentayga Start Stop Switch (SC16/29) |
| Campaign number | EA67 |
| Type | PDI Campaign |

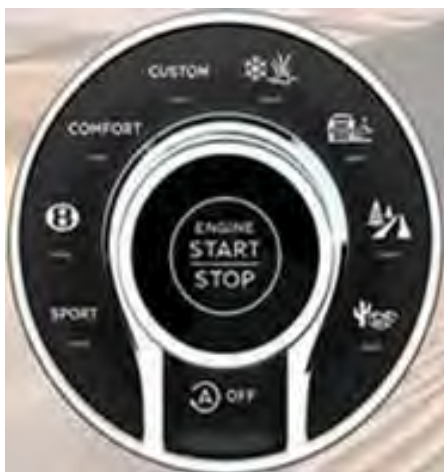
Figure 1

If the vehicle is not already listed as repaired in the "Repair History" (ElsaPro), check for the presence of a RED identification mark on the underside of the Service Cover for the Brake Fluid Reservoir - figure 1.

Cycle the Start Stop switch twenty times without starting the vehicle, after twenty operations start the engine and use the Bentley approved diagnostic tool to check for stored fault codes in Control Module 0046 – Central Module Comfort System. Should Diagnostic Trouble Code B143C29 – "Access / Start authorisation button implausible signal" be present, replace the switch pack "Button for driving profile" containing the Start Stop switch.

Upon completion place a RED identification mark on the underside of the Service Cover for the Brake Fluid Reservoir - figure 1.
