SERVICE BULLETIN

APPLICABILITY: 2010-12MY Legacy and Outback 2.5L NA Models
 2013-2017 Legacy and Outback 3.6L Models
 2014-17MY Forester Turbo Models
 2015-17MY WRX
 All Above Models Equipped with TR690 CVT

NUMBER: 16-103-16
DATE: 12/14/16

SUBJECT: Transmission Fluid Seepage

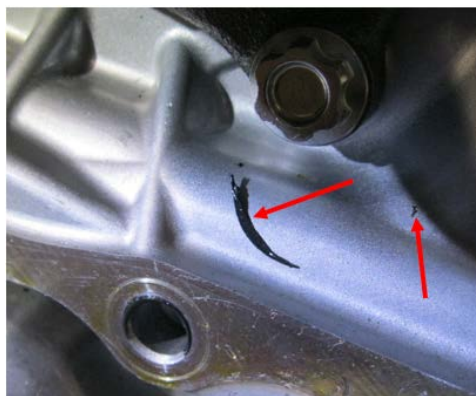
- CAREFULLY** remove all residual sealant completely from the cover and mating surface of the housing. **DO NOT** use any abrasive or gasket removal / cleaning discs. Use the adhesive side of a piece of duct tape (or equivalent) to pick up any loose pieces of sealant which may be found in the cavity around the stator support. **DO NOT** use compressed air.

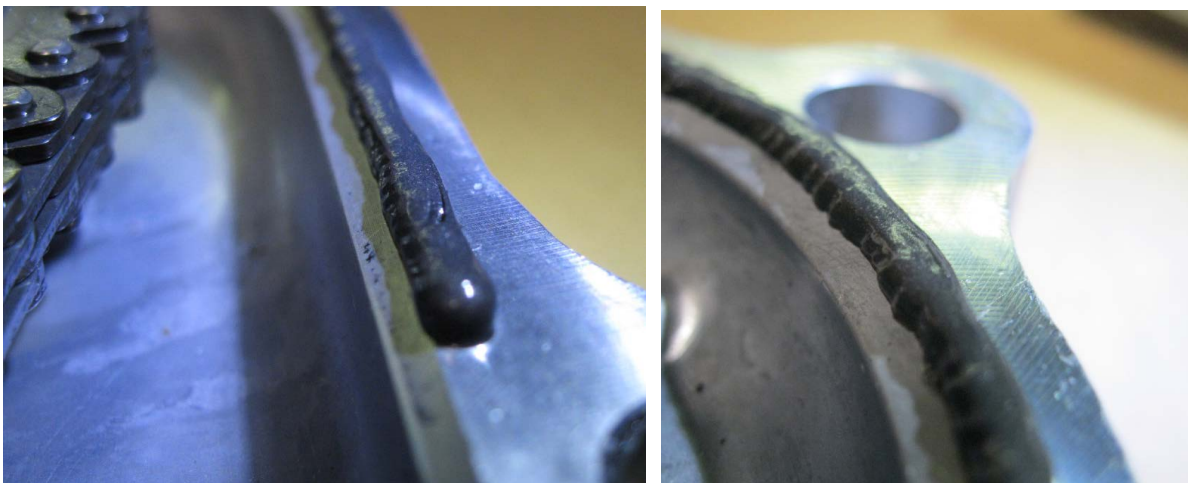
- Once both surfaces and the area surrounding the cover are completely clean and dry, **CAREFULLY** apply the new sealant bead to the cover along the edge of the chamfer as shown below.
