## SERVICE BULLETIN

**APPLICABILITY:** 2015MY Outback Models

**NUMBER:** 12-202-16

**SUBJECT:** Rear Gate and Rear Gate Buffer Information

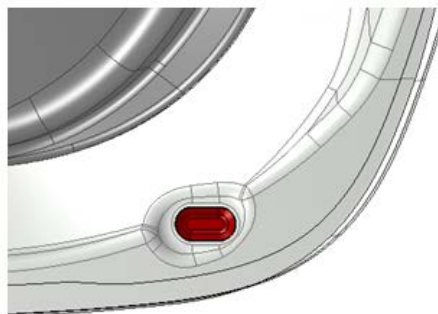
**Water Drain Plug**

**Drain Plug Installed**

This bulletin describes a design change to the rear gate panel eliminating the plugs previously installed in the lower outer corner water drain holes. As a result of this change, there has been a change made to the rear gate buffers as described in the Service Procedure section below.

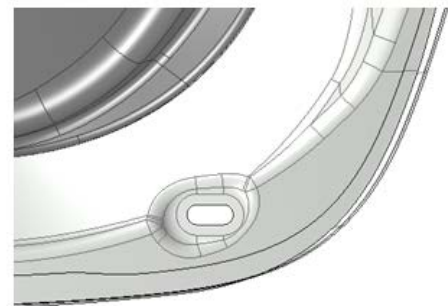
**Drain Plug Removed**

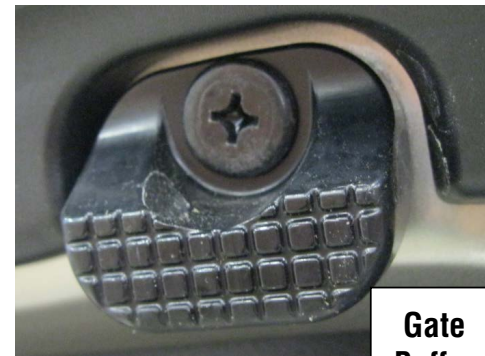
**Gate Buffer**

- On Vehicles **BEFORE VIN F\*207916**: the buffers and the retaining screw are **One-Time Use** items and must be replaced with the part numbers shown in the table above.

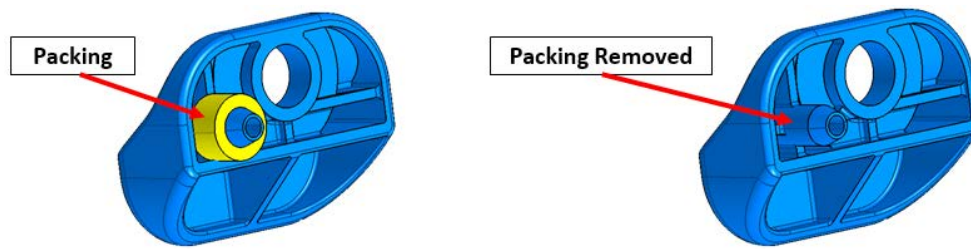
- On VIN F\*207916 and later: the original buffers and retaining screw can be reused **BUT**, the rubber “packing” shown in yellow on the illustration below must be removed before installation.
- Torque the retaining screw to 5.5 ft. lbs. (66 inch-pounds).
