NOTE: THIS LSC EXPIRES ON JULY 31, 2019

**TECHNICAL INSTRUCTIONS
FOR
LIMITED SERVICE CAMPAIGN GLI
CARPET FLOOR MAT REPLACEMENT
CERTAIN 2016 MY RC 300 AWD & RC 350 AWD**

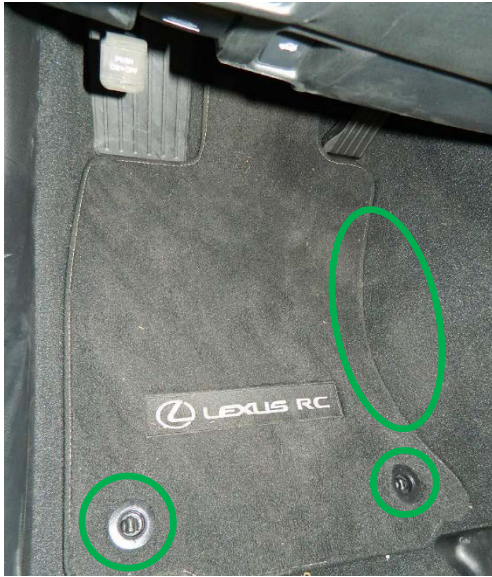
The mat should fit around the transmission tunnel as shown.

Both rear hold down clips should line up and be secured.

THIS IS THE CORRECT FLOOR MAT

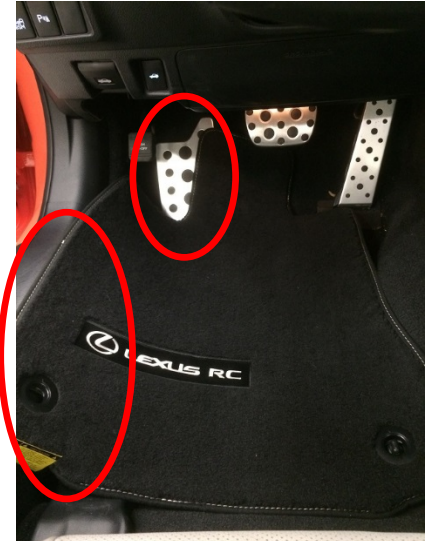
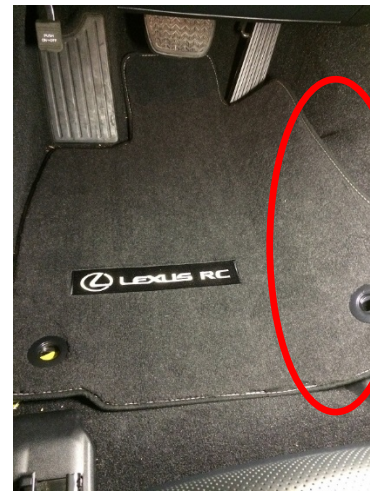
The edge of the mat does not fit in the vehicle correctly.

The dead pedal may be partially covered.

One or both rear hold down clips do not line up and are unsecured.

**THIS IS THE INCORRECT MAT
REPLACE ALL 4 FLOOR MATS**

NOTE: All-weather floor mats are not involved in this LSC. If all-weather floor mats are installed in the vehicle and the carpeted floor mat is NG, place the new mats in the trunk. DO NOT install the carpeted mats on top of or under the all-weather mats.
