Bulletin No.: PIT5487B

Subject: Service Park Assist/Camera/Cruise/ and/or Front Park/Turn/Cornering Light Inop Blown Fuses (Front

Fascia/Bumper Harness Chaffing)

Models: 2015 - 2017 Cadillac Escalade Models

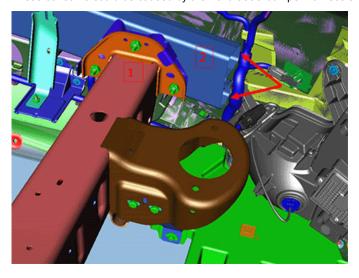
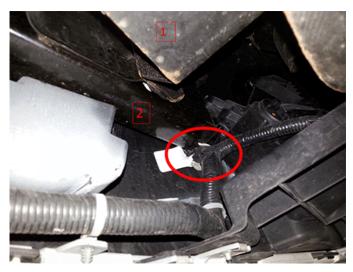
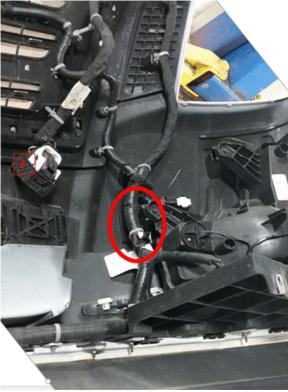
These concerns could be caused by the front fascia/bumper harness shorted at the end of the right front bumper bar (2), as shown below.

- **1.** Right front frame rail
- 2. Right side of front bumper bar
- 3. X100 inline connector

The front fascia may need to be removed to make repairs to the wiring harness if any damage is found. After repairing any damaged circuits, reinstall the front fascia and pay close attention to reroute the wiring harness behind the front bumper bar and secure with a zip tie to the fascia, as shown below. This will prevent it from damage again in the future.
