Service Bulletin

Subject: Removal of Transit Blocks During Pre-Delivery Inspection (PDI)

Models: 2014-2016 Chevrolet SS

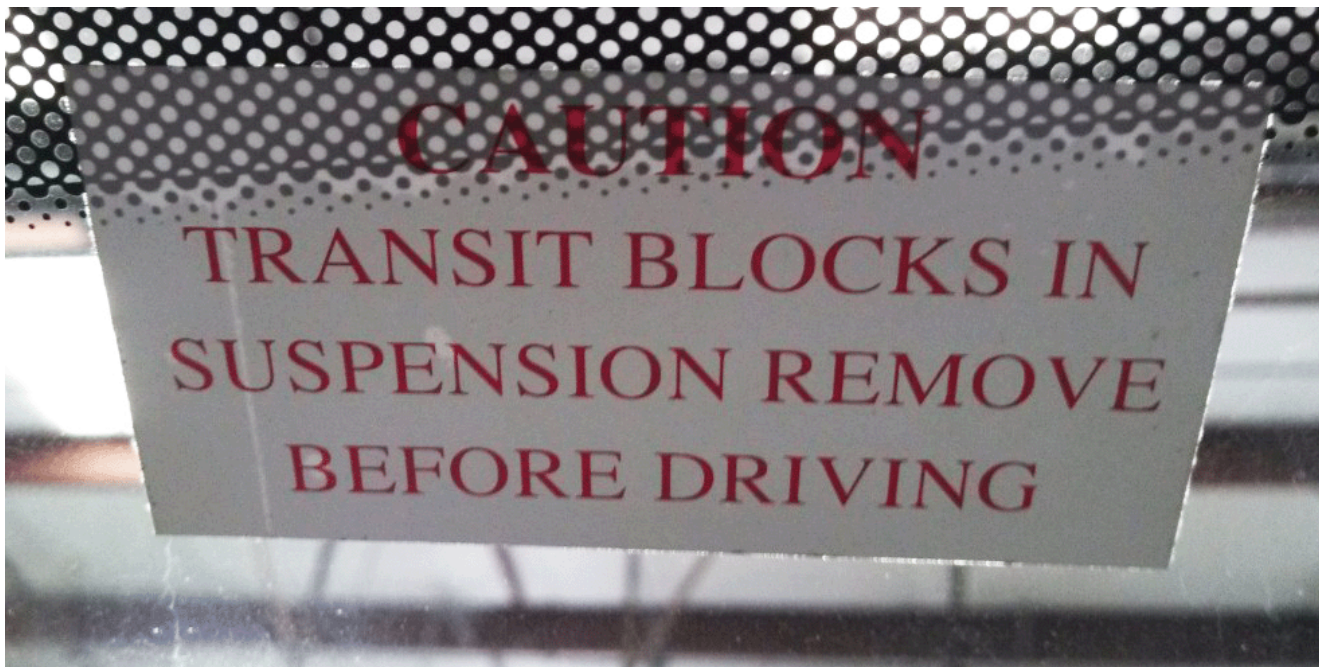
Removal of Transit Block Window Sticker

A reminder sticker to remove the transit blocks is applied to the vehicle windshield during assembly. This sticker should be removed only AFTER the transit blocks are removed.

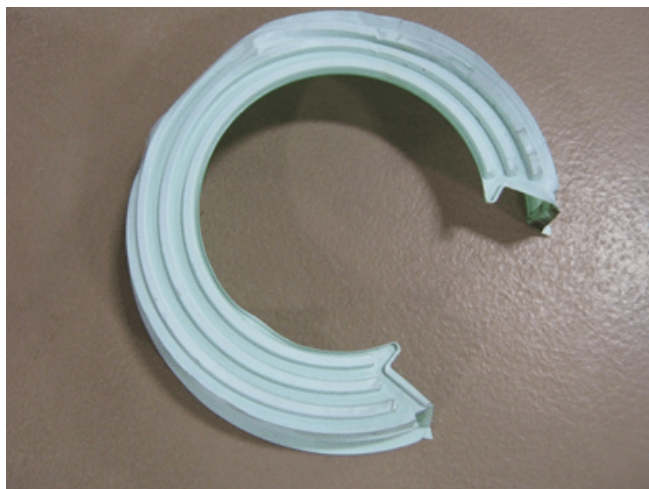
Rear Disc Brake Rotor Protection Covers (2014 MY Only)

- The factory installs rear disc brake rotor protection covers during vehicle manufacture. These covers MUST be removed from the rear rotors when performing the PDI.

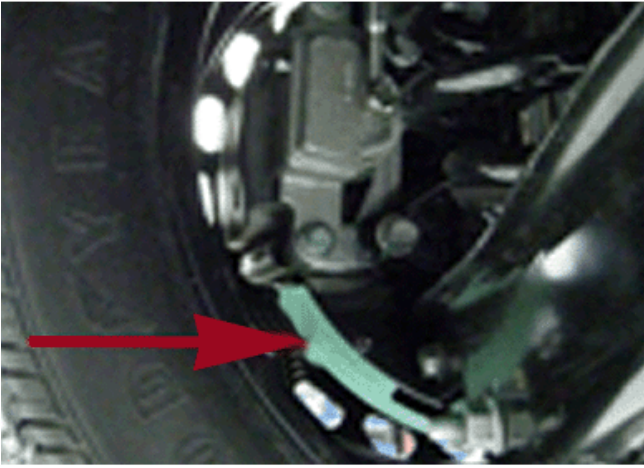
- With the vehicle on a hoist, rotate the wheel while at the same time pulling the torn end of the cover away from the disc brake rotor and wheel. Ensure that all material is removed and repeat for the other side.
